Conservation and management of historical buildings 2008

*Programme of work for the preservation/maintenance
plan for the old District Officer's administrative
colonial building in Malindi, Kenya*

**Abdulswamadu A. Ali
Engineering Technologist
National Museums of Kenya**

November 2008

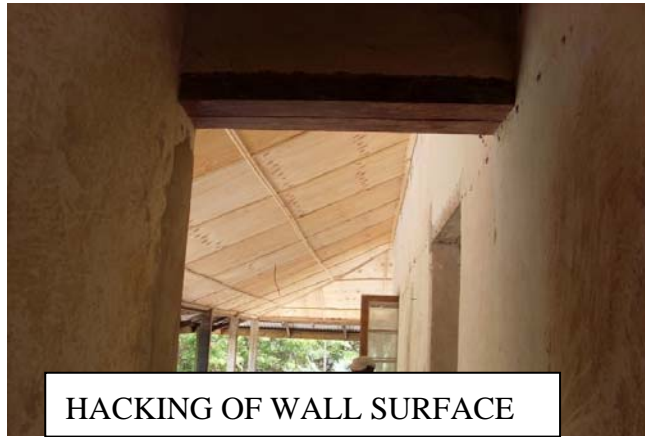
HACKING OF WALL SURFACE

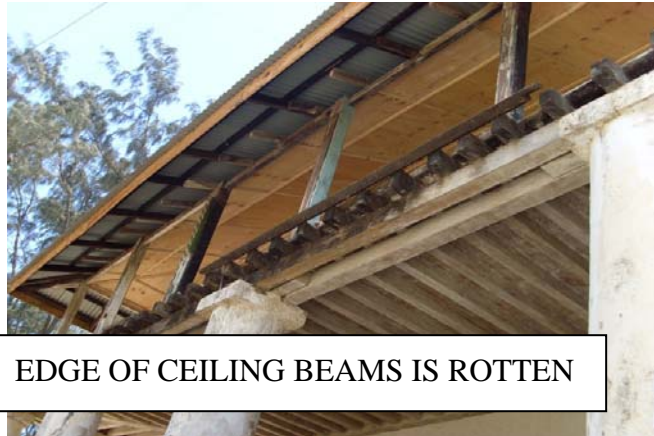
EDGE OF CEILING BEAMS IS ROTTEN

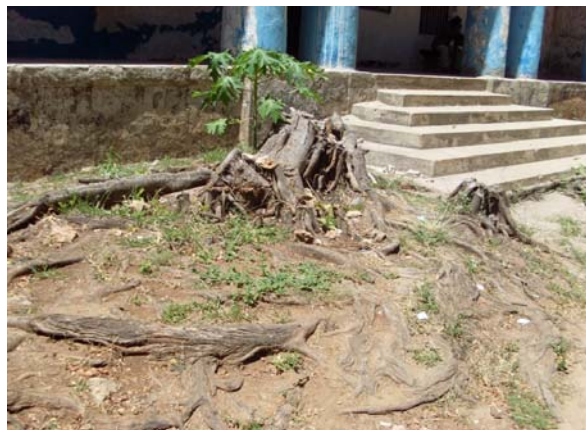
ROOTS UNDER THE BUILDING

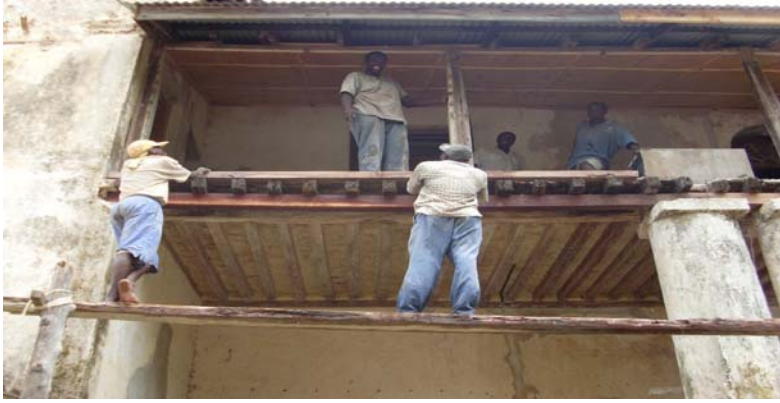
REPLACEMENTS OF MAIN BEAM

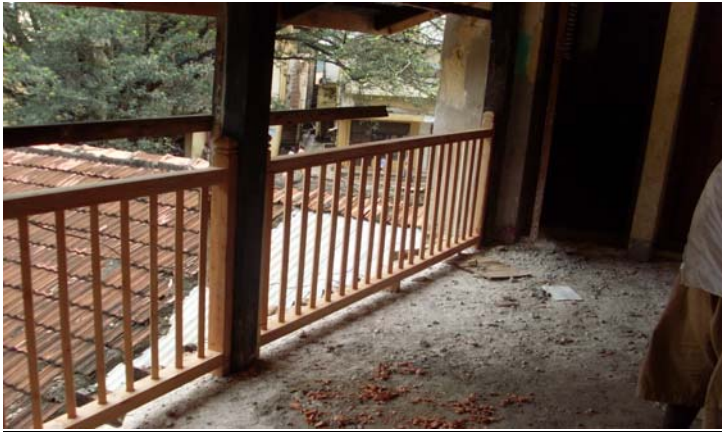
BALCONY REPLICA

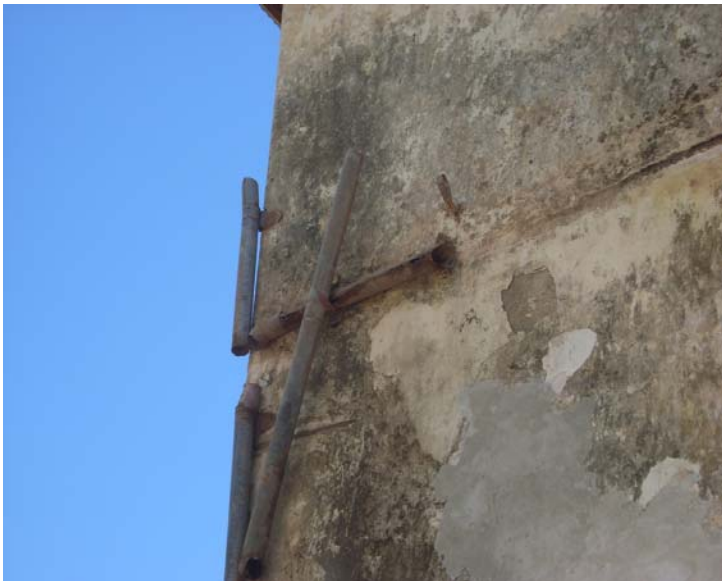
DELAPIDATED DRAINAGE SYSTEM

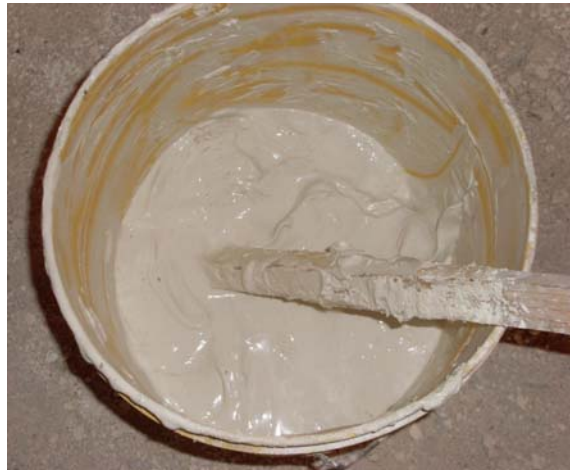
NERU 1 :4 (W.CEMENT AND LIME)

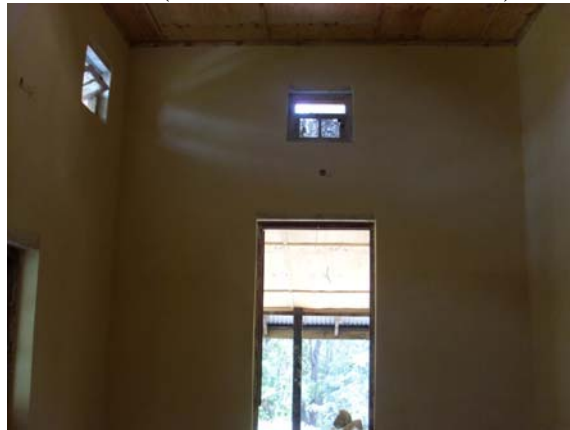
COMPLETED PLASTER

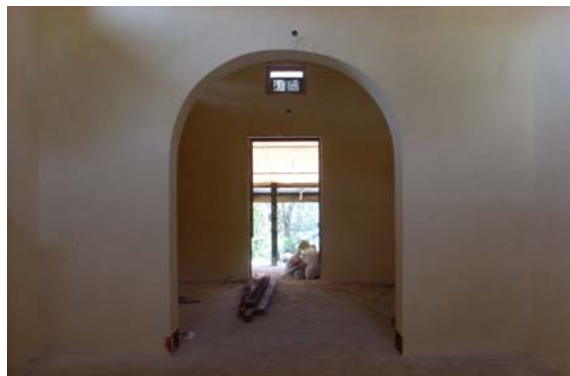
ARCH RESTORED

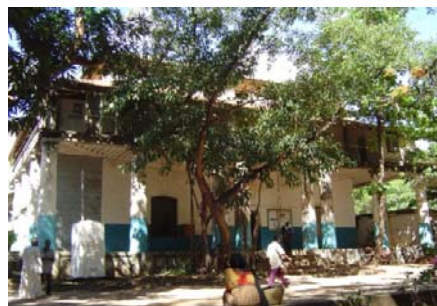
Front blocked with trees

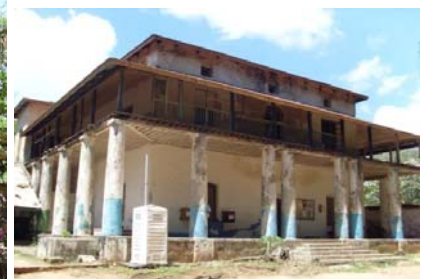
Front faced clearly visible

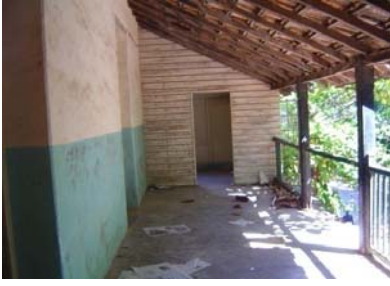
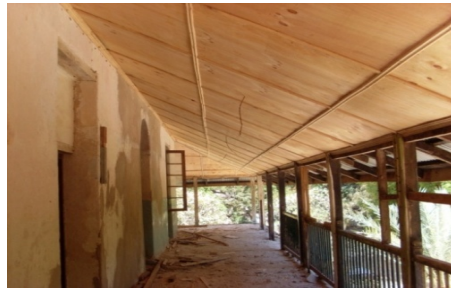
The roof has been entirely reconstructed, with a new structure resting on walls. All the roofing sheets have also been replaced with pre painted galvanised sheets. A new wooden ceiling has been re-constructed.

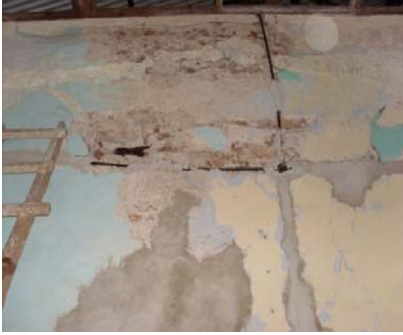
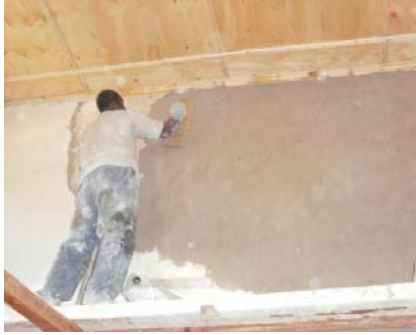
Lime plaster to walls finished with screed of 1 part of white cement to 4 parts lime.

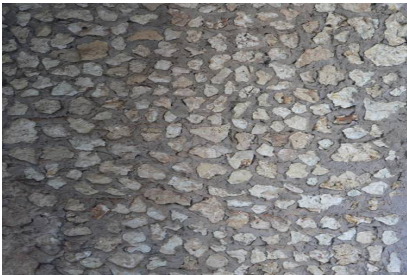
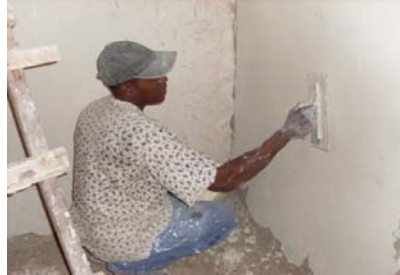
All the plaster has been removed. The weak surface of the walls strengthened, re-levelled with a layer of coral stones laid with lime mortar and finished with lime plaster with screed finish.

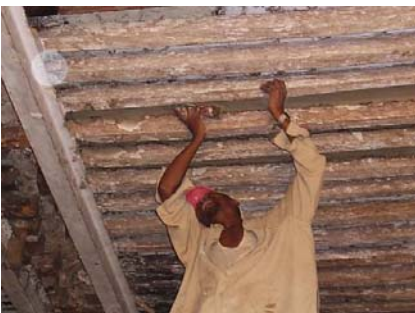
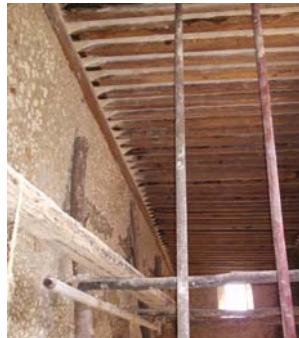
Replacement and propping of the ceiling beams

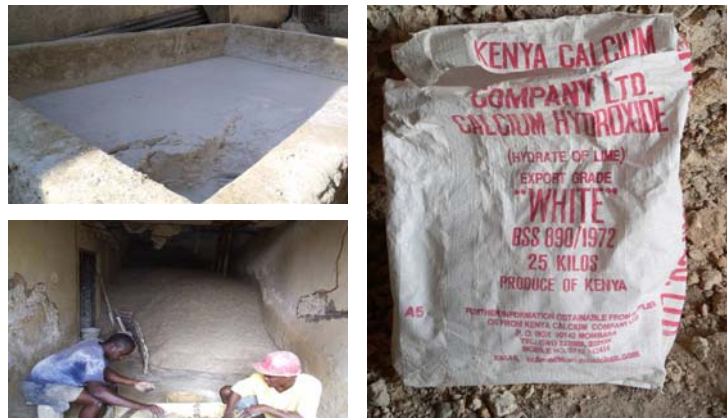
Slaking and treatment of lime
