LANE House

Maintenance Program & Plan

Lia Mayumi

DPH - Department of Historic Heritage/ Municipality of São Paulo/ BRAZIL

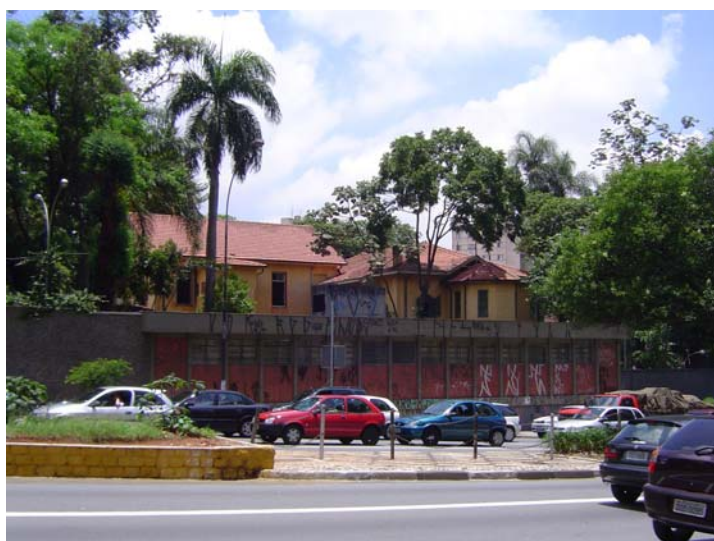
Figure 7: The Lane House completely hidden by the supplementary building built in the 1970s. The demolition of the supplementary building will allow the house to be seen from the street. Photo: Tatiana Cipoli

The demolition of the supplementary building is included in the conservation project.

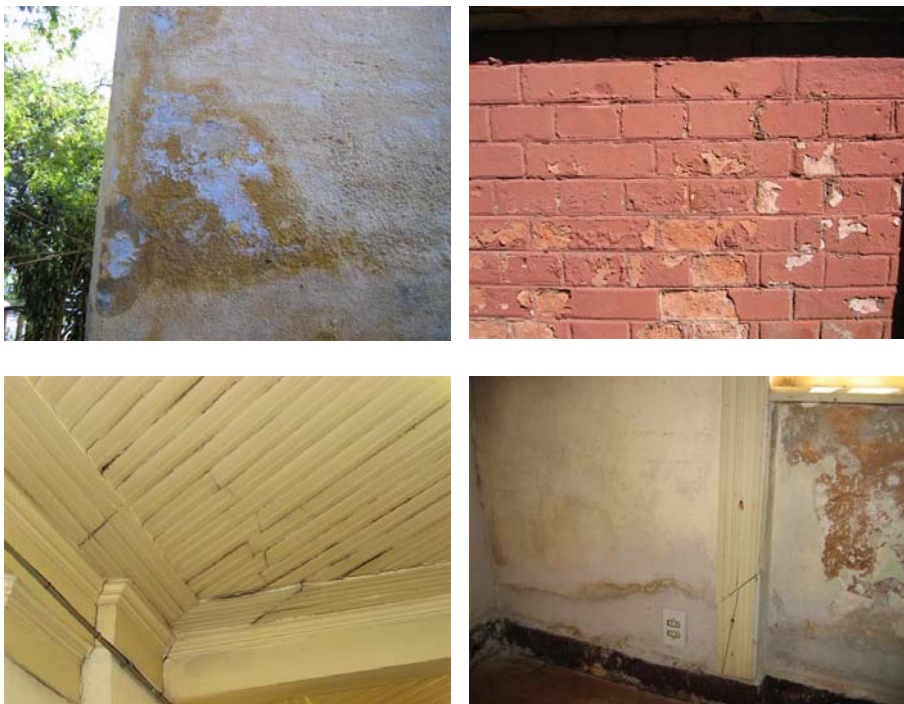
Leakage of rainwater is coming into the second floor rooms because of rusted metal gutters of the roof. The leakage penetrates the walls and reaches even the ground floor walls. Moisture can be seen on the painted surfaces of the walls.

Vegetation is growing inside the gutters and inside the small cracks which appeared in the external walls of the terraces. Bigger roots are destroying the stability of the terrace walls.

Unauthorized plastic paint covers the brick walls, causing the bricks disaggregate. Also cement plaster was applied without the permission of the Department of Historic Heritage architects.

Wooden parts of the roof were attacked by termites. Also the windows and doors frames and sashes were attacked by insects.

Figure 15-18: Damages: infiltrations, leakage, humidity, sunlight effects, inadequate plastering.

1. Treatment of every existing and new timber against termites. Moisture deriving from leakage of rain water from the roof is the main cause of the presence of termites in the roof trusses and door frames. The correction of the roofing system (change of broken tiles and gutters) is supposed to help stopping the water leakage process. Walls: Replacement of deteriorated lime-based plasters, using lime mortar.

2. Roof: Replacement of timber damaged by attack of termites or humidity. Replacement of the totality of metallic gutters. Replacement of broken French tiles (Marseille tiles).

3. Walls: Replacement of deteriorated lime plasters, with application of new lime mortar.
4. Ceiling: All the rooms have wooden plank ceilings. Planks are deteriorated mostly by leakage of rain water. Deteriorated planks will be replaced by new ones.

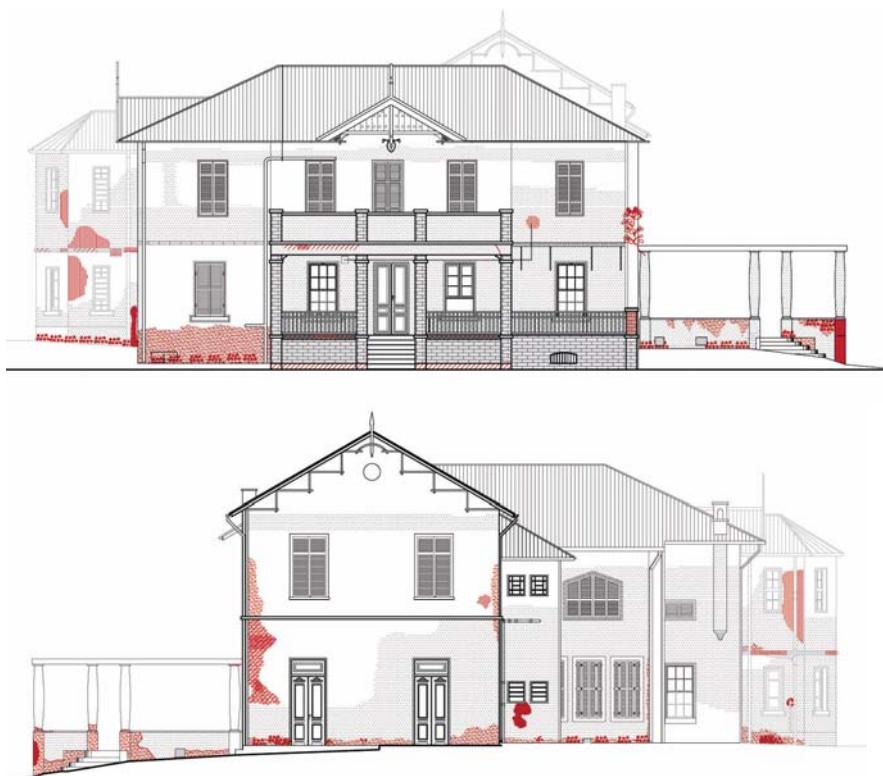
Figure 20, 21: North and South façades elevations, showing damaged paintings and plasters.

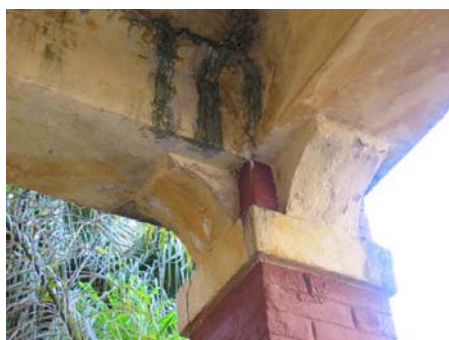
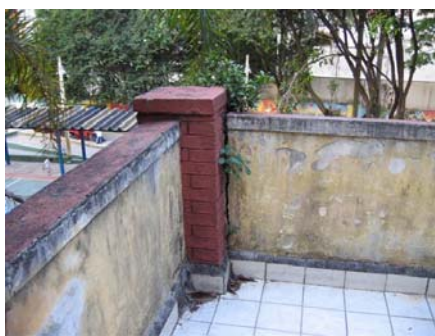
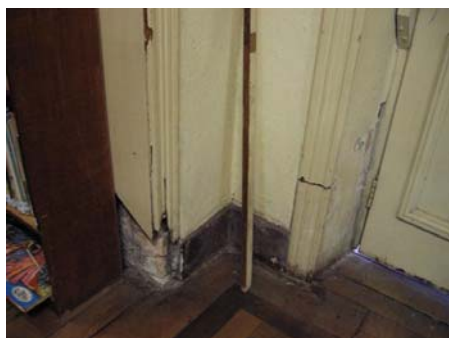
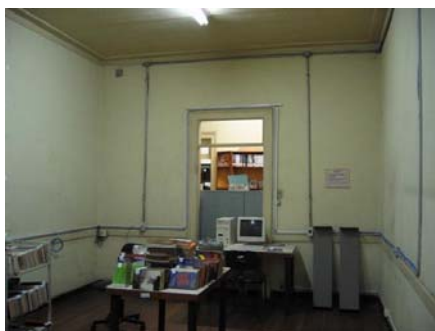
Figure 22-25: humidity, vegetation, missing parts, provisional electrical system.
