The Subercaseaux Building

Evaluation of the structural capacity in traditional construction in Valparaiso

Marcela Hurtado Saldías

Universidad Técnica Federico Santa María – CHILE

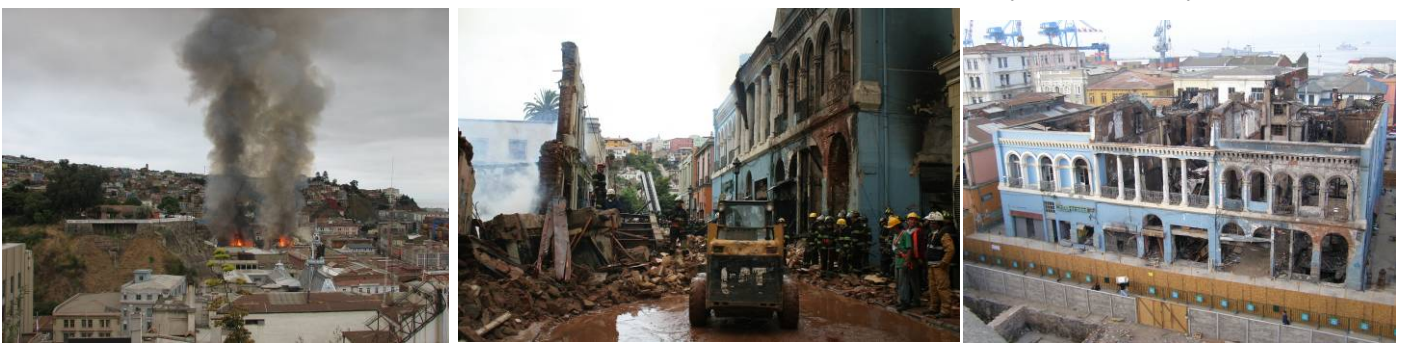
In February 2007, due to the explosion of a colindant building, several damages occurs to the Subercaseaux building. The inner wooden structure and the ceiling are the most damaged ones. The external walls stand, as well as some interior walls, all made out from clay brick masonry.

Figure 9. General views during and after the fire.

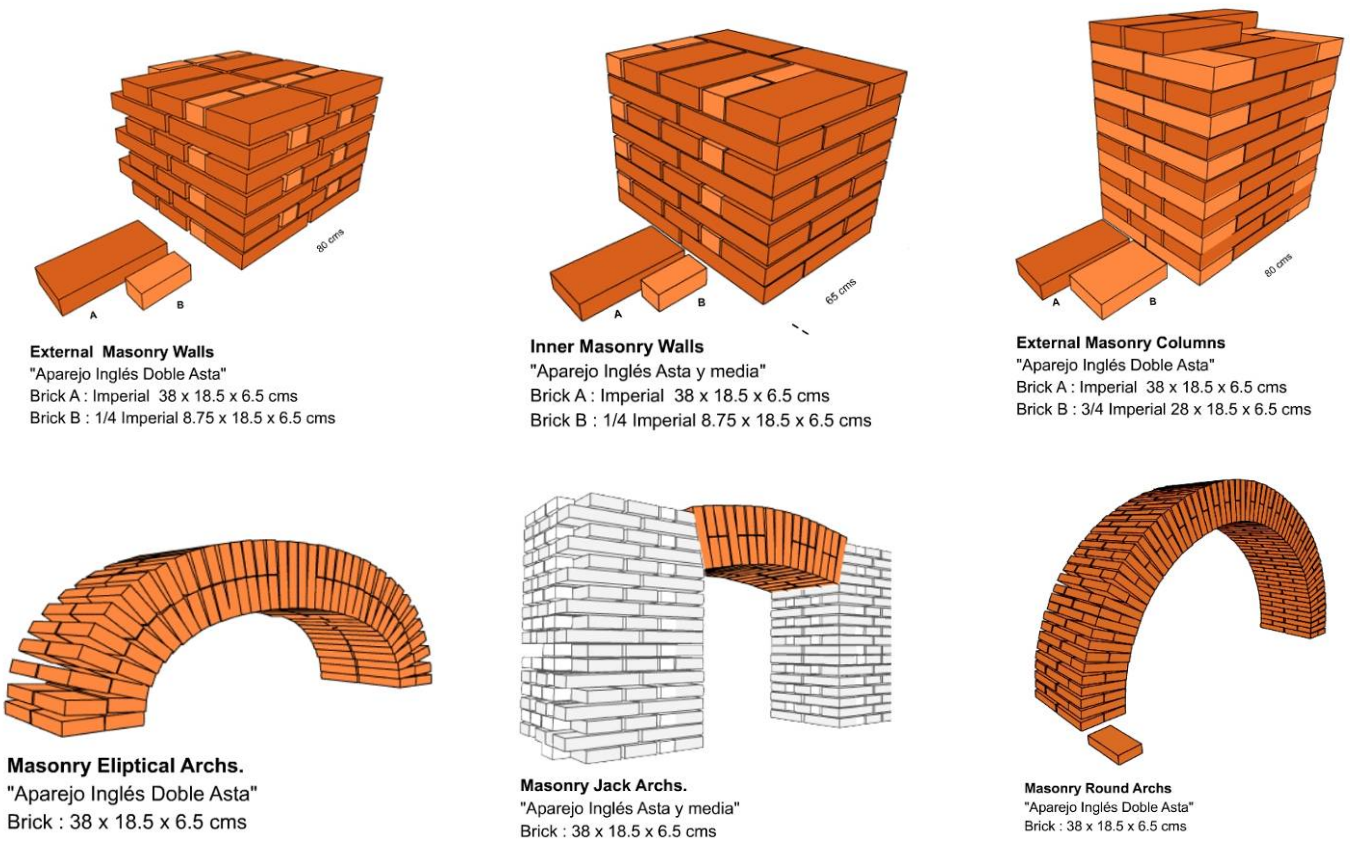
This particular work (2 and 3 stories) it's composed by a clay masonry structure (72 cms wide) with lime mortar. In its perimeter and two of the interior's main axis's. The bond type employed is detailed in Figure 10. There's no evidence of the use of any bracing metal element, like beam sections or strap, as it's observed in other city buildings, build some decades later, with the same technology.

Figure 10. Masonry walls

The Subercaseaux building did endure in a great way the two previously mentioned earthquakes. The clay masonry walls state confirms it: even after the explosion, they remain in a good shape, making a homogeny mass, without the presence of cracks. We don't have any figurative chart prior to the explosion, but, from the photographic documentation available it is possible to detach that its condition was optimal.

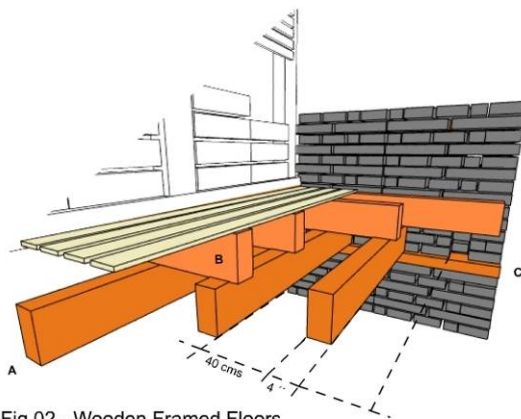
The rest of the walls were wooden structures, with different fillings (brick or clay): The floor structure is also of wood; made from oak and oregon pinewood, set with 65 cms in between axis's.

Fig 02 - Wooden Framed Floors.
 A.- Main Oak Joists 4x8" @ 40cms
 B.- Secondary Oak Joists 4x8"
 C.- "Empotrado" Beam 2x4"
 D.- Wooden Subfloor

Figure 11. Wooden roof structure.

The floor wooden structure acts also as a strapping element, in the form of a diafragm, specially because it is a very thick system, made out of very strong pieces. The vulnerable pints in these cases would be the entailment between the beams and the walls. The effect that an earthquake can cause is the wall displacement, or the wall “beating”. The evidence we have at hand reveal that the floor and ceiling structure were in perfectly united to the wall. The problems observed are originated more from humidity or non technical interventions. All this, as we pointed before, weaklings the original structural system.

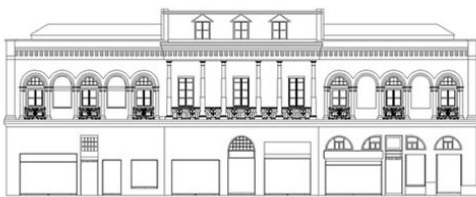
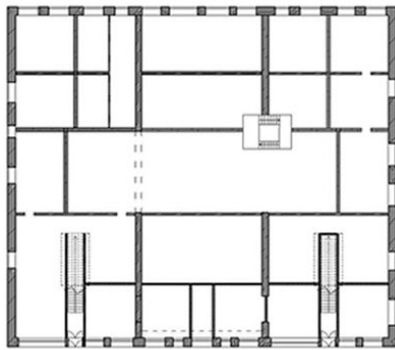
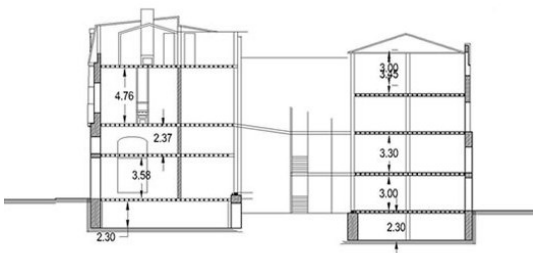
These changes are not easily perceptible from the outside. Nevertheless they weaken and degrade the original design, specially the two inner yards system.

In its lower commercial floor there are many transformations made, affecting its main façade in Serrano Street. Those changes affect aesthetically and structurally the original design, because they suppress brick columns to get wider spans. All these interventions happens using reinforced concrete. There are doors and windows change too.

Figure 13. The building in 20th century.
(Drawings: Taller Intramuros.
Department of Architecture. USM_2007)

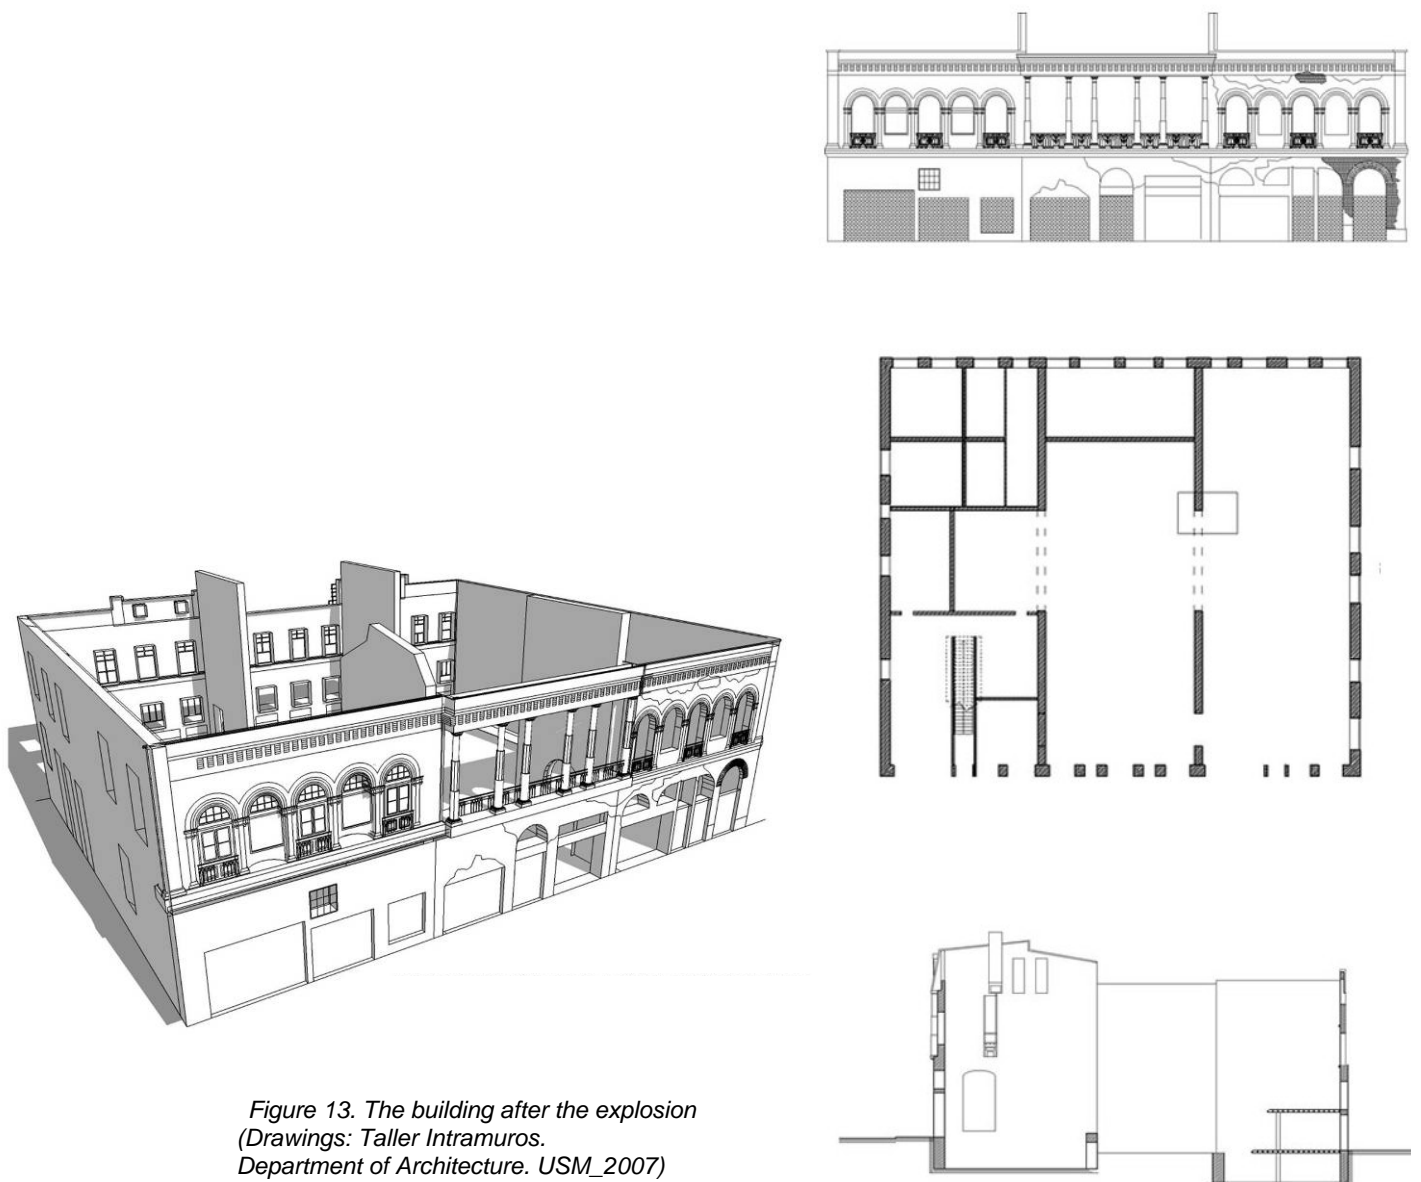
After the explosion, practically all the wooden structure is lost or seriously damaged. As it was pointed out, all the materials used in the previous interventions were, in the majority of the cases, of rapid combustion. The clay masonry, including the perimetral and the interior ones stand, without significant inclination or collapsing danger, even though they are much altered. The photographs show the stat of the building prior to the explosion. This state made possible to suggest an hypothesis for the recuperation of the original structural system (clay masonry walls and a wood floor structure) ; however, after a technical study, it is proposed an reinforced based in a new structure, considered the demolition of the rest of the work`s interior walls, leaving only the ones of the perimeter and the incorporation of a steel structure, of beams and strut. This structure was planned as provisory, while the future of the building was resolved (an eventual purchase from the Municipality, i.e.)

This condition changes after the decision of eliminating all inner elements, and incorporating an additional structure, apparently provisory, but, as all kind of materials utilized and its link system with bearing walls, cannot be eliminated without making even more damage in this walls.

Figure 13. The building after the explosion
(Drawings: Taller Intramuros.
Department of Architecture. USM_2007)

The remaining walls should be integrated with the new shapes and materials with full respect of their original condition, in order to prevent them to look as plain facades wrapping a new building.
