Patio del Moro House

Case Study C&MHB Course 2007-2008

Maria Mojica

Abstract

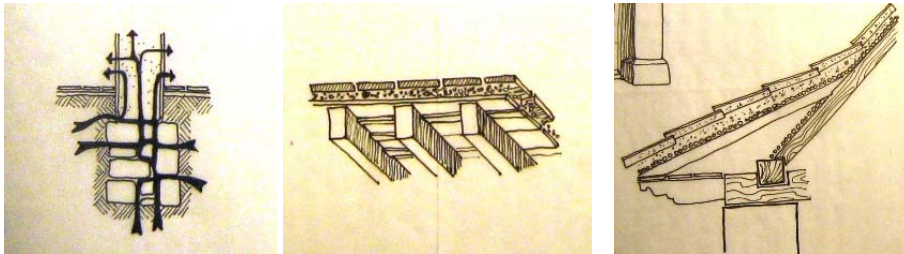
Certain type of moisture comes from the soil and passes upward through foundations and by capillarity appears later on the walls. *Figure*

Small perforations made beneath the walls and grouted with waterproofing substances could be enough to seal and control the water.

And in a complex case it is necessary to excavate along the walls and build a drainage duct in both sides at foundation level to evacuate filtration water.
