The Old House of the Currency

Maintenance Program and Maintenance Plan

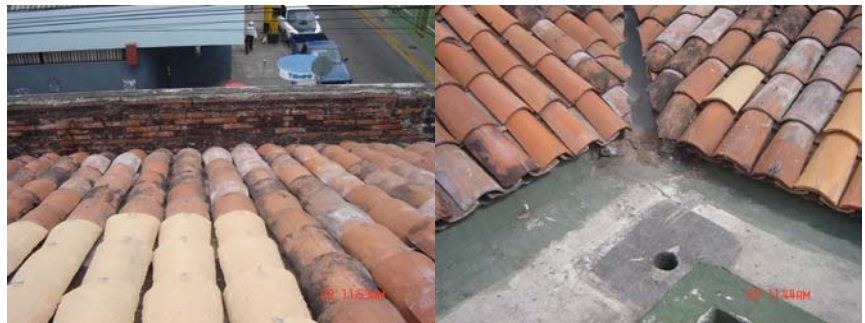
Figure 13: Roof tiles do not match existing ones. Parapet wall is exposed to weathering and lacks capping. Valley canals are zinc made; downspouts in main canal are not protected.

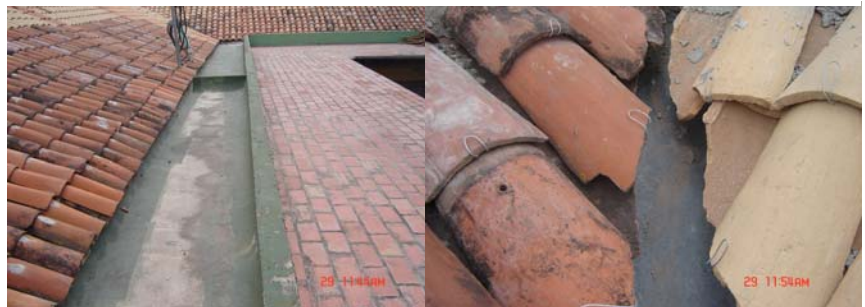
Figure 14: Partitions in main roof canal are due to insufficient slope for water to evacuate. Tile fasted with galvanized wire.

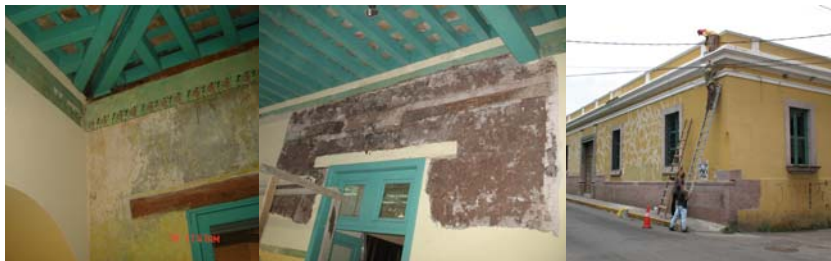
Figure 15: Wall humidity at the bottom of roof canals, untraditional repair with wire mesh, and industrial gypsum compound for repairing cracks in exterior walls, and humidity and mold at unprotected bottom of exterior walls.

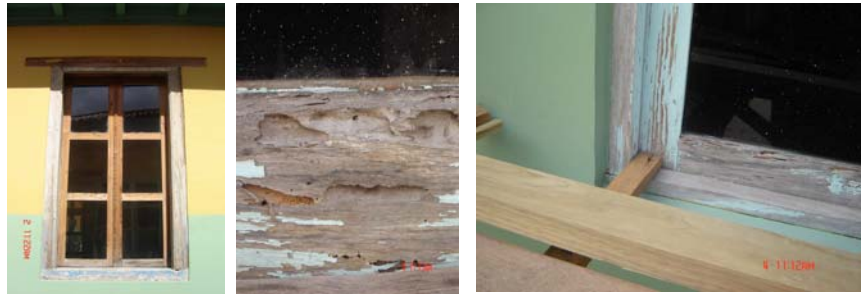
Figure 16: Window frame, termite attack on window element, scaffolding nailed to window frame.

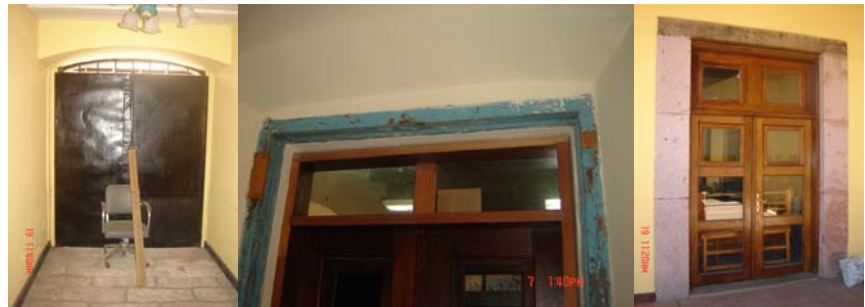
Figure 17: Replaced metal door in basement access. Door frame painting peeling and wooden repaired parts.

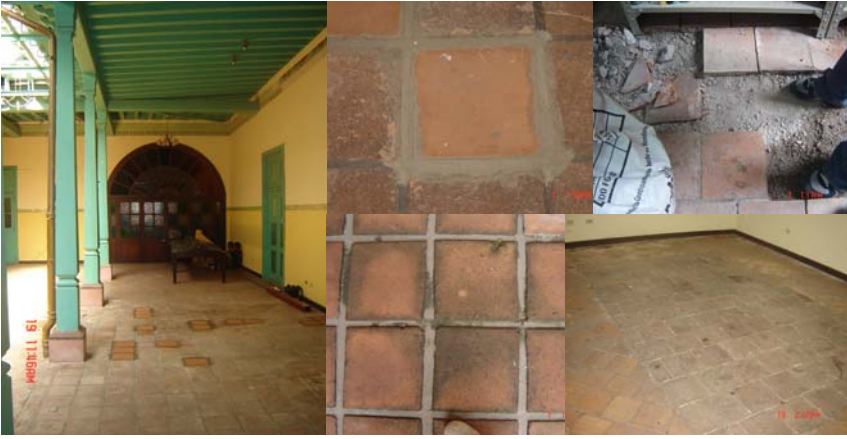
Figure 18: Replaced tiles in corridor outstand because of difference in material. Close up of new terracotta tile and joints. Presence of humidity and mold in tiles. Testimony of original tiles in a room, the quality is superior to those used in later repairs.

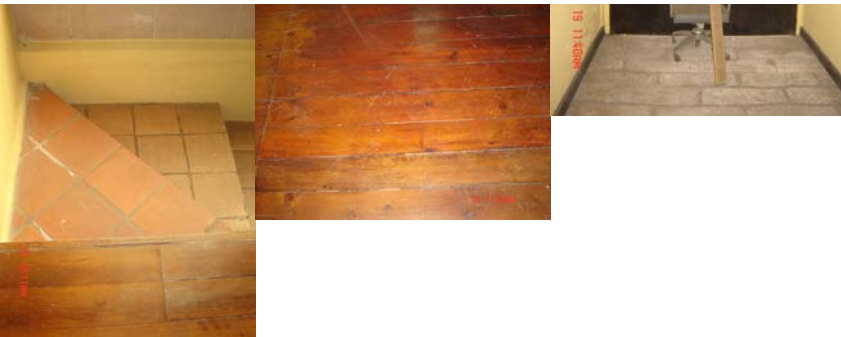
Figure 19: Scratched and warned down wooden floors, varnish is peeling. Basement entrance with original stone blocks pavement.

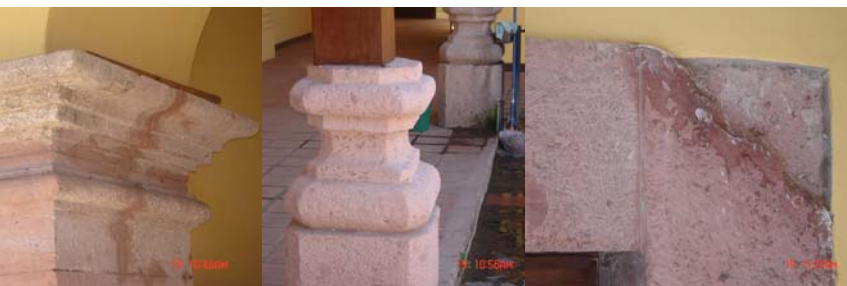
Figure 20: Repaired joint, porous stone and mold growth, repaired door detail.
