# Updating a modern building

## Renovation of the elementary school J. H. Pestalozzi

### Abstract

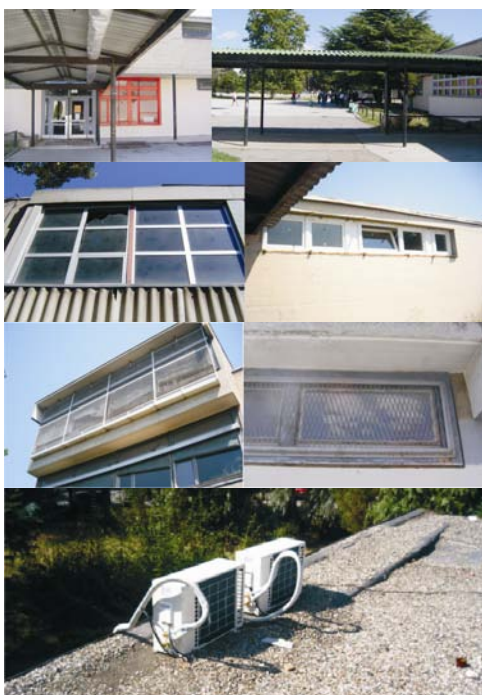
As a result of urgent needs a number of minor interventions were done that luckily did not affect much the original architecture and could be easily removed in future:

- Covering of the semi open porches with green sloped metal sheets/plates in order to place the heating installation in the space between the covering and the construction in the in-between space. Effort should be made to keep the heating installation but to make an attempt to bring the look as close as possible to the original;

- Partial change of the windows on the gym hall (on the west and south side) with PVC and Aluminum profiles that differ in shape and in material from the original;

- Steel safety wire/net placed as a protection on the windows on some parts of the building (especially the computer center). They should be replaced with appropriate designed protection;

- Air conditioning equipment installed on several spots of the buildings which points out the obvious need for solving the problem with air conditioning on the level of the entire building, not only partially (having in mind the fact that in summer the temperatures in Skopje often go over 40 deg.). Besides the bad appearance they also damage the hydro insulation;

Figure 12. Changes that could be relatively easily removed: covering of the porches, changed windows, safety nets, air-conditioning equipment

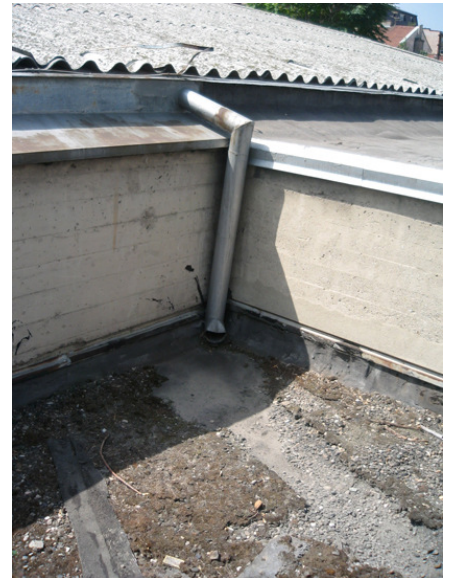
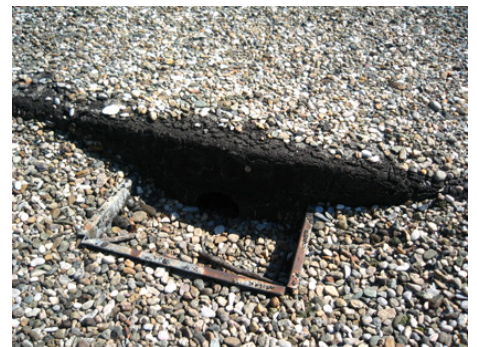
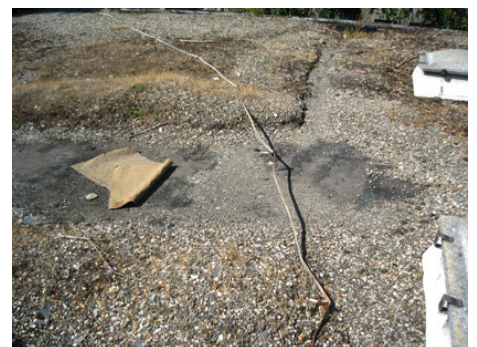
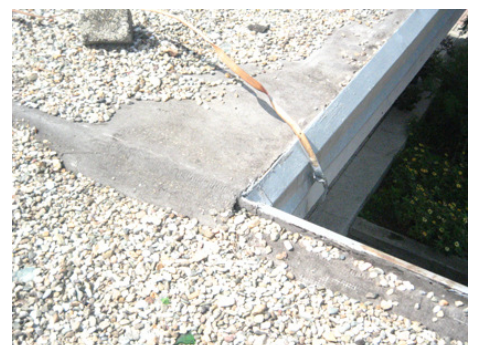
**Roof constructions:** The roofs are in generally bad condition /both flat terraces and sloped roofs/ due to dampness and leakages caused by inappropriate water evacuation, damages on the waterproof layer and thermo insulation layer, leakages on the places of the glass roof cupolas etc.

- a. Most critical is the condition of the flat roof terraces (parts **A.** and **B.**), mainly connected with the water removal/evacuation
  - for different reasons the systems for evacuation of the water are not functioning properly/are completely out of function – filled with gravel, dirt, garbage etc.

- damages on the hydro insulation – due to the displacement of the protection layer of gravel during time, large areas are open and exposed to different weather conditions (which in Macedonia are quite extreme – from  $-25^{\circ}\text{C}$  in winter to over  $40^{\circ}\text{C}$  in summer). This often results in cracking of the hydro insulation layer and leaking of the water inside the construction (eventually the accumulated moisture/damp shows up on different spots on the ceilings and walls).

- damages on the dilatations of the building (between parts with different height)
  - critical condition of the roof lights (cupolas) due to natural ageing of the material, exposure to UV rays, serious mechanical damages, human vandalism etc. These damages also enable the rain water to enter inside the construction.

- Mechanical damages on the ventilation
- b. slight vertical deformation on the steel frames in the gym hall - part **B.**) that could even increase in winter due to the extra load from the snow. One possible cause is wetting of the light wood-concrete plates bellow the terrace which rise the weight of the plates and additionally cause overload on the construction. To solve this problem there is necessity of a prompt response, more elaborate investigation of the causes and extent of the damages (possible taking samples of the different layers of the roof), thorough static calculation regarding the structure (deformations of the beams, probable/possible corrosion of the steel elements, condition of the plate etc.) as well as, emphasize on the necessity of thorough repair of the roof construction. Attempt should be made towards keeping the building in its original condition in order to maintain the original character of the building.

- c. Since both the part **C.** and part **D.** have similar metal construction regardless the different roof covering (flat terrace in the part of the gym hall and sloped roof covered with asbestos cement plates over the festive hall), similar calculation and examination of the steel frame construction should be done in the festive hall. All the repairs

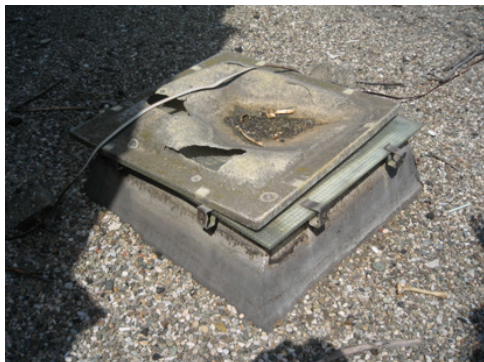
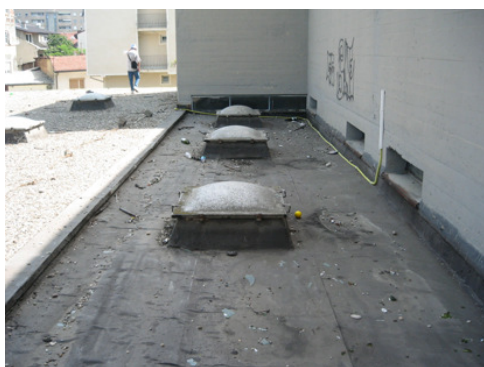
- a. flat terraces covered with protective layer of gravel (both in the parts **A.** and **B.** above the reinforced concrete construction and in the part **C.** above the steel frame construction).

The condition of the roof terraces in general (regardless the construction below) is very serious and ask for a total sanitation, cleaning, protection and replacement as a part of the total repair. At present, the fact is that there is a serious problem with steam diffusion and kept moisture (probably even kept water) in the sub construction. Although there are certain methods to remove this moisture and to dry the materials even without removing the thermo insulation, they never guarantee total protection without repeating the same process. The suggestion is to open the construction and clean it thoroughly, to remove all the secondary layers placed over the basic load bearing construction and to replace them with new, high quality materials - high quality UV protection plus a selected quartz sand finishing. The condition of the existing hydro insulation should be considered in order to make a decision weather it should be completely removed or kept as a base for further intervention.

What is important to notice is that a thick layer of gravel finishing has proven to be a good protection for the hydro insulation – therefore it can be repeated as a principal. What is important is to emphasize the necessity for proper maintenance (to refill the layer wherever the gravel is missing, to place a protective net over the gutters etc.).

- removing of the existing gravel protection
- removal, replacement, sanitation of the water drainage system (both horizontal and vertical elements) and all the elements in contact with the hydro insulation
- interventions concerning the kept moisture
- new hydro insulation in layers + hydro insulation tape according to the standards
- protection of the domes, walls... gutters with three layers of bitumen
- protection foil + gravel or quartz sand

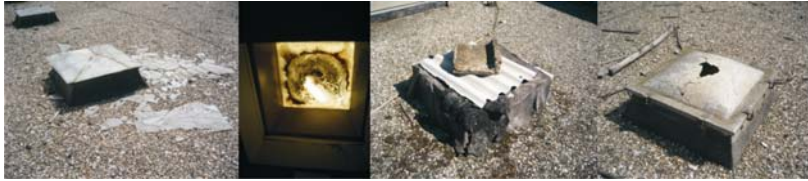
Since the cupolas are all damaged due to different causes to the extent that they not only no longer perform the original function but also cause leaking problems, replacement with new ones is necessary.

Figure 14. Damaged roof lights

Suggestion: to replace them with new two layers Plexiglas or Polycarbonate cupolas which are available at the market (product of LITTING). According to the manufacturer, the roof light replacement should be performed simultaneously (in the same time) with the roof terraces repair (so that the necessary connection with the hydro insulation could be obtained).

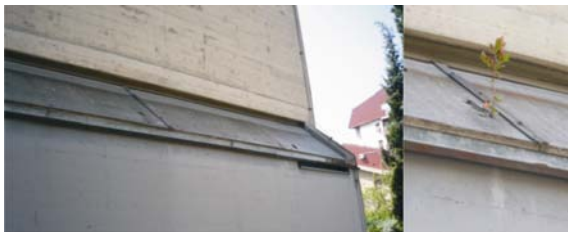
Figure 15. Slped glass surfaces

As for the flat, sloped roof lights, since they have visible damages and signs of weariness, they should be replaced with similar two-layer polycarbonate transparent or translucent plates. These plates could be fixed over the existing construction.

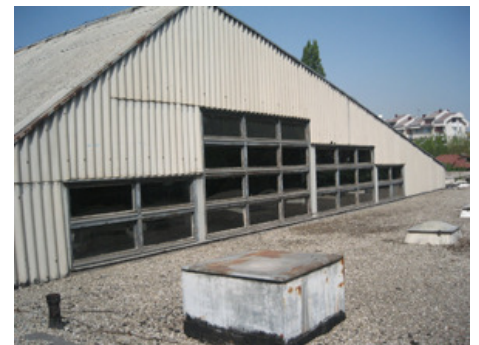
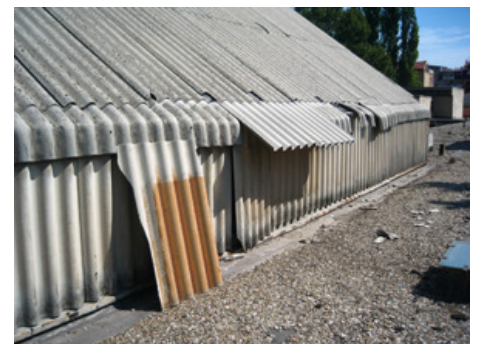
c. sloped roof construction covered with asbestos cement plates - over the festive hall. The characteristic appearance of this part of the building is determined/defined with waved asbestos-cement plates, both on the roof and the facades. The used material has low price and quality, with a short life span of 15-20 years (in time when the school was built it was considered as an economic solution). Later it was discovered that the asbestos is not only with low durability but is also a health hazardous material. Therefore it should be completely removed and replaced with new, similar material with ecological performances such as silicate fiber plates that contain silicate instead of asbestos<sup>7</sup>. Another possible solution with a slightly different material could be waved metal plates that by color and texture would not differ and would provide similar architectural appearance. If larger damages are detected after the opening of the roof, the construction below should be renewed just as well.

Figure 16. Sloped roof over the festive hall

Roof-lights above the festive hall – although they are not in bad condition, renewal of the lights is recommended; remaking in the same material over the existing sub-construction.

<sup>7</sup> One possible proposal for the change are the silicate fiber plates, product of ANHOVO, Slovenia, which have longer durability and better structural performances.

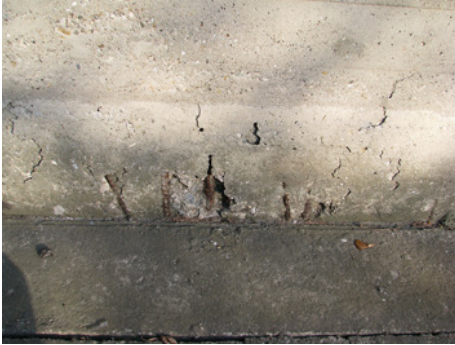
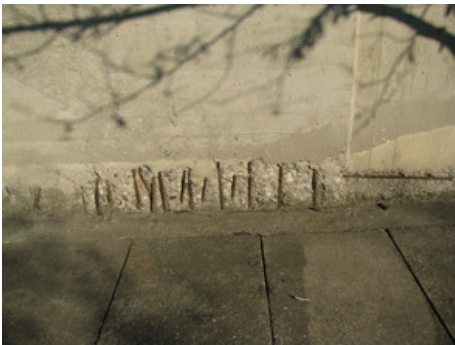
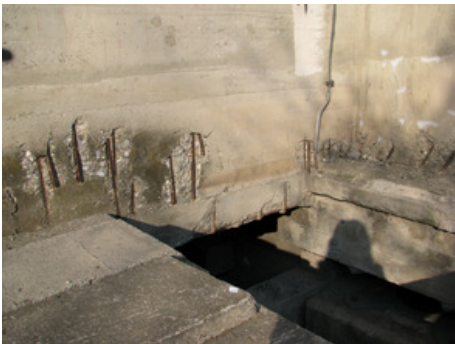
1. Visible concrete – the reinforced concrete facades are mainly dirty, on vast surfaces painted white or with graffiti. In the lower parts near the ground, cracks and spalling of the superficial layer have been detected as well as white areas/spots (probably due to salts). These damages could be a result of different causes:

- bigger amount of dampness near the ground;
  - environmental conditions – rain, snow (freeze-defrost cycles), high temperature changes;
  - not very thick protection layer of concrete over the steel reinforcement or even more – unequal disposition of this layer (in the time when the building was built using tools for keeping equal distance between the steel and the concrete wasn't common);

- local corrosion of the steel reinforcement; the rust increases the volume of the steel by 10 times which causes bigger pressure and cracks on the surface layer;<sup>8</sup>

- erosion of material simply due to aging.

Important thing is that no structural cracks caused by overloads were detected. The conclusion after the preliminary field survey is that the cracks are not structural and active but are from local character. Regardless the cause, the cracks and the lost of the superficial material did not affect the general stability of the building (only small areas are damaged+the concrete walls are reinforced with steel net that make the whole surface load bearing). In a case like this complicated procedure of cutting off the parts of the reinforcement and replacement is unnecessary; cleaning of the affected concrete areas from the cracked/ damaged concrete, cleaning the rust from the reinforcement and applying new layer of concrete or a special kind of plaster is sufficient. The repairs are quite difficult, regarding the appearance (possible change of color and texture) and the durability. However, the techniques and the materials available today can extend the life of such structure for an indefinite period.

Figure 17. Damages on the façade concrete walls

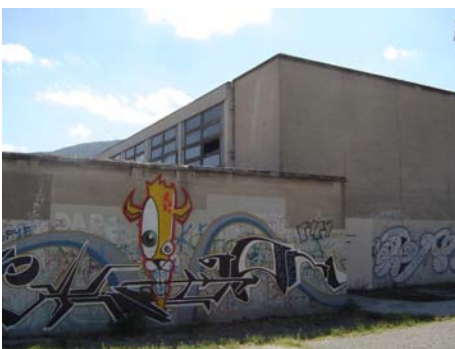
Figure 18. Concrete wall covered with graffiti

Another issue that could be considered as damage over the concrete facades are the vast areas covered with graffiti. Done in different materials, black and colored, mainly they are sprayed over the concrete surface. These are wall inscriptions and drawings that exist for a longer period and attract even more graffiti. It is already well known that hasty and untested removal attempts can cause harm to the historic surfaces. Therefore, a detailed examination and analysis is needed in order to find out all the types of color applied; how

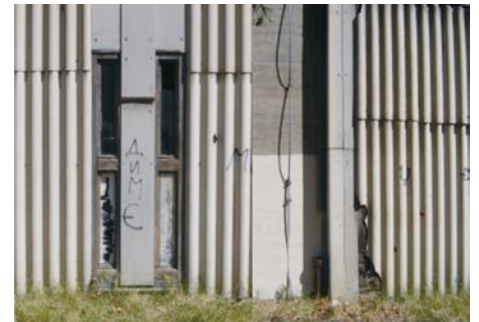
2. Asbestos cement plates placed on the gym hall façade wall. For this façade the same procedure should be taken as for the roof construction. Not only due to the bad condition (mainly with cracks), but mainly because being discovered as a health hazardous material, this façade should be completely dismantled and replaced with a new one (the same silicate fiber plates).

Figure 19. Asbestos cement façade on the gym hall

The asbestos cement plates on the facades are placed over light contemporary timber frame construction and forms total thickness of the wall of 24 cm. Therefore, after the removal of the superficial covering, the construction and insulation have to be checked (especially the condition of the thermo and hydro insulation); replacement with contemporary hydro insulation material is recommended (PVC foil).

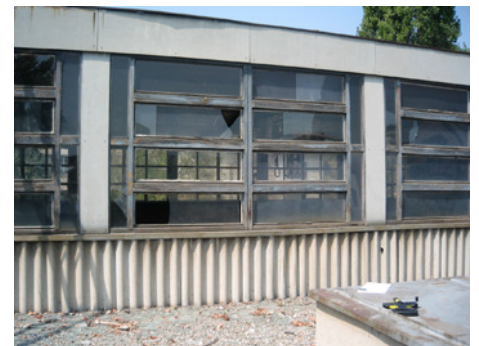
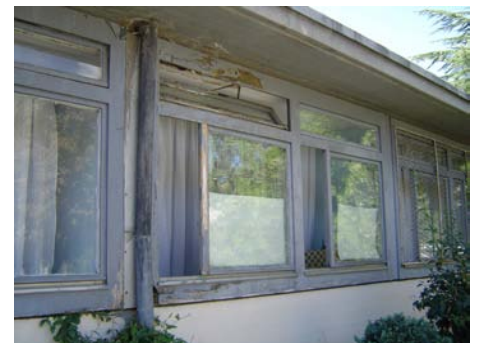
**Doors and windows** – since being neglected and not maintained properly during the 40 years period of existence of the building, the wooden parts of the doors and windows are damaged to a great extent; occasionally the glass is also broken. In worst condition are the windows on the eastern side of the gym and festive hall. (the window of the gym hall that have already been replaced with new ones with Al and PVC profiles should be returned to the previous condition and replaced with replicas of the original ones).

glass only) could be difficult if not impossible to execute because of the deformation of the frames. Also, the present type of double wing window is not recommended today because of its complicated construction, thermo and acoustic protection, difficult for maintenance and cleaning. This leaves the question open for the moment; however it was suggested that the replacement should be done with new, energy efficient kind of glazing.

Serious damages are detected on the sun protection tents as well as the mechanisms for their opening/closing. Therefore total replacement was suggested, if possible with same type of sunshade (since they were also designed specially for this building).

Figure 20. Damages on the joinery

The renewal of the joinery in the whole building is a serious issue/position (both as an amount of work and as an amount of money). Therefore it should be considered with attention, especially because there are in a way unique - designed for this particular building. Therefore an effort should be made to keep their authentic look as much as possible. However, the solution should be sought for not only in direction of keeping the authenticity of the design and details but also having in mind the progress in the field of energy efficiency that happened meanwhile.<sup>9</sup> Unlike the times before the energetic crisis, when the energy sources were considered almost infinite, energy efficiency is an important issue today. Today, when renewing this building we must have in mind the contemporary norms for total energy efficiency of the building in general (and especially having in mind the use of the building as a school).

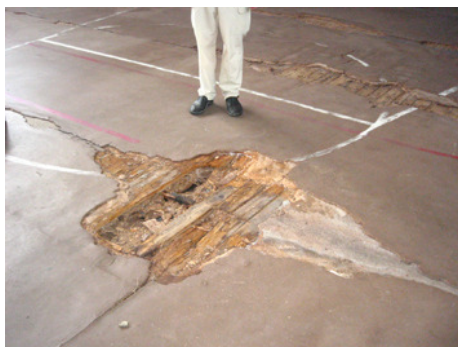
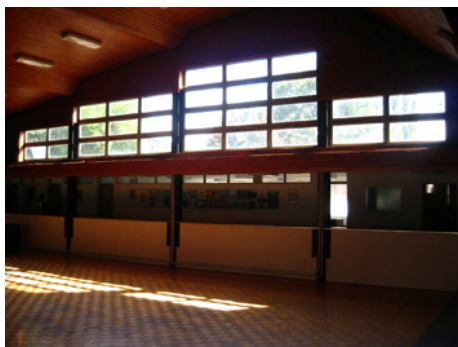
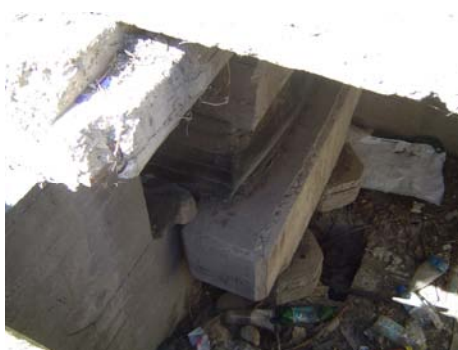
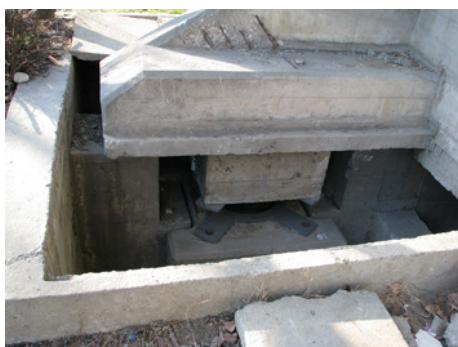
Most damaged are the floors in the gym and festive hall. At certain spots they are brought to the extent when the use of the space is put under question.

In the gym hall the floor is totally damaged and out of use. The original construction was: reinforced concrete floor/wooden elements/wooden floor/final layer of special linoleum (material that has relatively short life span 10-15 years). Today not only the final layer is damaged, but also the subconstruction at certain points is unusable. Therefore it should be completely removed and totally replaced - both the finishing and the subconstruction (no partial solution is possible for this floor). With the cost estimation study two solutions were suggested: with rubber finish and with laminate finish.

In the festive hall the floor is worn out from long and intensive use but it's also damaged from water (due to the leakage from the roof). The floor is made from wooden parquet that could be partially replaced in the most damaged areas. Here the question of approach rises: should the floor be totally renewed since the hall has a representative character or should it be only partially replaced in order to save as much as possible from the authentic material.

Figure 21. Main flooring positions: the gym hall, damaged beyond use and the festive hall

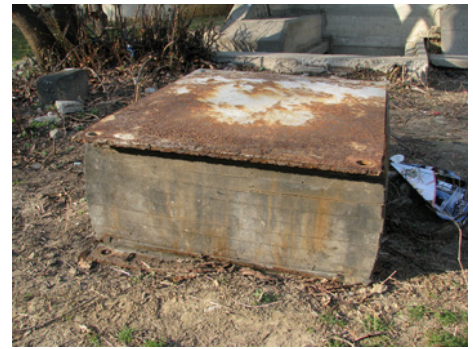
The pneumatics under the foundations are covered with removable concrete plates in order to obtain possibility for occasional control over them and their repair. For years, every two years the system was checked and maintained by the representatives of the company from Zurich. However, through the years some of the plates were removed from their original position and the pillows are exposed to all weather conditions /sun, rain, snow.../ and also to vandal human behavior. Currently, IZIIS /Institute of Earthquake Engineering and Engineering seismology/ is doing a replacement; the pneumatic are taken out and new neoprene foundations with better technical performances from the natural rubber are to be placed instead.

Figure 22. Pneumatic foundation, condition September 2007 and February 2008
