Conservation and Management of Historic Buildings 2008-2009

Conservation and Urban Planning of Kenya Railway Headquarters

Irene Keino

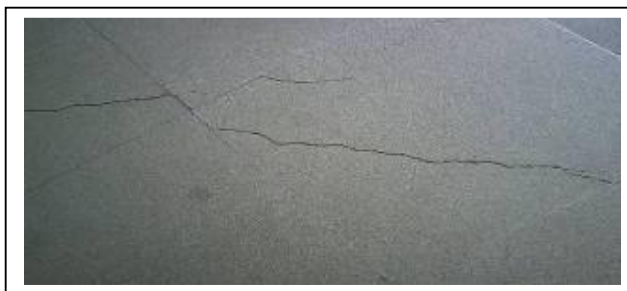
Plate 11: Cracks on the floor are due to ground transmitted vehicular vibration Source: Author, 2009

The Embassy was 100 meters away from the Railway Headquarters. The explosion had devastating effect on the railway headquarters whereby deep cracks were formed. The office building is also surrounded by heavy vehicular traffic; one side by the railways bus stop and the other at Haille Selasie Avenue. See plate 11 and 12.

- Repair and maintenance of Haile Sellasie Avenue road to reduce Vehicular vibration.
- Banning of heavy vehicles from the C.B.D.
- Relocate Bus station from the vicinity and plan the site to ensure adaptive reuse and economic viability of the Cultural Property.

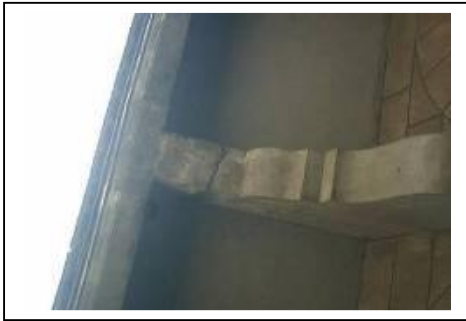
However much vibrations are from the locomotives (railway) whose proximity is less than 50m away. Cracks have been formed or exaggerated by ground transmitted traffic vibration. (See plate 12 on the next page).

Plate 12: Cracks are due to ground transmitted vehicular vibration

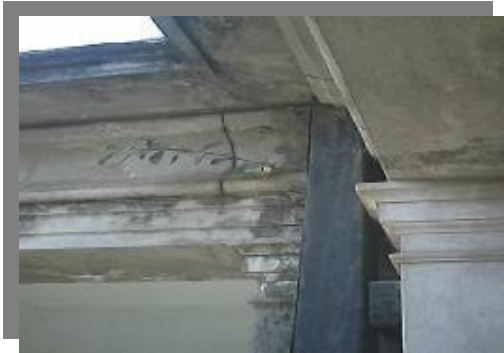
Plate 13: Concrete moulding and blocks have been attacked by plants and algae,

It was also noted that the external walls made of concrete block have been attacked by plants and algae, primarily due to the humid climate of the equatorial region and poor maintenance of the cultural property. See plate 13.

The walls have also been discoloured by the vehicular exhaust fumes of the nearby traffic.

- Scrub the walls with wire brush to remove soil and smoke materials
- Replace broken windows and doors. Toxic washes can be used to kill algae, lichens and mosses.
- Incipient lichen and algae can be softened and removed by wiping with diluted ammonia
- Heavier growth of plant life can be killed by spraying with formalin

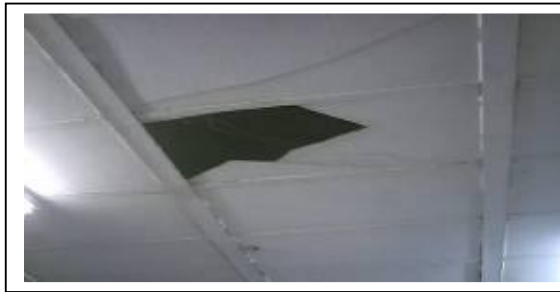
Ceiling: It was noted that the state of ceiling in most interior spaces were pathetic. The poor state of interiors spaces were mainly due to the lack of proper maintenance plan (plate 14).

Plate 14: Poor state of ceiling
Source: Author, 2009

- Repair and strengthen the steel trusses
- Replace broken mangalore roofing tiles
- Repair and repaint ceiling as well as replacing softboard ceiling materials with acoustic ceiling tiles

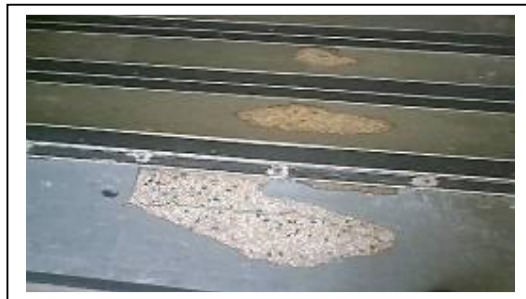
Staircase finishes: It was noted that the brass balustrades of the main staircases were maintained through occasional repainting. However terrazzo finishes had since been replaced with PVC tiles. The PVC tiles are unfortunately poorly maintained (plate 15).

Plate 15: Staircase treads have deteriorated
Source: Author, 2009

- Replace PVC tiles on the staircases. The paraque finish should also be replaced with new ones

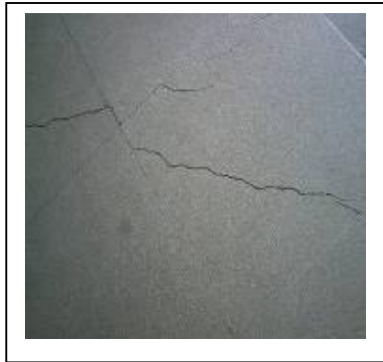
Floor finish: The interior spaces have paraque finishes while the veranders and corridor have terrazzo finishes. The state of paraque in most of these spaces are poor while the terrazzo floor finishes have few cracks (plate 16).

Plate 16: Cracks on the terrazzo floor

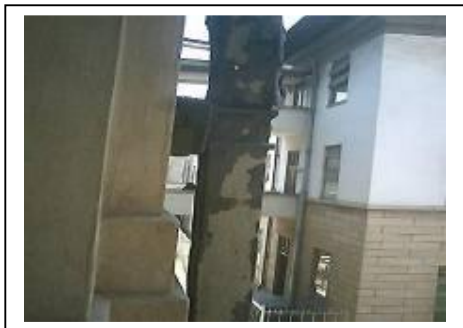
Drainage and services: The cast iron drain pipes are blocked with matter and some have corroded (plate 17).

Plate 17: Drain pipe have corroded

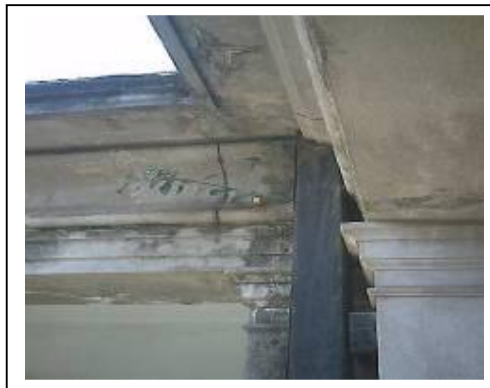
Bacteria and lichens have attacked on the building materials by producing acids which react chemically with the structural material. Algae, moss and lichen all grows in stone masonry walls and builds up homes in which much longer and more damaging plants have grown. (plate 18).

Plate 18: Attack on concrete block and moulding by algae and plants

Remedy: Toxic washes can be used to kill algae, lichens and mosses. Incipient lichen and algae can be softened and removed by wiping with diluted ammonia. Heavier growth of plants can be killed by spraying with formalin.
