Protect from Decay Threat

Reconstruction of the German Boma, Bagamoyo

Arch. Isabela Mtani

Institute of Human Settlement Studies, Ardhi University, Dar es Salaam

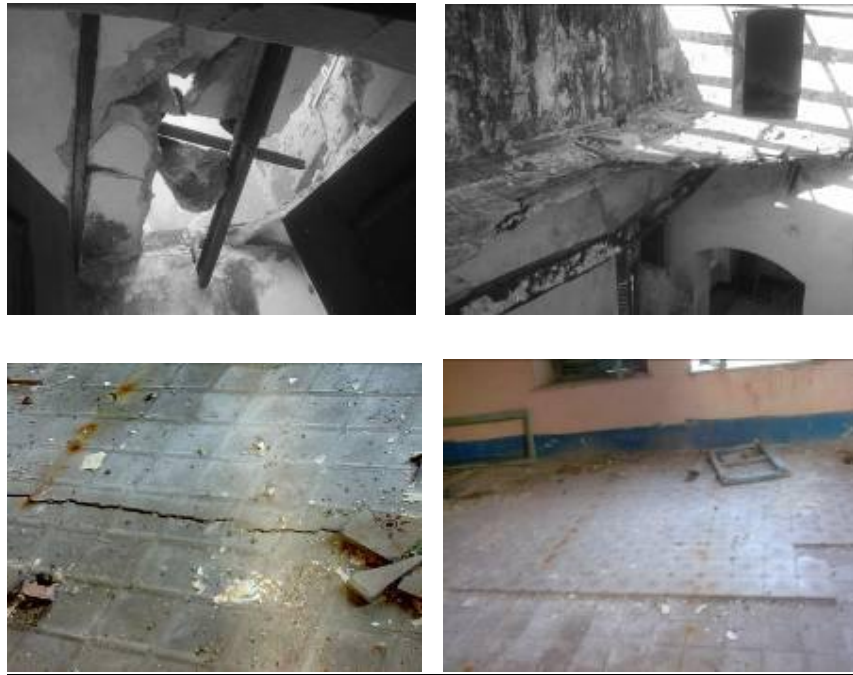
Floors have developed lateral cracks at the positions of buried I – beams especially on the floor slab at the first floor. Some floor tiles at some rooms of the first floor have been stolen. The remaining is dirty and need cleaning and repolishing. The floor structure is sagging, threatening to collapse. The I - beams support are seen to bend downwards. The balcony at the front of the fort fell in and the parts of the suspended slab inside the building show clear signs of sagging and almost falling in. There are also undulations in the glazed striated tiled floors of the hall and corridor. The undulations follow the lines where the I – beams are buried suggesting excessive rust of the iron beams. It would be desirable to remove a few of the glazed tiles for further investigation of the floor beneath the tiles.

Figure 11-: The poor condition of floor slab and floor finish

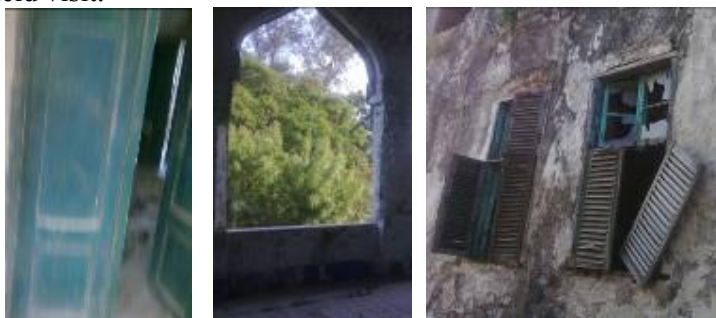
These are wooden jalousies and are in a very poor condition as far as the paint finishing is concerned. However, the wood structures are still strong. Though the double leafed enamel painted panel doors are in good conditions. Some glazed wooden casement windows are in good condition. Doors and windows are cracked with missing timber louvers and broken glass. This building has being shorn of its doors and windows. The entrance door to the tower and door to the roof opening are also missing.

Figure 12 : Absence of window panel, broken windows and flaking painting in existing openings

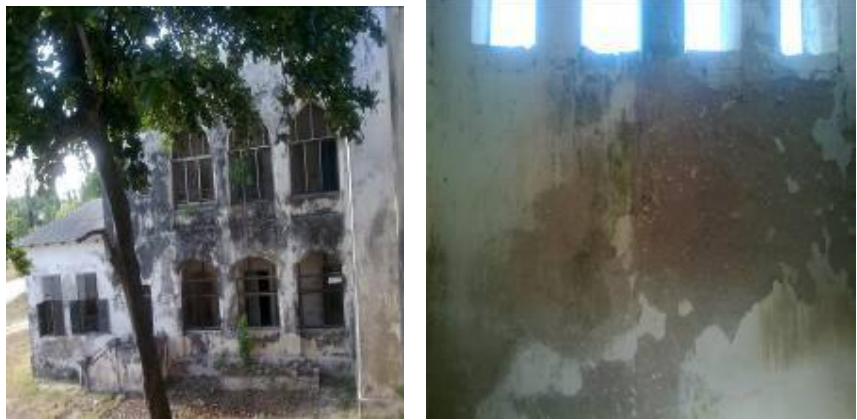
The building facade are generally in bad shape with cracks running virtually across the walls which seem to have originated from the rusted I – beams and the paint work is flaking off. The flaking off paints revealed the different layers of paints (see Figure 11), which provides evidence of almost 100 years in which decorative paints expressed their power (see Figure 3&4). An attempt to repair the cracks using cement mortar failed, because these walls have already cracked all the way down into the foundation. The continuous algae growth has completely turn the white washed lime paint into black and grey in some areas (see Figure 14). There are also termites on some walls.

Figure 14: External and internal wall defects

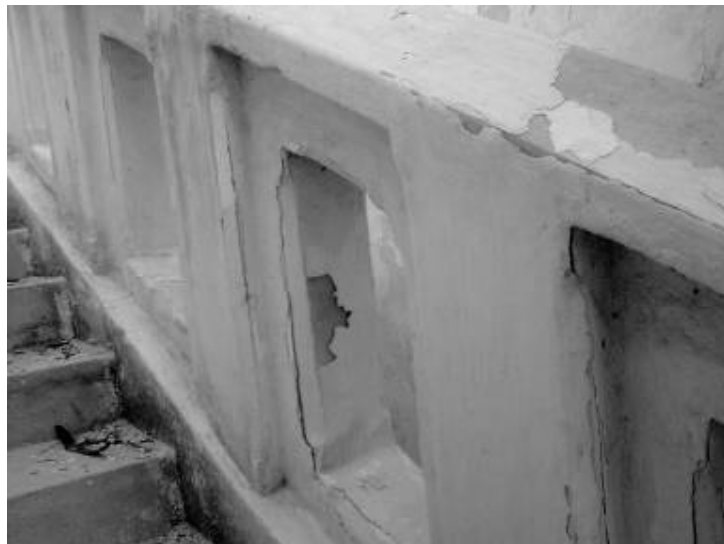
The I – beam at the head of the stairwell is in poor state due to advanced state of rust, at the end that enter the wall resulting in numerous cracks. The wooden stairs leading to the roof are also rotten.

Figure 15: Cracks and mortar peeling off on main staircase balustrades.

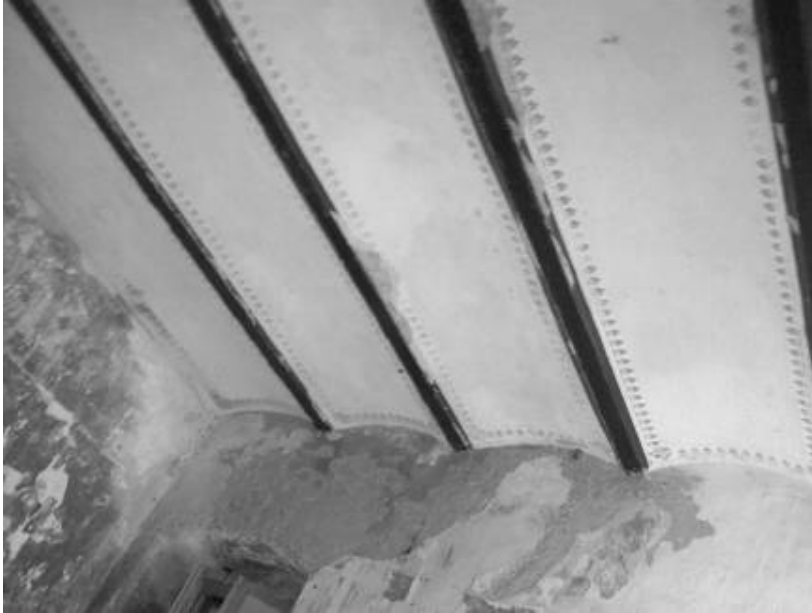
There are traces of fungal growth, flaking paint, rusty I – beams and exposed mortar show on the ceiling and these occur at the places with buried metals. The ends entering the walls are more rusted and have caused cracks to develop.

Figure 16 : Poor condition of ceiling vaults

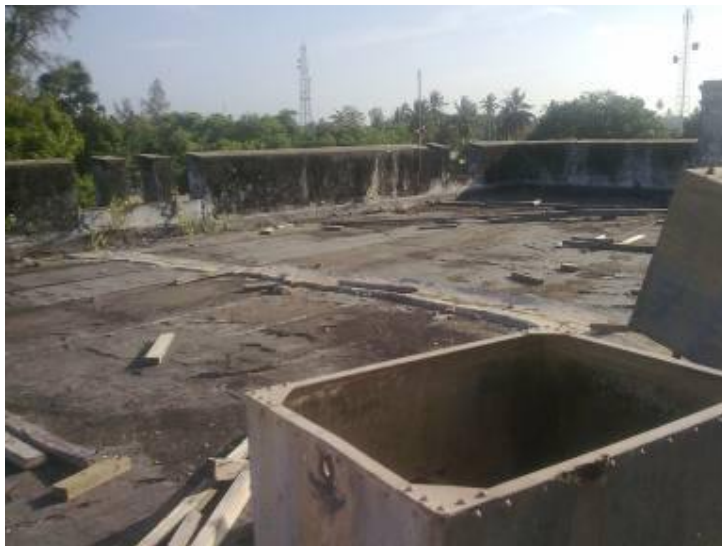
Like other building components, this part is badly maintained. There are virtually no “falls and cross falls” for fast and effective drainage of the roof, the sealing materials used are bituminous felt mar glass and cement screed, all have cracked due to poor workmanship. The flashing between roof slab and walls has also cracked.

This was constructed with hardwood boards, bituminous roofing felt and covered with corrugated iron sheets. All nails are corroded hence allowing rain water on to the felt and boards.

Figure 17: The peeled off of bituminous felt on the roofing slab

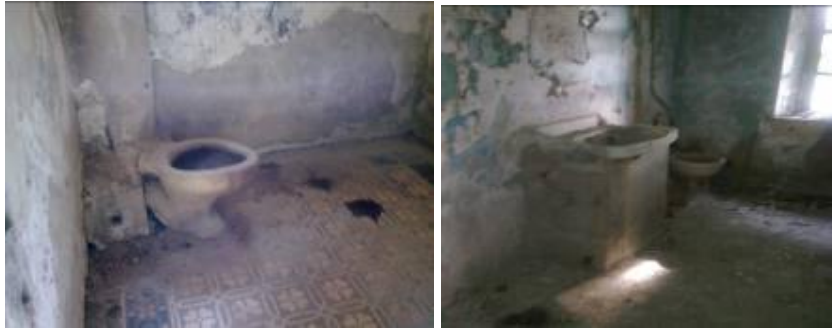
Figure 18: Unused sanitary appliances in very unhygienic condition

There is a carved antique settee, a cupboard and a side board in one of the rooms of the main block. This interesting set of furniture needs to be protected and preserved. The WCs are in poor condition. The piping system is non-existent after being worn out over time and some are stolen. However, the remaining galvanised pipes should be replaced with PVC to arrest eventual rust.

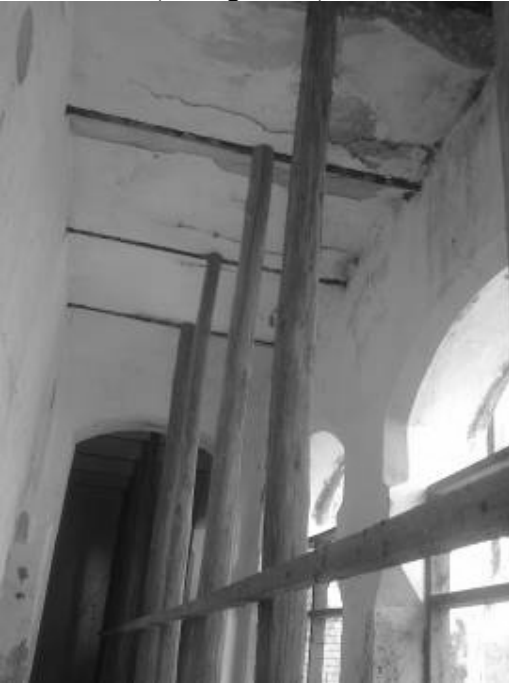
- The feasibility study was undertaken, it established that the building is at present unsafe for human habitation. The building has several cracks and its structural stability seems very weak to protect it from further structural damage. The Antiquity Department provided wooden poles to support the structural slab and beams (see figure 22).

Figure 22: Efforts to protect the building from further deterioration
