Conservation of Teferi House As A Museum

A Project Proposal for Rehabilitation of the Teferi House
that will have new function after maintenance and
modifications

Imran AbdAllah

March, 2009

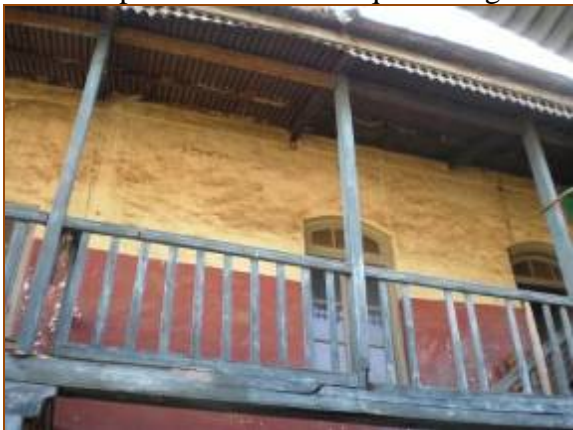
Fig.3.2. Painting done recently which is inappropriate

In an effort to document the form, type and color of coatings such as paint; and the condition of exterior wood features prior to beginning project work were done and it is found the coatings of the buildings are entirely lost. The present colors are recent inappropriate additions to the building by poor inhabitants that occupied the building for the last 40 years.

Regarding the paint it will be necessary to repaint the wood -if possible lacquer if not varnish. And the same white and blue paint on the internal and external walls as these are colors that are appropriate to the building and the old town.

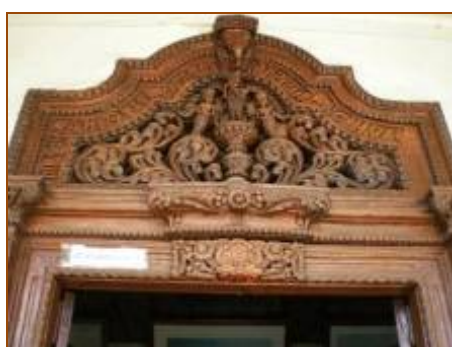
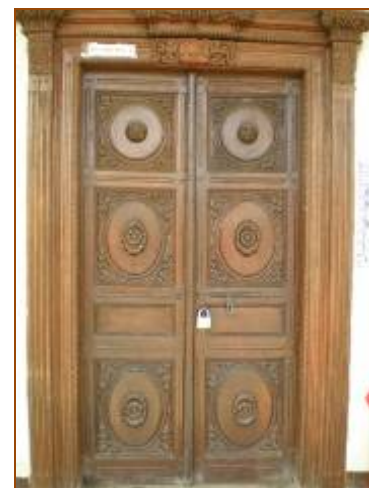
Fig 3.3. The main front door is in a good condition.

Almost all part of the exterior wood surface is damaged. The parts that need cleaning rather than repainting are almost nil except that of the front door at the ground floor, which is in a good condition.

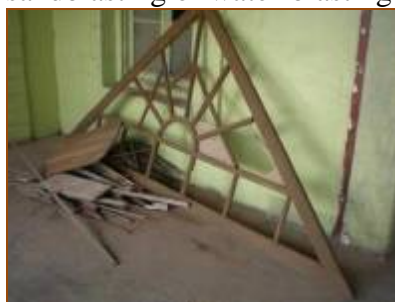
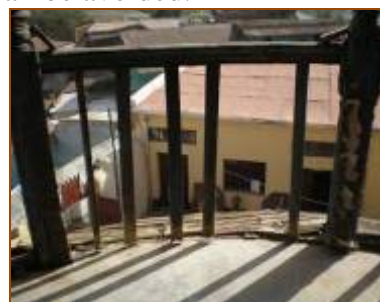
Decorative wood elements especially are completely stripped of their paintings. Some are even cracked physically damaged.

Fig.3.4. Decorative Elements are missing or damaged in lots of places especially the first floor front features.

Conservation work in these wooden elements should be done by Removing damaged or deteriorated paint to the next sound layer using the gentlest method possible (scraping and sanding by hand), then repainting in kind. If hot-air guns are used it shall be used carefully. Destructive paint removal methods such as propane or butane torches, sandblasting or water-blasting shall be avoided.

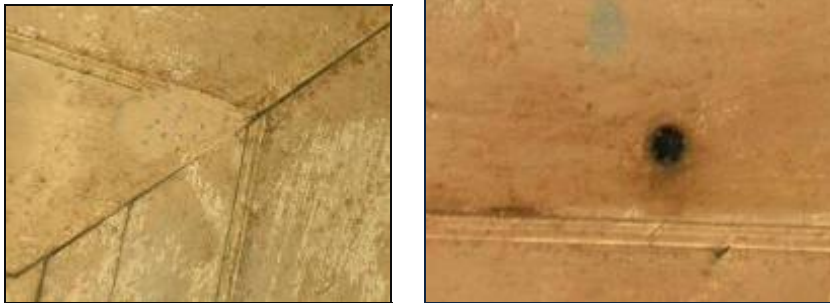
The first floor is the most damaged part. Insect infestations on some parts of the wood are seen on the first floor rooms and also on the outside part of the whole building.

Fig.3.5. Insect infestation on the ceiling of the first floor

The causes of infestations shall be treated immediately; vents needs to be opened, treating active infestations of insects by first identifying the type of insect and then implementing a program of elimination appropriate to that insect.

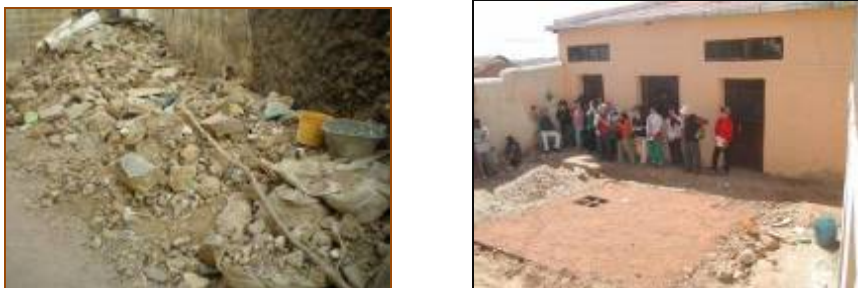
The water drainage structures are badly damaged. The gutters are leaking here and there. There are cracks and holes in sidings, piled up earth resting against the building and vents are closed. All these has created a problem in weathering.

Fig.3.6. Piled up earthing against the building, and inappropriate water reservoir building works in the compound.

What to be done, in this case is prevent water penetration and maintain proper drainage and re-moving piled up earth resting against the building and applying a chemical preservative treatments, to arrest dampness.

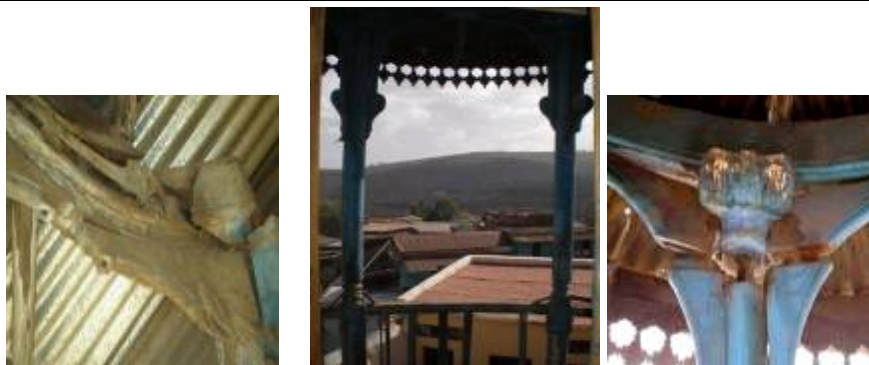
Columns, both on the ground and first floor are deteriorated. Cracks and structural weaknesses are witnessed. Nevertheless more scientific study beyond mere observation is needed to talk about the stability of the building. The capitals in the first floor are also in bad shape as shown in fig.

Fig.3.7. Columns and associated decorative elements are deteriorated

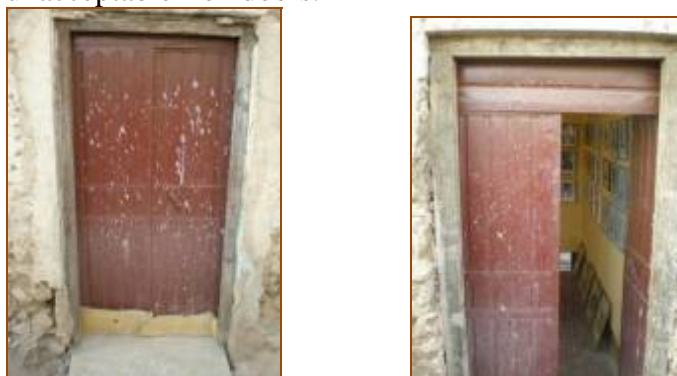
Some of the original doors are missing and already replaced by totally unacceptable iron doors.

Fig.3.8. In appropriate metal doors, which shall be removed

Extensively deteriorated or missing parts of all exterior wood elements shall be replaced in kind where there are surviving prototypes. The new work should match the old in form and detailing. If using the same kind of material is not technically or economically feasible, then a compatible substitute material may be considered. The metal doors which are alien to the house architectural style need to be removed and replaced by wooden doors. The new doors can be a new design that is compatible with the style, era and character of the historic place; or a replica based on physical and documentary evidence.

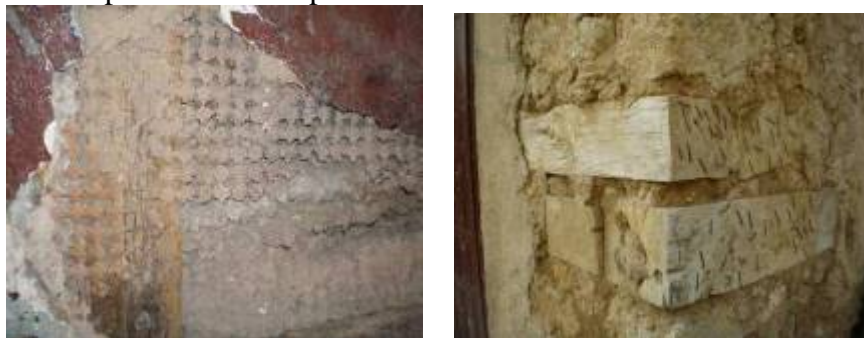
The conditions of the masonry walls, door surrounds, pediments, and details of jointing, tooling, bonding patterns, coatings, color, and conditions of these elements are assessed and the summary is put here. The masonry wall is basically done with old techniques of using limestone and related earthen materials. The ground floor masonry is somewhat better than the first floor where the masonry is very dirty and soiled caused by soot, graffiti and other factors. On some places it is even in pretty bad shape of crumbling away. Deteriorated Mortar joints, loose stones, damp walls or damaged plaster work are all over the building which is seen in many areas. Water I also penetrating the

building masonry in the back of the building, where it is creating a serious problem of dampness.

Fig 3.9. damages to the masonry from 1rst floor and ground floor accordingly.

What needs to be done regarding these problems with the masonry is cleaning it using recognized preservation methods and only when necessary to halt deterioration or remove heavy soiling and graffiti. Cleaning masonry surfaces shall be done using the gentlest method possible, such as low-pressure water and detergents, using natural bristle brushes.

The masonry walls and other masonry elements shall be repaired by re-pointing the mortar joints where there is evidence of deterioration such as disintegrating mortar, cracks in mortar joints, loose bricks, and damp walls or damaged plaster work. Mortar should be compatible in strength, porosity, absorption and vapor permeability with the existing masonry units. With regard to water percolation in the back of the house, we need to apply new or non-historic surface treatments such as proven water-repellent coatings to masonry after repointing repairs, Paint in many part of the building is deteriorated badly.

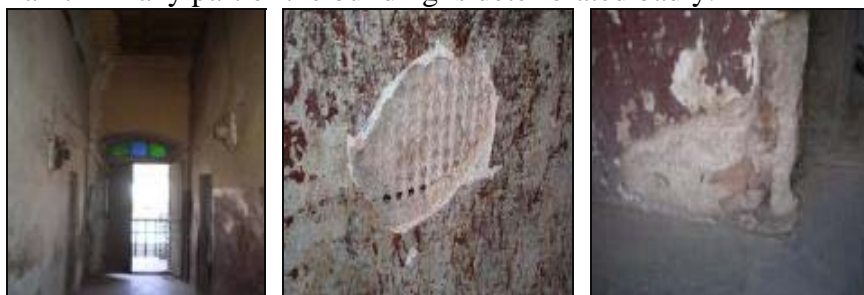
Fig.3.10. Deteriorated paint on different part of the house

Treatment of the paints on the wall will mainly include removing damaged or deteriorated paint only to the next sound layer using the gentlest method possible (e.g., hand scraping) prior to repainting, repainting with colors that are historically appropriate to the building and the old town of Harar.

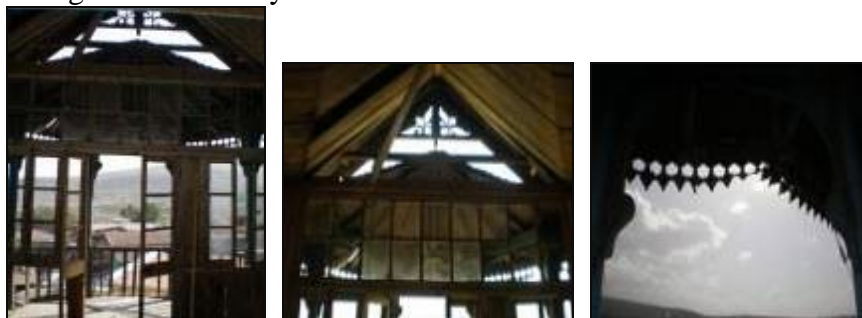
One of the first architectural metal elements that attract an attention is the claddings on the first floor which are deteriorated due to corrosion

and extreme weathering where some are missing, but still beautiful enough to catch an eye.

Fig 3.11. Iron claddings corroded and deteriorate

To Protect and maintain the architectural metals of the cladding from corrosion, apply method that will prevent water penetration and by maintaining proper drainage so that water or organic matter does not stand on flat, horizontal surfaces or accumulate in curved, decorative features. Clean the metals, to remove corrosion prior to repainting or applying other appropriate protective coatings.

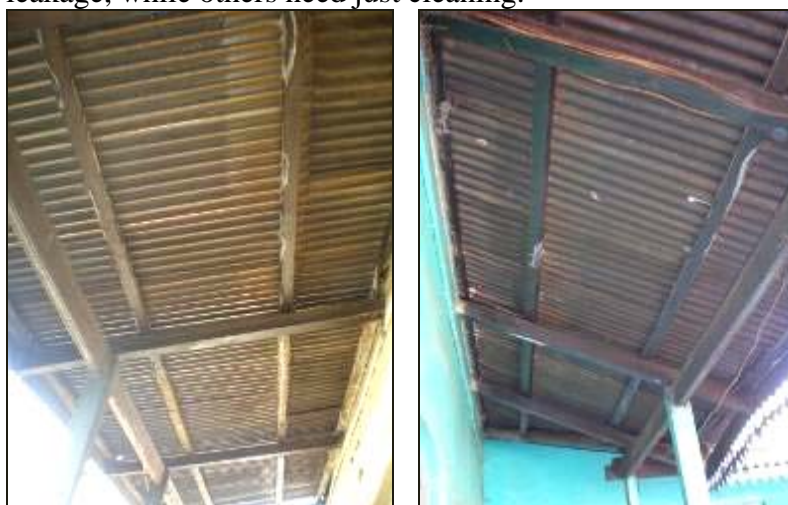
The roof top is fully covered with corrugated iron sheets, which are still there but deteriorated lot. Some needs replacement as there is leakage, while others need just cleaning.

Fig.3.12. Roof top iron sheets are corroded

Remedies will include cleaning and maintaining the gutters and downspouts and replacing deteriorated flashing in kind. Roof sheathing should also be checked for proper venting to prevent moisture condensation and water penetration; and to ensure that materials are free from insect infestation, There I also a need for provision of adequate anchorage for roofing material to guard against wind damage and moisture penetration.

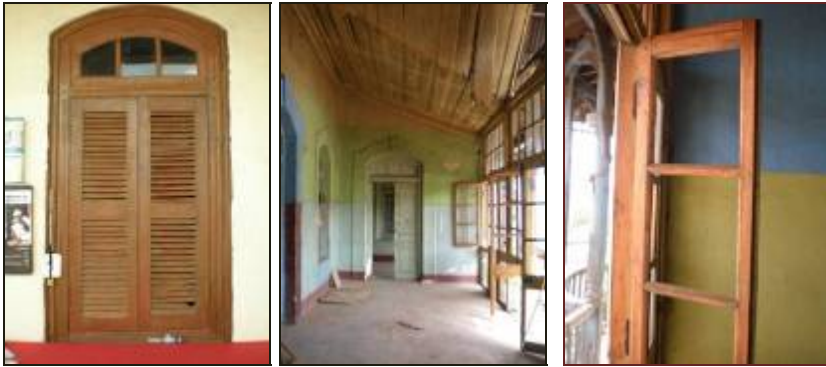
The windows are all made of woods. The ones at the ground floor are in good shape, except in two windows there are small missing

elements and dentures. But on the 1st floor the windows are damaged a lot. Woods damaged, glasses broken. Some windows are completely stripped of their glasses.

Fig.3.13. Windows are damaged, which needs a lot glazing work

To Protect and maintain the windows, the wood and architectural metals that comprise the window frames, sashes, and surrounds use appropriate treatments such as cleaning, rust removal, limited paint removal and re-application. Sound windows and window elements or deteriorated windows and window elements that can be repaired, shall be retained

Deteriorated windows and window elements shall be repaired and stabilized by structural reinforcement, weather protection, or correcting unsafe conditions, as required, until any additional work is undertaken. Repairs should be physically and visually compatible. window frames and sashes, will be repaired by patching, splicing, consolidating and reinforcing.

Extensively deteriorated or missing parts of windows will be replaced in kind, where there are surviving prototypes. The new work should match the old in form and detailing.

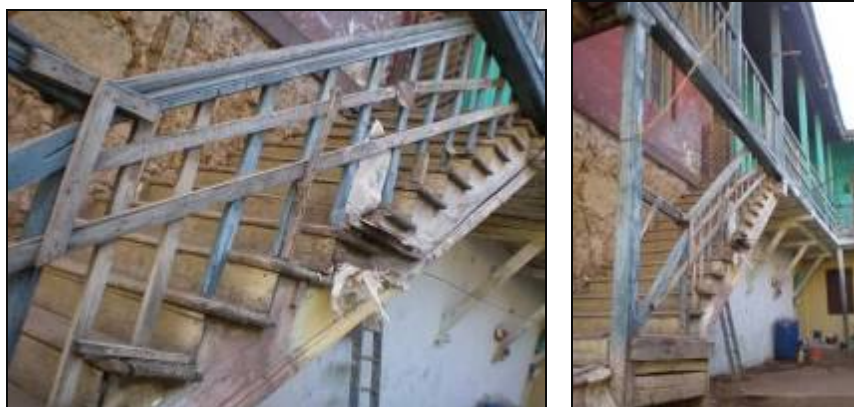
The stairs to the first floor, in the back of the main façade are in bad condition. (see the following fig.)

Fig 3.14. Dilapidated stairs to the first floor

The deteriorated backdoor stairs elements need to be repaired by structural reinforcement, and correcting unsafe conditions, as required, until any additional work is undertaken.

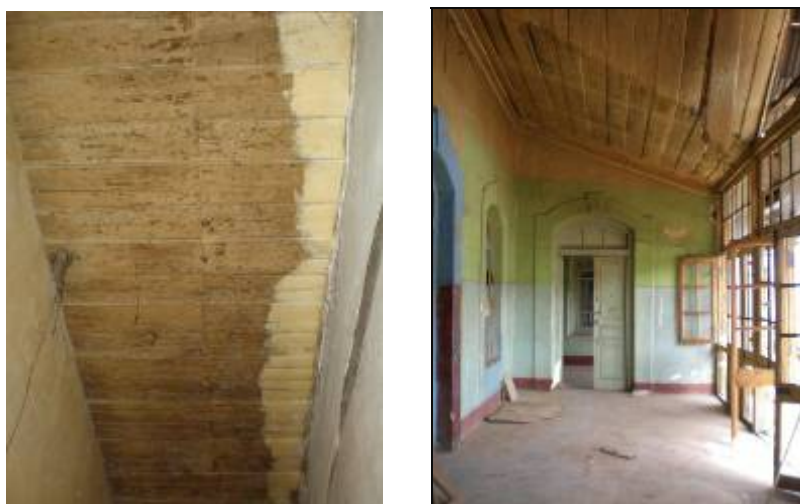
When we look at the interior space in the ground floor and the first floor, there are damages. The first floor interior spaces, has dirty and broken elements which needs cleaning and maintenance.

Fig 3.15. Decaying interior space

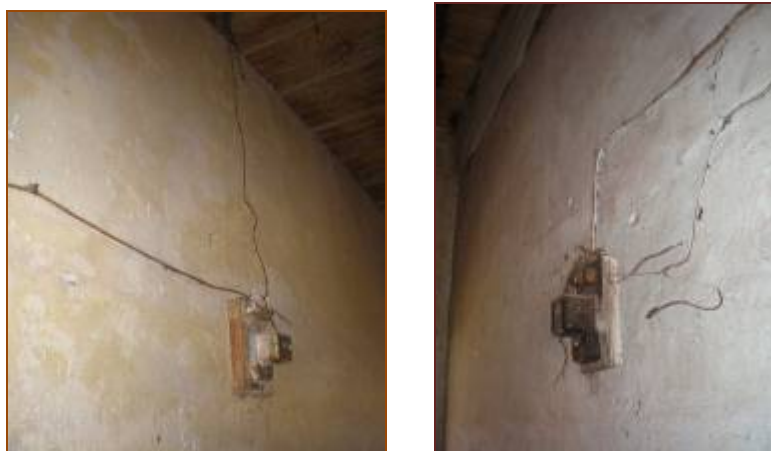
The electrical systems in the building are outdated, done in a hazardous way, and damaged in so many places. The one in the first floor is especially completely damaged.

Fig. 3.16. Inappropriate electrical wires

There is a need to dismantle the whole electrical system and add a new line and systems that will be compatible with the visual feature of the building. The cables shall be installed in non-character-defining areas.
