Conservation and Management Plan of the Ganoza Orbegoso House

And guidelines for a *mise en valeur* project

Conservation and Management of the Ganoza Orbegoso House

Melissa Thereliz Cabrera Rodríguez

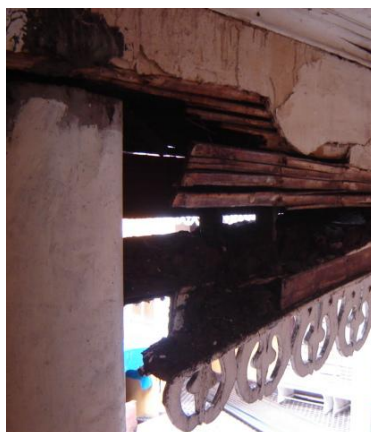
Through a visual inspection is quickly identified structural cracks in walls and roofs and humidity in the *adobe* walls (fig 16). It is known that one of the biggest enemies of *adobe* structures is humidity because it loses compaction. The roofs have in some cases detachment of stucco ceiling (fig.17), in other cases humidity in stucco plaster finish. Zone 3 is the one having the worse condition, having been used as a deposit, some beams there are on the verge of structural collapse. (fig.18)

Figure 15: Structural cracks

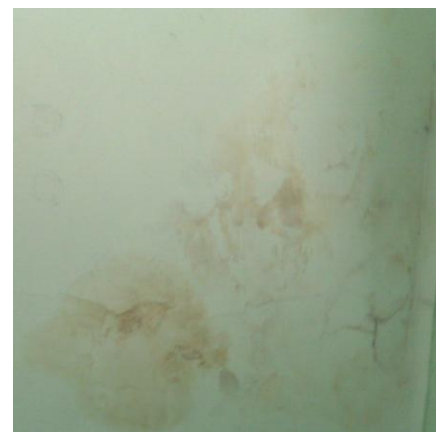
Figure 16: Humidity in walls

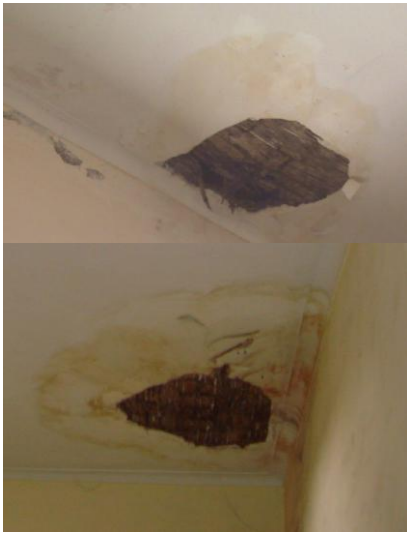
Figure 17: Leaks in quincha roofs

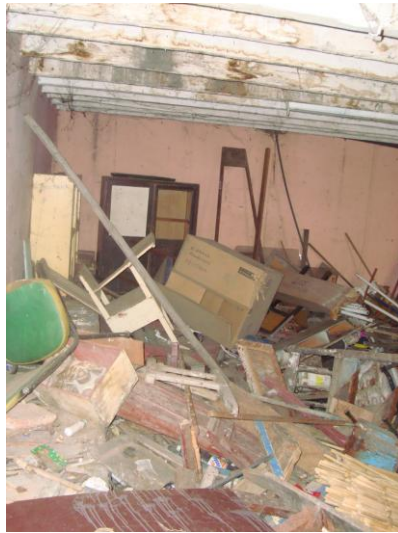
Figure 18 Leaks in quincha roofs

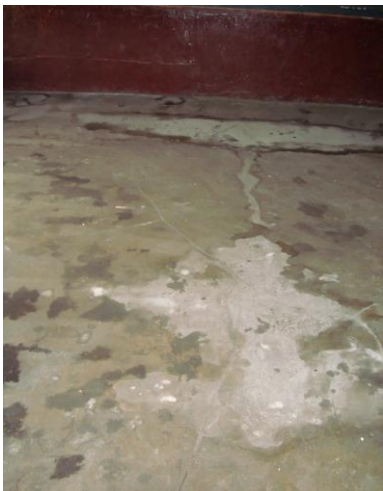
In general, the conservation status is regular from the architectural point of view. However, the floors are in terrible condition because of leaks (fig 19) there is loss of glass elements in the doors, some elements such as balustrades, pinnacles and cornices have been removed or are rusty (Fig. 20), ceiling decorations, rosettes, are incomplete (Fig. 21), some windows frames and doors have been sectioned or attacked by xylophagous (fig.22).

Figure 19: Humidity in floors

- Floors: Treatment with wood preserving chemicals.
- Walls: Fix stucco plasters and then paint all walls based in the stratigraphic creeks, including façade.

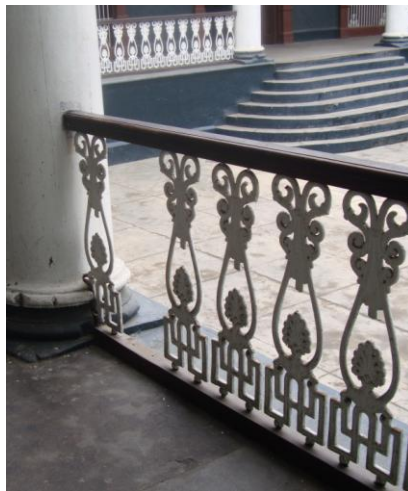
Figure 20: Missing baluster

In Zone 2 is necessary to restore metal railings, wooden pinnacles and cornices and to complete decorative elements such as rosettes. In addition some openings that have been closed must be opened in order to obtain the original entries.

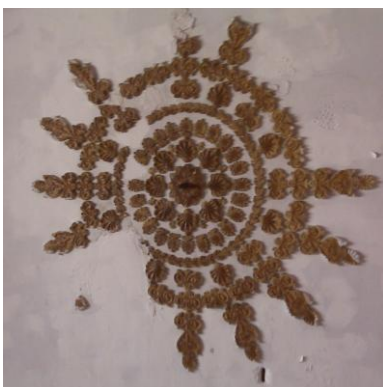
Figure 21: Incomplete gold leaf floor rosette

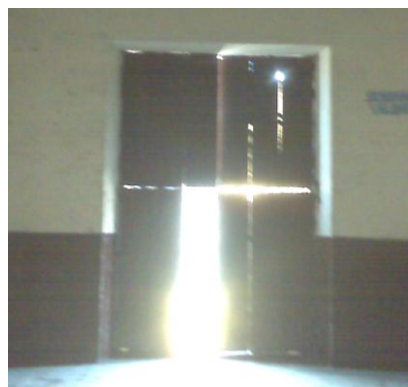
Figure 22: Window's wood swings sectioned

- Doors: Replace windows and place door locks. Apply varnish to the wood. Paint according to wood color chart.
- Decoration: Replace existing lamps rusty.
- Wooden Arcs: Restoring intrados of wooden arcs.

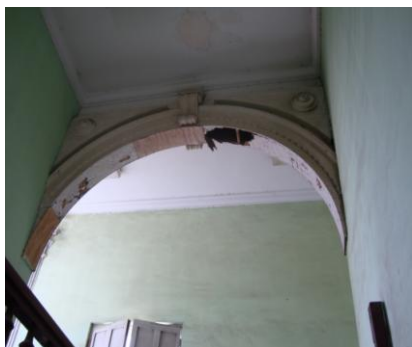
Figure 26: Damaged intrados of wooden arc

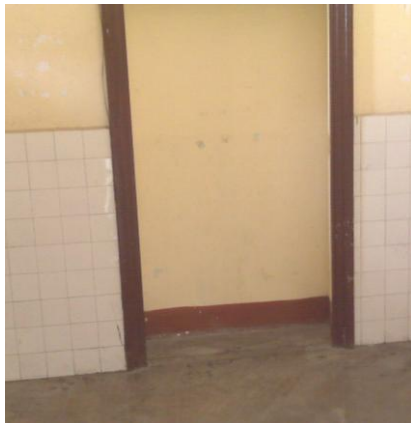
Figure 29: Door closed with a wooden board

In Zone 2, in room codified F-019, is necessary to remove the ceramic tiles and wooden board that is closing the door vain (fig. 29).

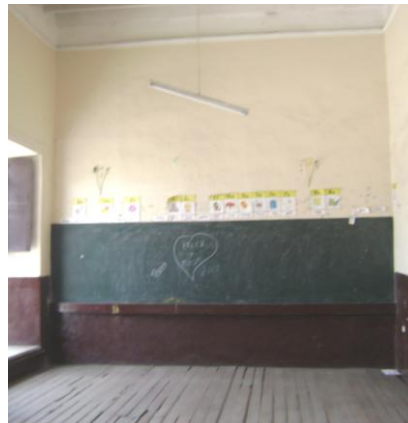
Figure 30: Blackboard embedded in adobe walls

In the Zone 1, 2 and 3, extract embedded blackboards of F-004, F-005, F-010, F-012, F-013, F-016, F-017, F-020, F-021, F-022, F-025, F-032, F-033, rooms that have been used as classrooms (fig. 30). In zone 3 there is a brick wall, built to adapt a school tent, which breaks the original architectural reading of the second yard (fig. 31).

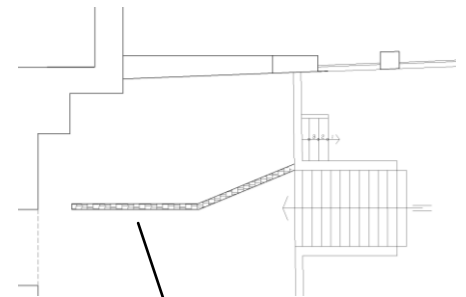
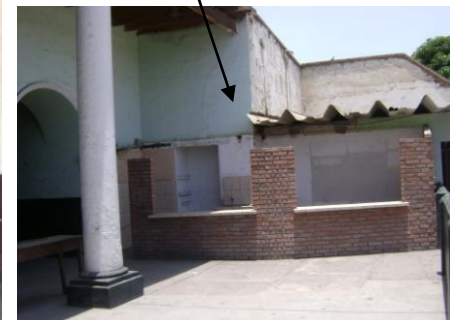
Figure 31: Brick wall needed to be removed

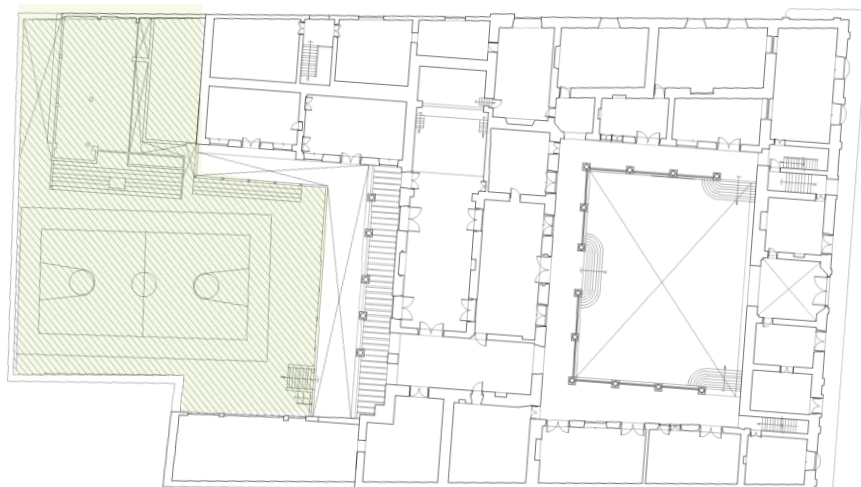
Figure 32: Demolition area: Contemporaneous constructions.

In the Zone 4 this action means to remove the existing contemporaneous additions that do not follow a harmonious architectural reading with the historical part of the building and whose function was only for educational use. (fig. 32)

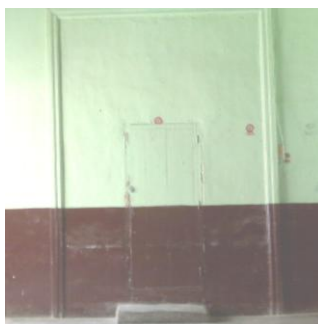
Figure 33: Closed door vain.

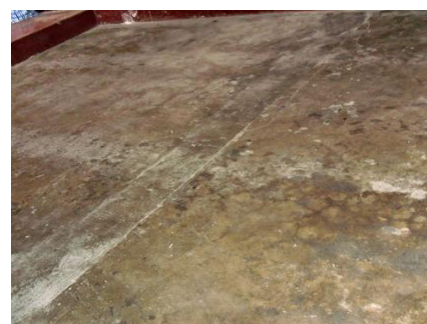
Figure 34: Footprint of an adobe wall removed.

- Consolidation:
The second action would ensure stability in horizontal and vertical elements that are prone to collapse, to integrate and give strength and solidity to the building to ensure its perdurability.
- Rearrangement:
The last action to be performed would be restoration of some parts or elements of the house to recover its original distribution, based on physical evidence such as traces on adobe wall, walled openings, etc.

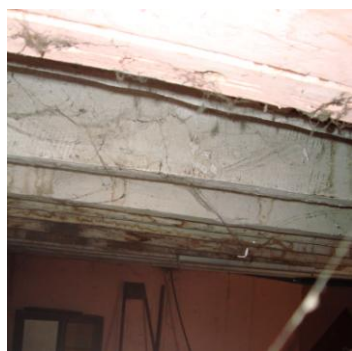
Figure 35: Cobwebs in beams

Task	Schedule		
	Daily	Weekly	Monthly
Map the floor	X		
Remove garbage	X		
Polish floors		X	
Remove cobwebs from walls and ceilings		X	
Treat wooden elements with termiticides			X
Treat metal elements with anticorrosive			X
Ocular inspections			X

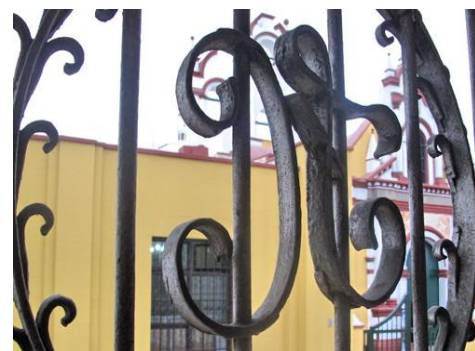
Figure 36: Rusty gates
