**Conservation and Maintenance of
Dutch Naval Commissioners House,
Trincomalee - Sri Lanka**

Conservation and Management of Historic Buildings
Advanced International Training Program 2009/10
Lund University- Sida

MAINTENANCE PROGRAM AND MAINTENANACE PLAN AND DOCUMENTAION

THE DUTCH NAVAL COMMISSIONER'S HOUSE AT TRINCOMALEE - SRI LANKA

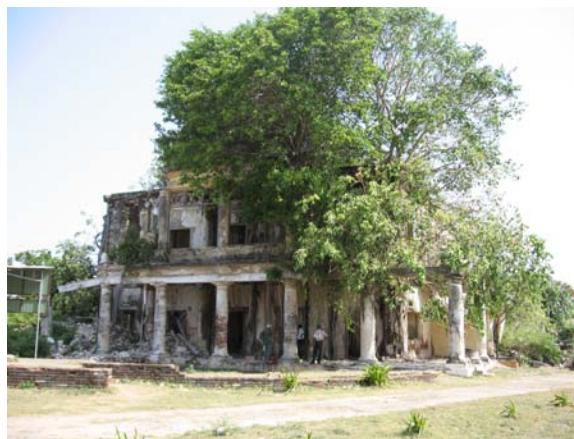
View of the building with large banyans trees

For more than 30 years, this building had been abandoned and was in a dilapidated condition, with large Banyans Trees within and around of which roots had attacked the building structure. But due to the proper restoration techniques used in the conservation project this threat has been minimized.

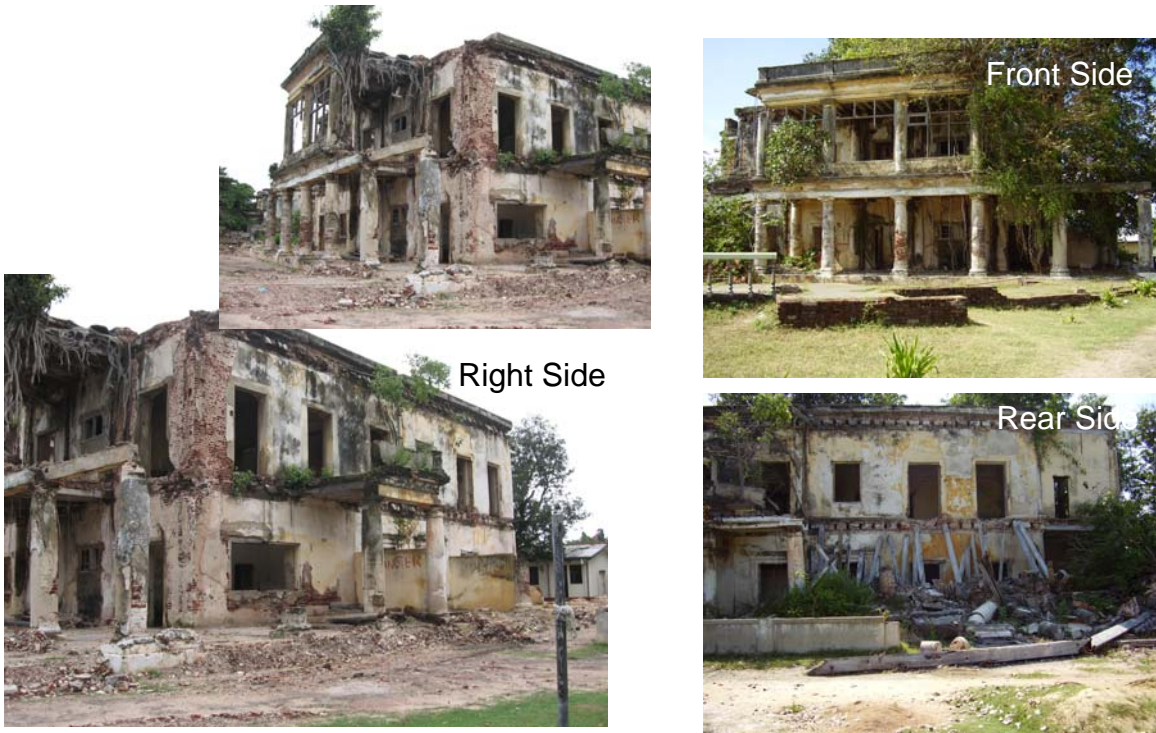
According to the archival records this building was the Dutch Naval Commissioners house. And later it had been used as administrative office of the area. But for more than 30 years, it had been abandoned and was in a dilapidated condition with large Banyans Trees within and around of which roots had attacked all the building's structure.

Views of the building in dilapidated condition

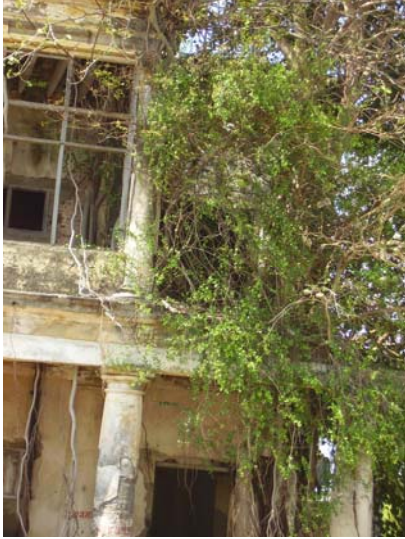
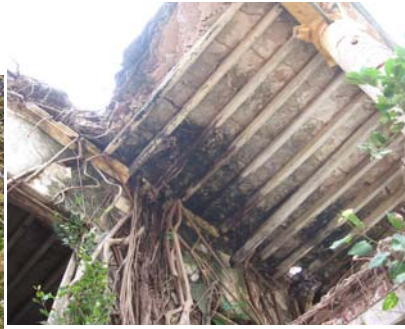
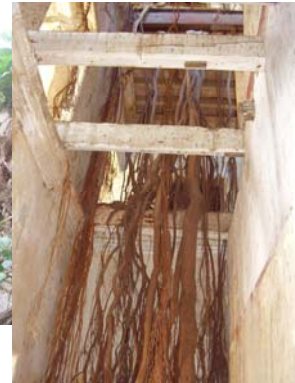
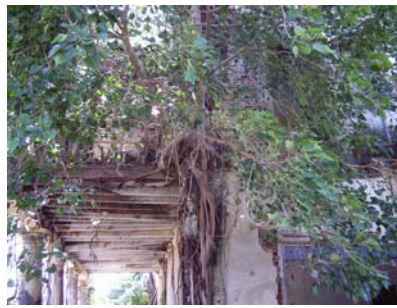
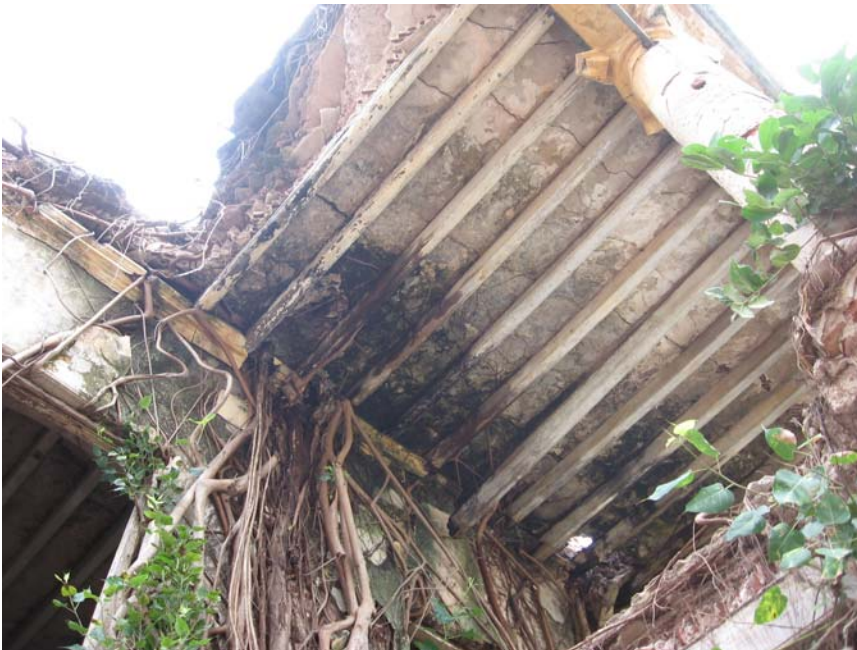
Main Causes of Defects in the Building

- Effect of the Trees and its roots

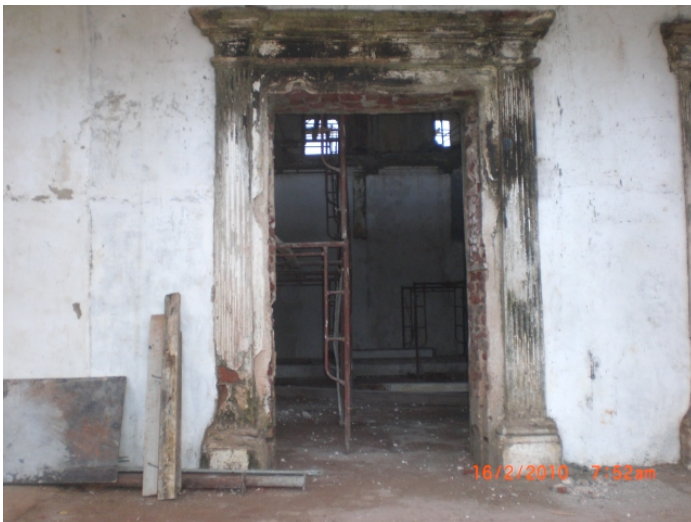
Doors and windows- Most of the timber parts of the doors and windows had been missing due to theft and damages. They were replaced using partly damaged timber members found from the site and new imported timber. Original timber parts should be carefully treated at the maintenance.

Building Being Conserved –Front Door

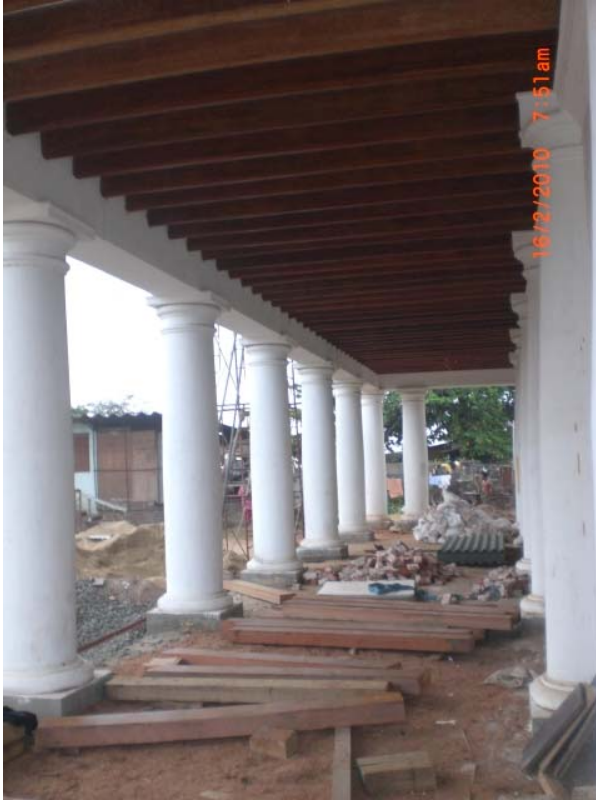
Slab and the beams of the outer verandah- only few timber beams are original and the others were replaced at the restoration with imported timber. Special care should be done for the original beams at the maintenance. Only small area of the original slab is remaining and special care is needed. Other areas were redone at the restoration

Building Being Conserved –Outer verandah

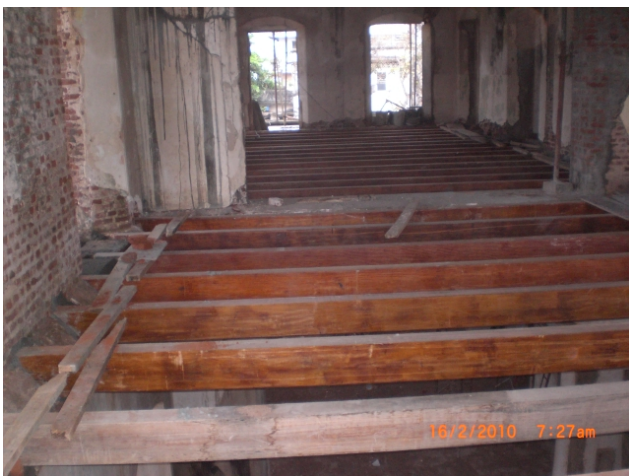
First floor slab and the beams of the inner area- Timber deck was missing and only few timber beams were remaining. The timber deck was completely redone. Special care should be extended to protect the timber deck and timber beams.

Building being conserved –First floor Timber Deck

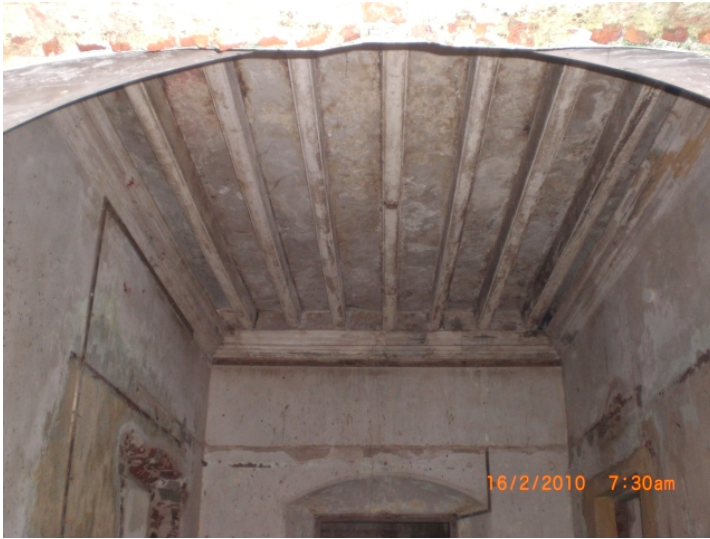
Slab and the beams of the roof - Most of the parts had been collapsed and destroyed. The roof slab and beams over the outer verandah was almost reconstructed at the restoration according to the evidences. The remaining areas of the roof slab in good condition were conserved. And for the other areas it has been imitated to get the same appearance from down, with flat cement fiber sheets. And also it was constructed a hidden modern roof over the inner part of the building to protect the areas including original slab and this imitation. The remaining original brick slab and timber beams should be treated very carefully at the maintenance.

Building being conserved – Roof slab

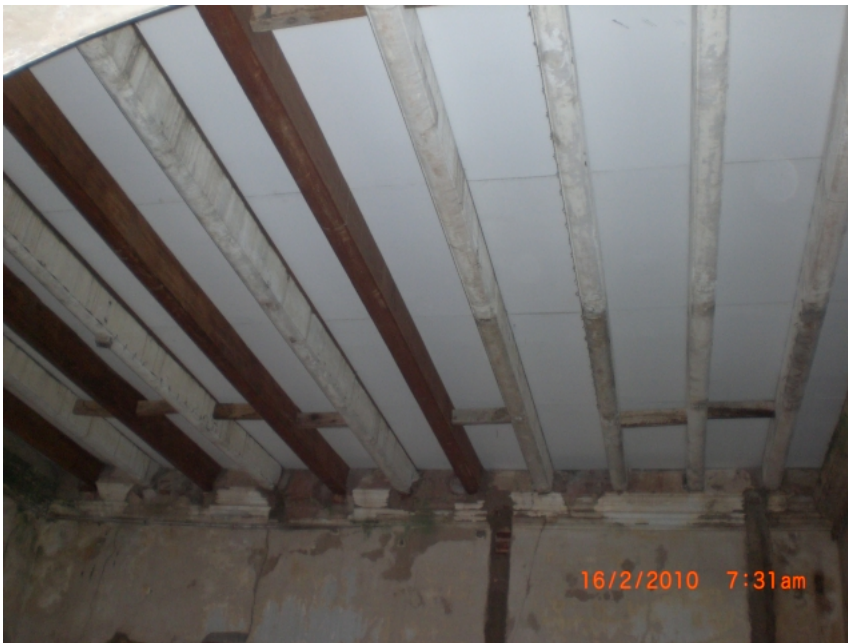
Building being conserved – Slab imitation

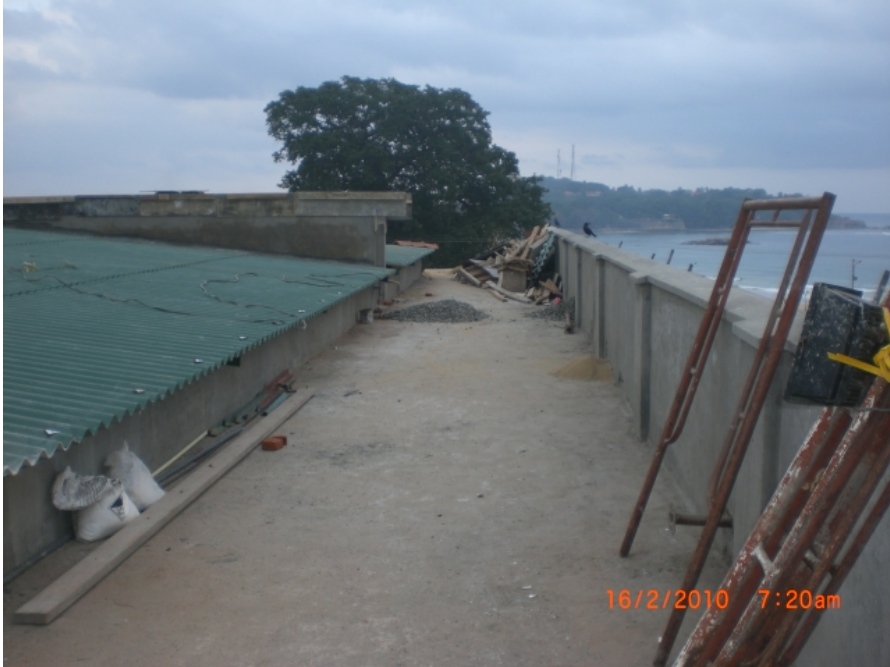
Modern roof – galvanized iron is used for the modern roof. Corrosion should be avoided with necessary actions time to time.

Building being conserved – Modern roof
