# ANNEX B

- PHOTOGRAPHS

**VALPARAISO**

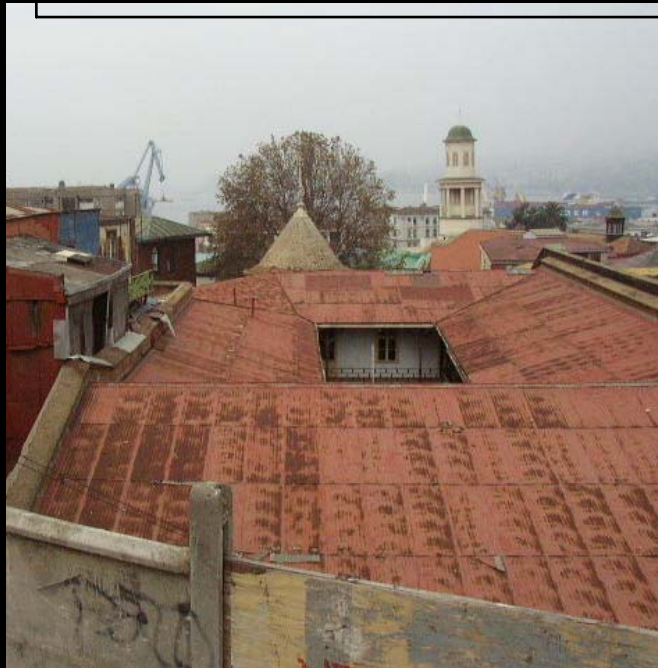
Before of the sinister

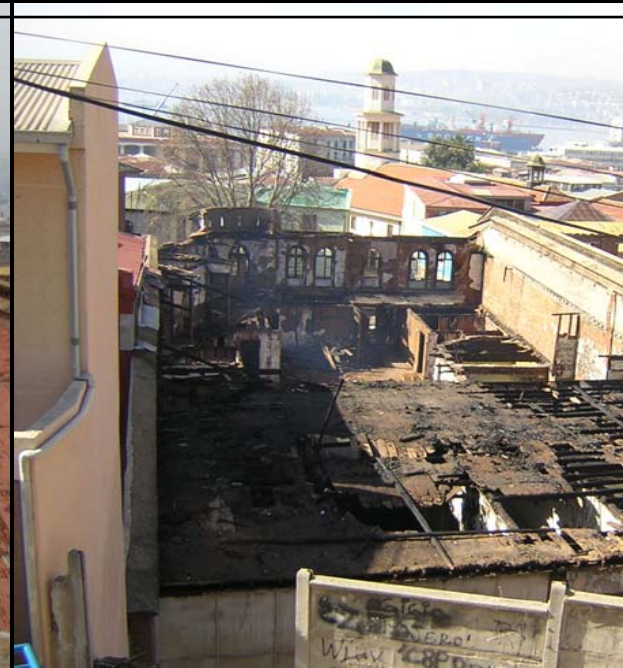
After the sinister

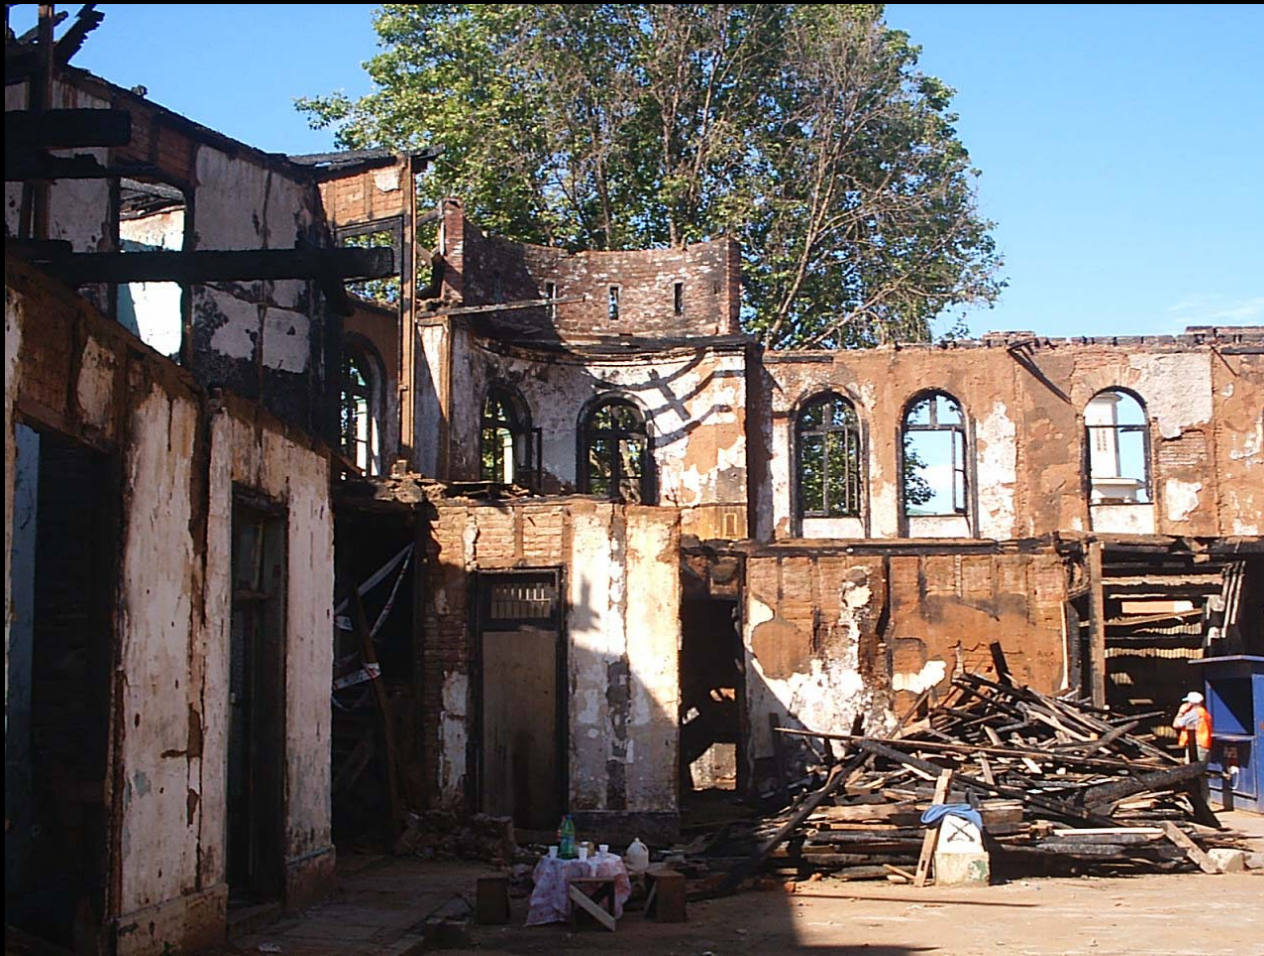
Photo N°1 : Bell tower of the Building located in the intersection of the streets

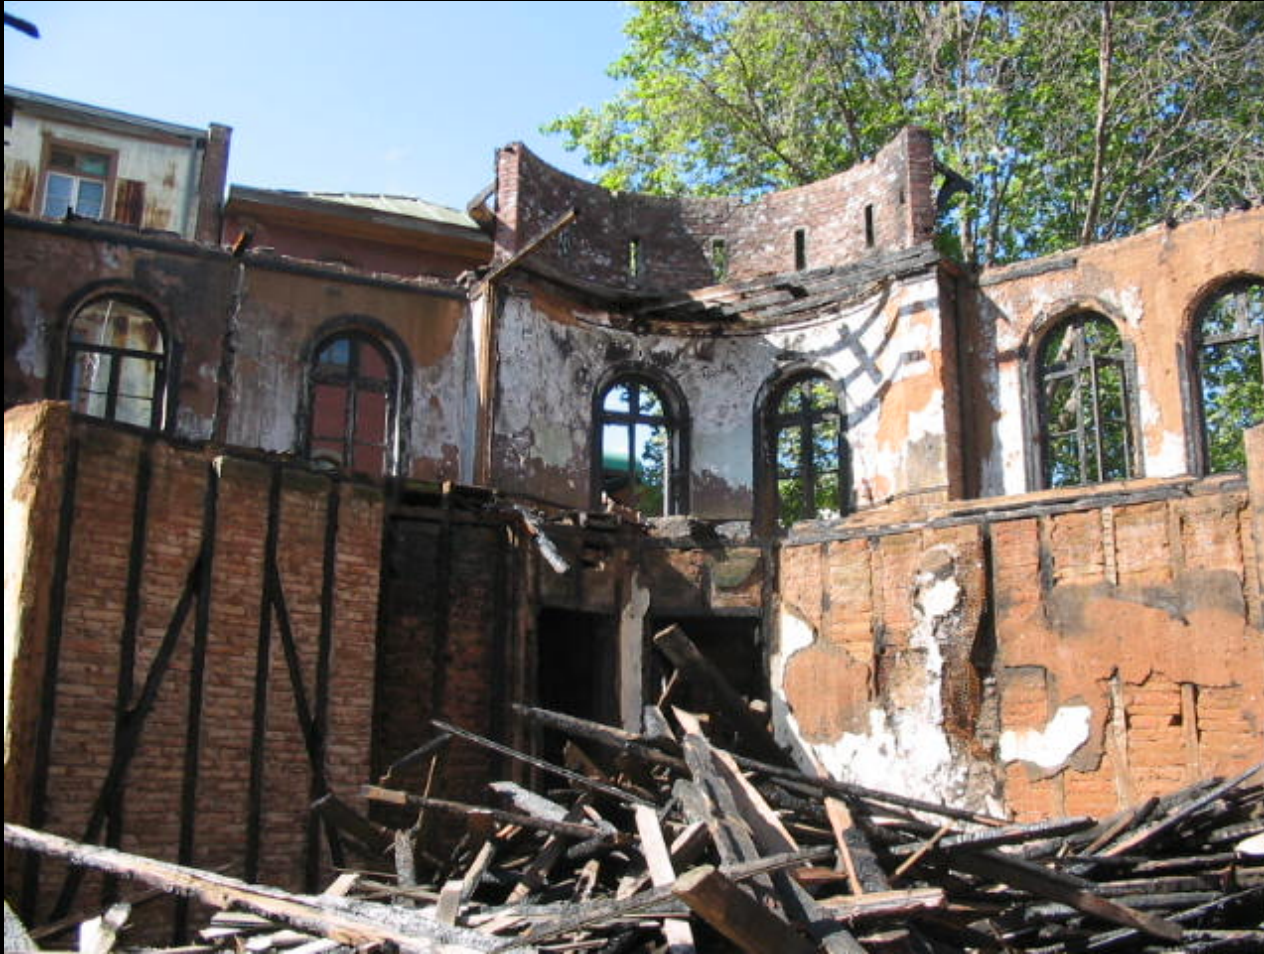
Photo N° 2: Bell tower of the Building located in the intersection of the streets Santiago Severín with Santo Domingo observed from the interior of the Building

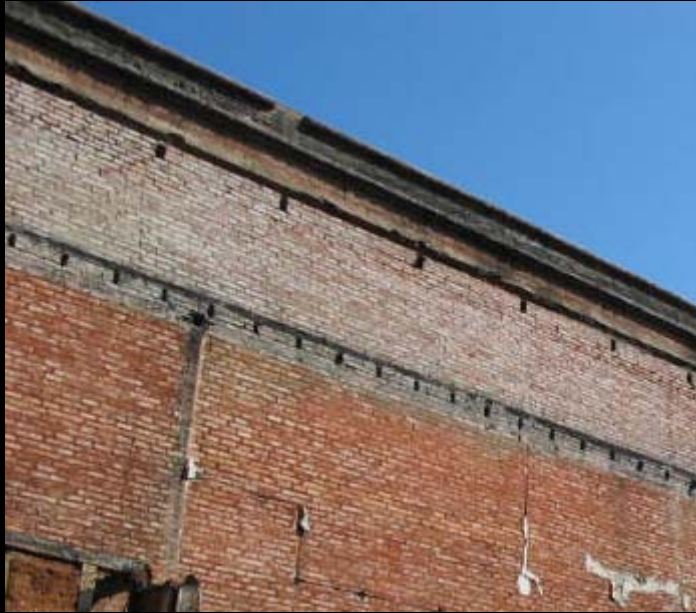
Photo N° 3: Fire wall building leaned by street Santiago Severín.

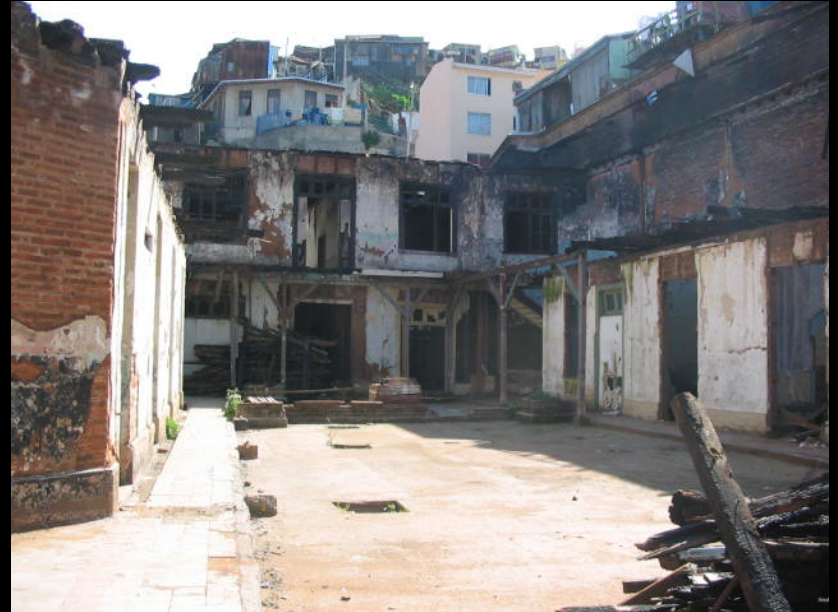
Photo N° 4 Present situation of the inner structure of the Building.

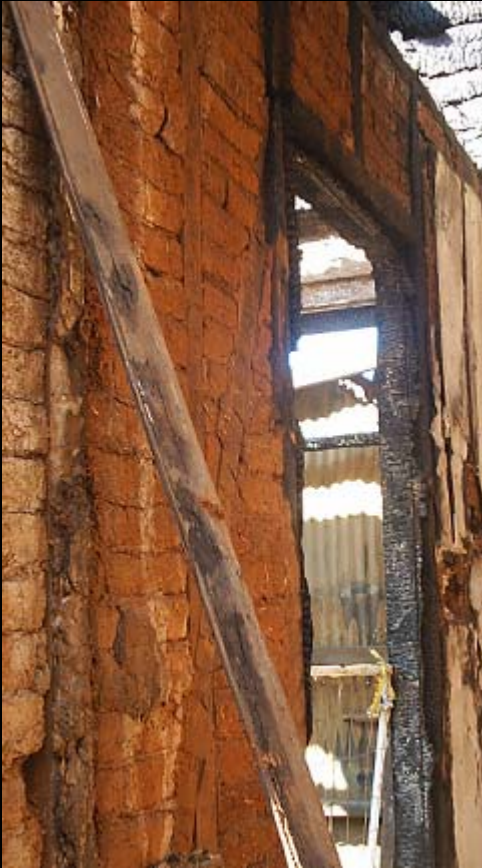
Photo N° 5 Present situation of the inner structure of the Building....

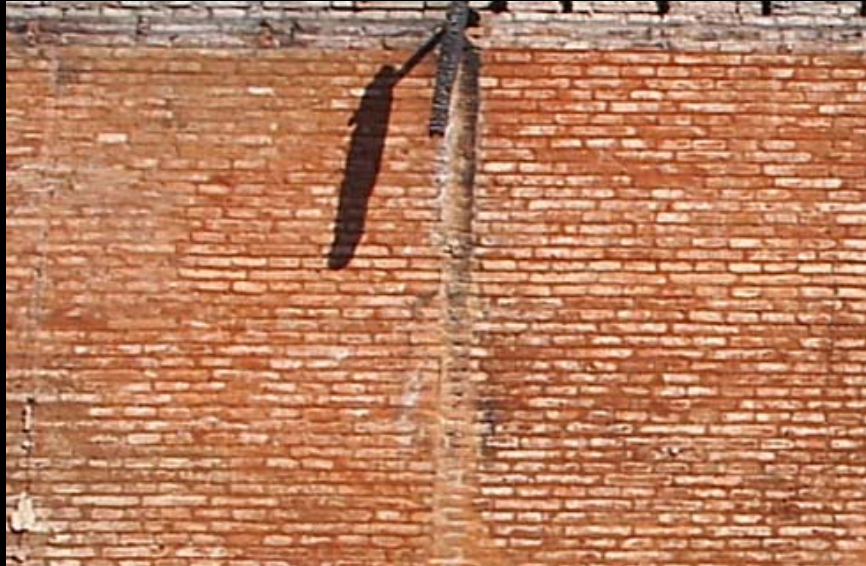
**Foto N° 6.** Beam Metallic Lintel, in vain of doors and windows  
Analysis Fire walls. The Severín building has two fire walls, one leaned to a structure by street Santiago Severín, which also was destroyed in the fire and other that it gives towards Santo Domingo street where at the moment inhabited constructions exist. The fire walls are of masonry and they are in good state as it is possible to be appreciated in the following photography's.

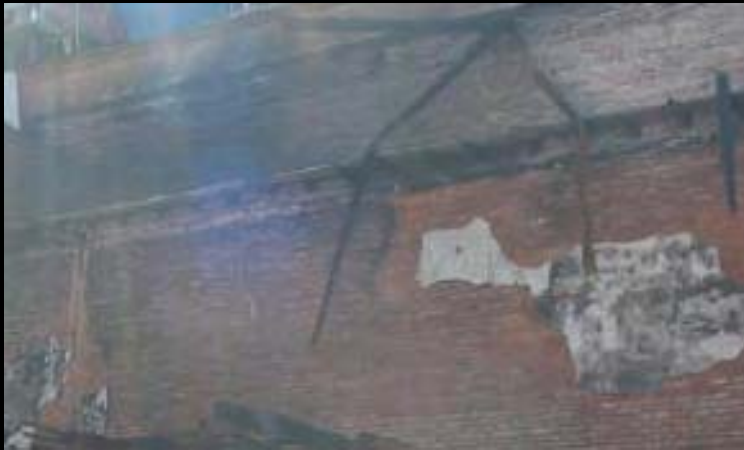
**Foto N° 7:** Wall semidetached fire wall to property by street Santiago Severín observed since the interior of the other property.

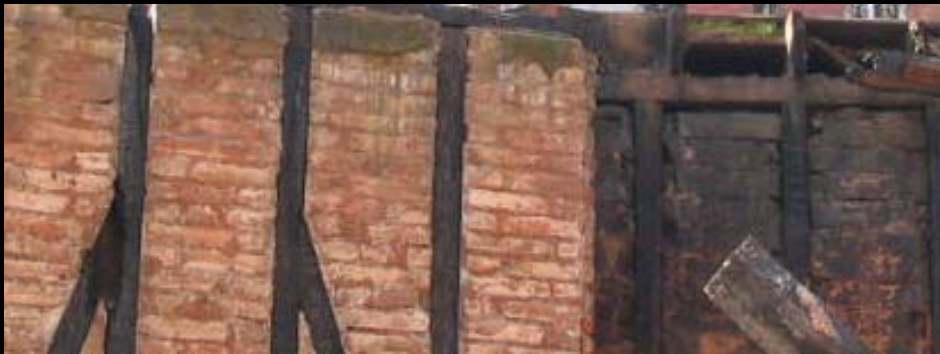
**Foto N° 8:** Image of present state of tabiquería interior of wood with bricklaying of bricks.  
Image of present state of tabiquería interior of wood with bricklaying of bricks

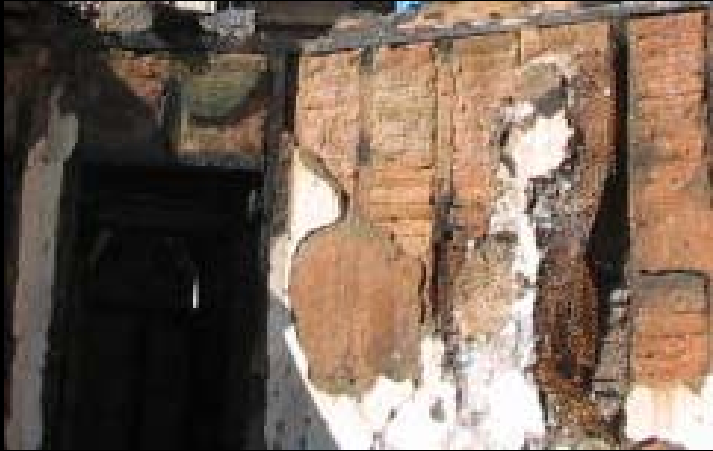
Foto N° 9: Present state image of tabiquería interior

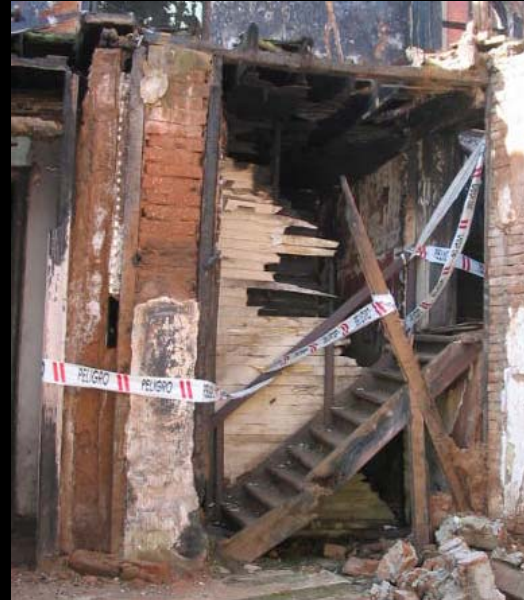
Foto N° 10: Present state image of tabiquería interior
