# **HAVANA GREAT THEATER**

## **Conservation Project**

**Training program Historic buildings  
and Conservation Management**

# Havana Great Theater: Conservation Project

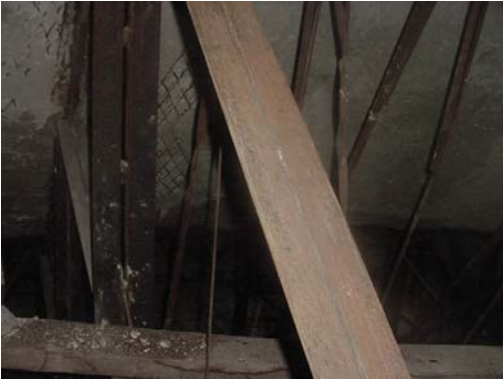
The structure doesn't have big affectations, only some concrete detachments in the areas with moisture surfaces. Deformations, defect or collapses are not appreciated in any element (fig. 43). Big problems of rust doesn't exist in the steel elements, except in some specific areas.

*figure 43: Steel structure, good state*

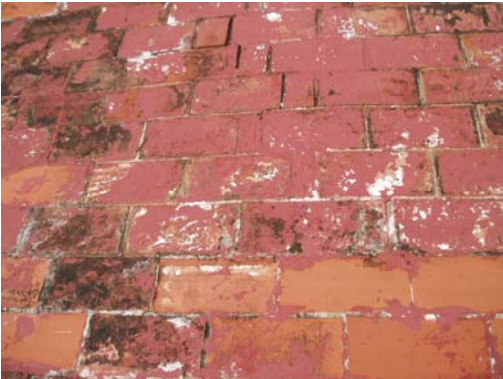
The roof have great deterioration because of the filtrations of rain water, caused by blocked gutters and conduits or bad solution of drainages. For this same cause the tiles are broken and in many cases, there is not joint materia. (fig 44)

*figure 44: Tiles broken and loss of joint material*

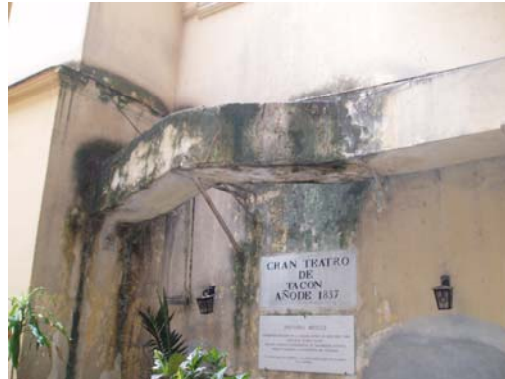
The infiltration of water has caused stains of moisture in the interior walls, mainly in the area of the rainwater vertical discharges or gutters. (fig. 45 and 46)

*figure 45: Moisture surfaces*

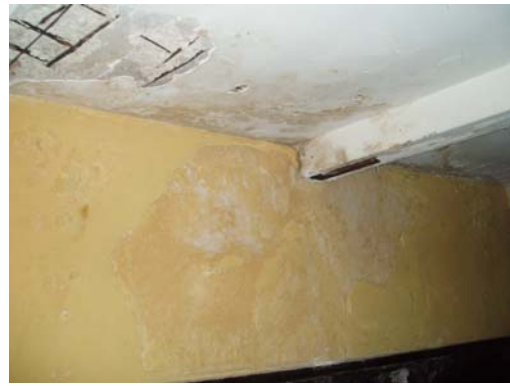
*figure 46: Interior walls - Moisture surfaces*

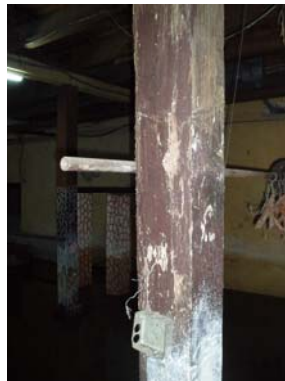
**The wooden structure of the stage is damaged in 50% due to the termites. (fig.47 and 48)**

*figure 47: Structure affected by termites*

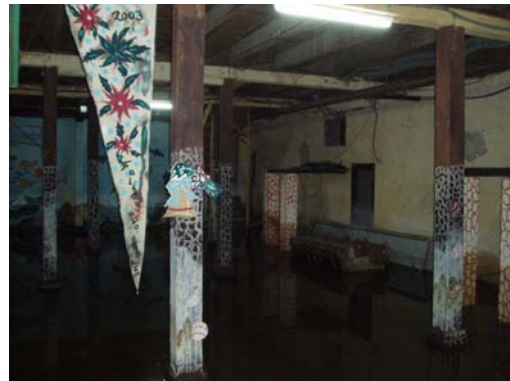
*figure 48: - Wood affected by termites*

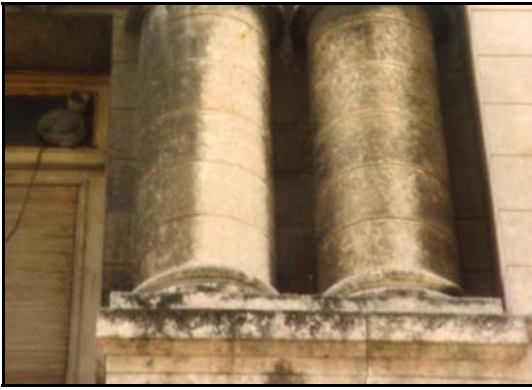
- 1. Surfaces modifications: pañtinas and black scabs that cover the parts fewer exposed to the sun and moistest of the wall; and saline efflorescences in the surfaces next to the sidewalk.( fig. 49)**
- 2. Elimination or loss of the material: Surfaces erosion, presents in a large part of the exposed garnishes; and alveolization, located in the most projected figures in the geometry of the facades and in the areas more affected by the rain and the wind. (fig 50 and 51)**
- 3. Ruptures and disjunctions: Detachments, mainly of the ornamental elements, balustrades, shields, etc.(fig 52)**

*figure 49: Black patina- San Rafael facade*

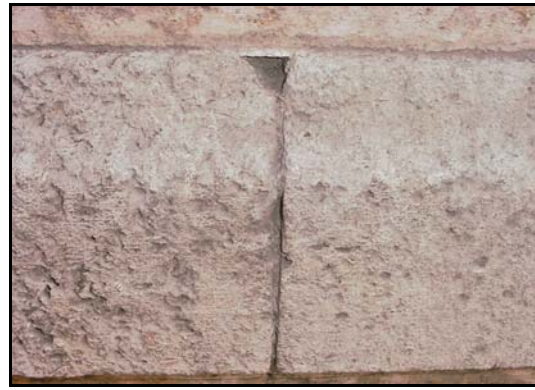
*figure 50: Loss of joint material.-San Jose facade*

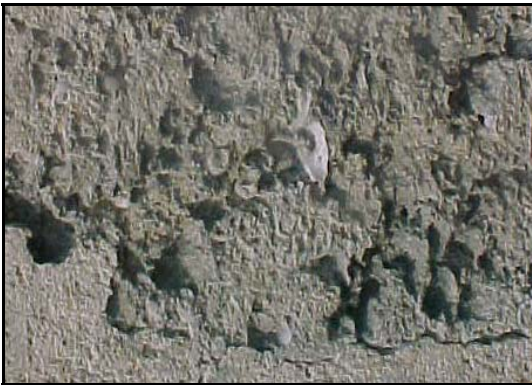
*figure 51: Alveolization- San Rafael facade*

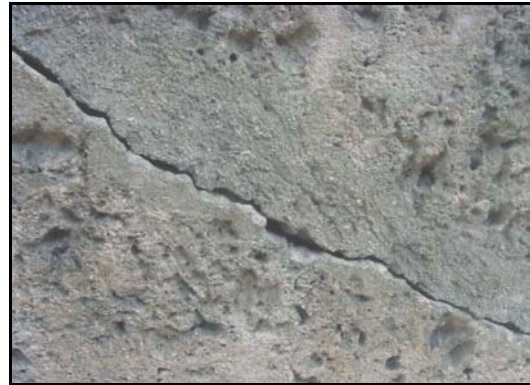
*figure 52: Rupture- Prado facade*

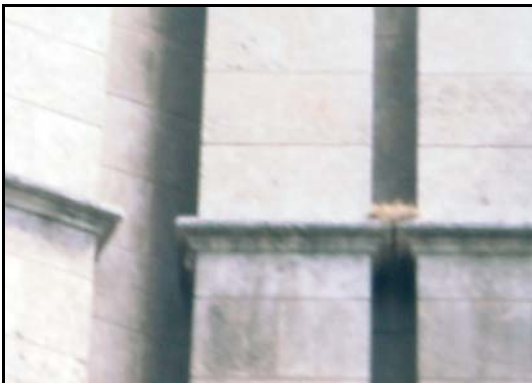
**Other problem that often can be often found are the antropics modifications, superior plants and liquenes colonies. The first ones are caused by inadequate solutions such as the use of Portlan cement mortars (that come off eassily) and some cleaning techniques used. The growth of superiors plants make cracks, because of its vital activity, introducing its roots in the wall. The liquenes colonies appear in moist surfaces , they are associated to the patinas. (fig. 53 and 54)**

*figure 53: Birds nest- San Jose facade*

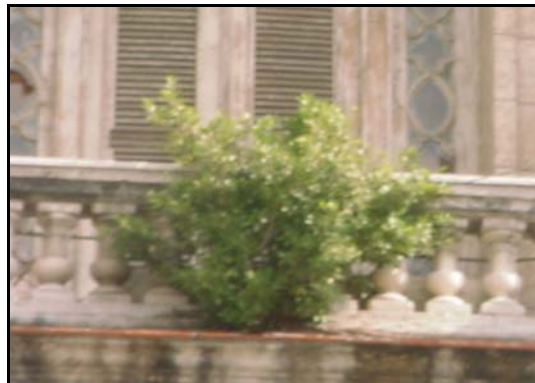
*figure 54: Superior plants- San Jose Facade*

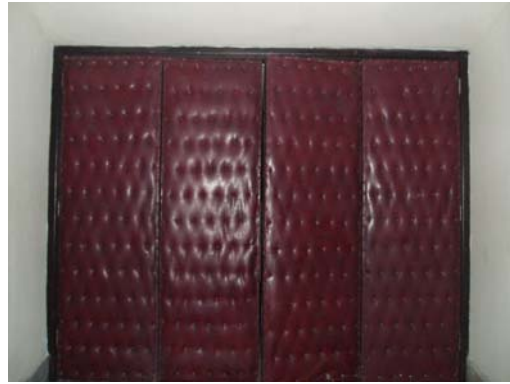
Some of the original interior doors and windows have been changed, like the entrance doors from the lobby to the Platea(fig. 55). The externals doors and windows remained the original one in regular state.

*figure 55: Entrances to Platea*

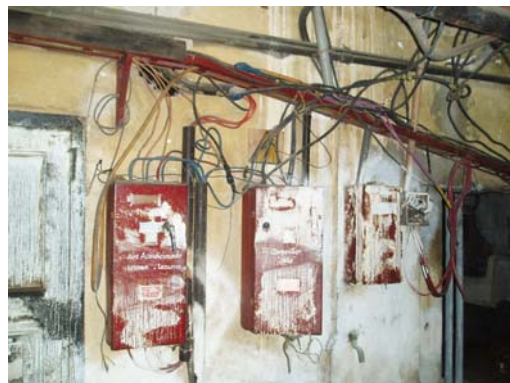
The loads center is constituted by switches of iron boxes with fuses, obsolete for this time and its ducts are exposed in a disordered manner.(fig.56)

*figure 56: Loads center*

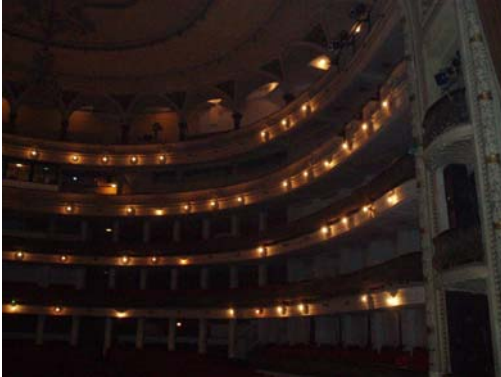
The lighting of the building is not enough, due to the lack of many lamps of different types that havenot been replaced, like the incandescent lights of the balconies and the rosette of the main roof. (fig.57)

*figure 57: Theater lamps*

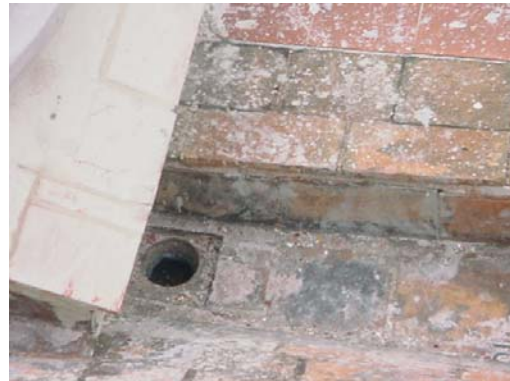
The rainwater discharges are blocked and there are not grating in the roofs.(fig 60)

*figure 60: Loss of gratings*

The rainwater discharges will be checked, and in the areas where the moisture affect the walls and the roofs, the tubes will be replaced .

Caps will be placed in each grating to avoid introduction of solid objects that cause block in vertical discharges.

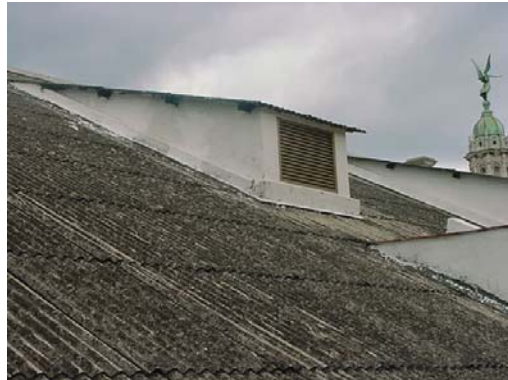
*figure 61: Restored roof- asbestos tiles*

1. Asbestos tiles : The broken units will be restored, using some that are stored in the basement of the building. (fig.61)

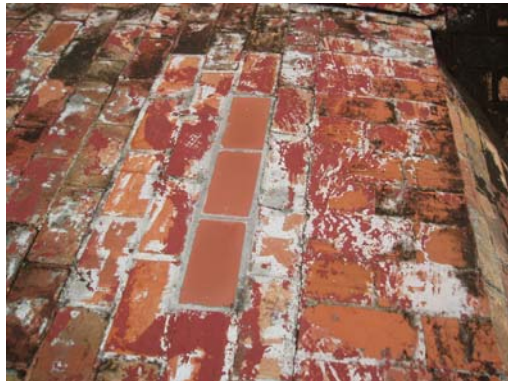
*figure 62: New ceramic tiles*

2. Ceramic tiles: The broken units will be substituted for new, the joints will be pointing, using special watertightness mortars with high adherence and durability and without retraction (fig.62)

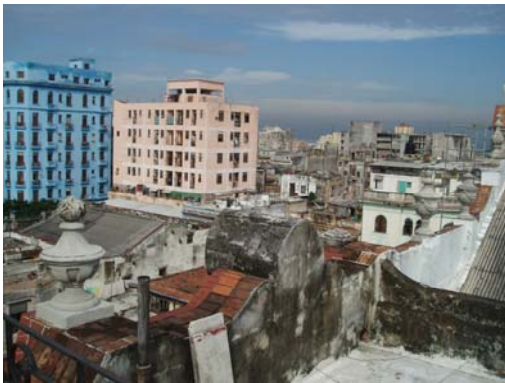
*figure 63: Damaged elements on the roof*

These recommendations are the bases for the work of restoration and repair of the stones facades and ornamental elements of the roofs that is being developed at this moment, using products there are in the Cuban market, such as special mortars for repairs with set accelerating addmixtures without retraction, bigger adherence with the old element, workable, bigger compressive, flexion and traction strength and high resistance to the chemical agents and the weather. (fig 63, 64, 65 66, 67 and 68)

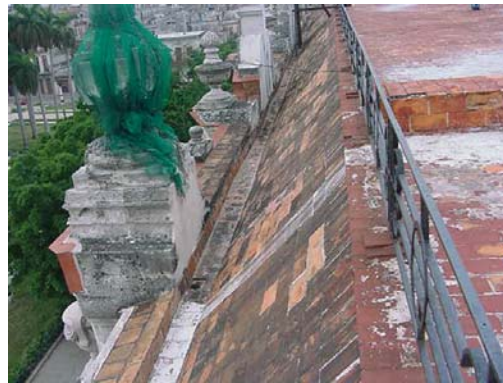
*figure 64: Damaged elements on the roof*

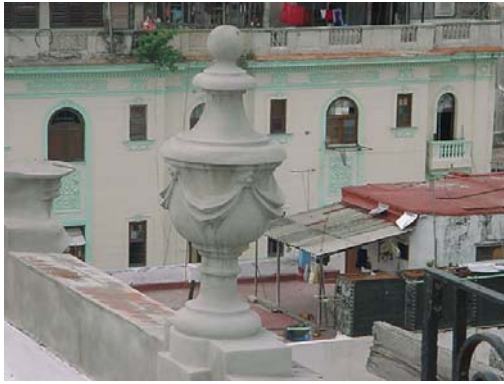
*figure 65: Restored elements on the roof*

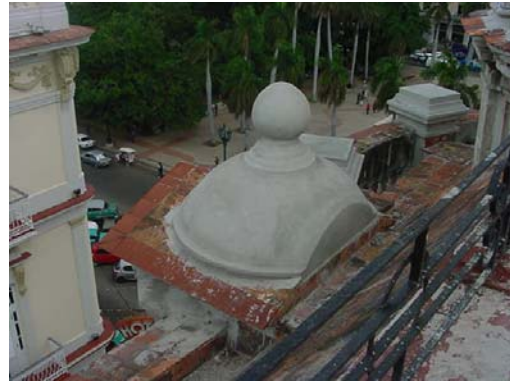
*figure 66: Restored elements on the roof*

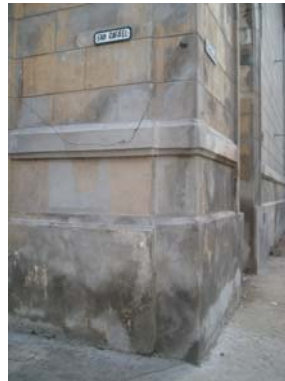
*figure 67: Damaged facade*

In facades we are applying mortars of powder of natural stones and strenghten add mixtures

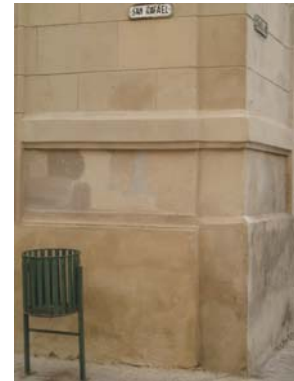
*figure 68: Facade in restoration*

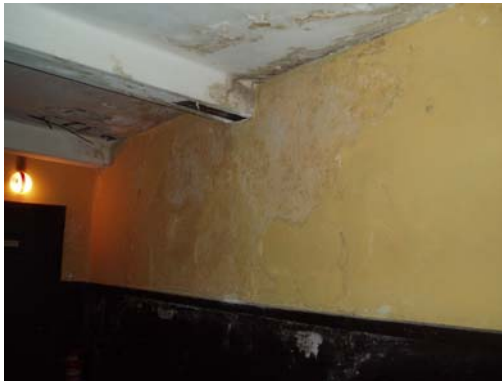
*figure 69: Damaged wall*

In interior walls affected by moisture we are aplying mortars with the same characteristics before explained. (fig. 69 and 70)

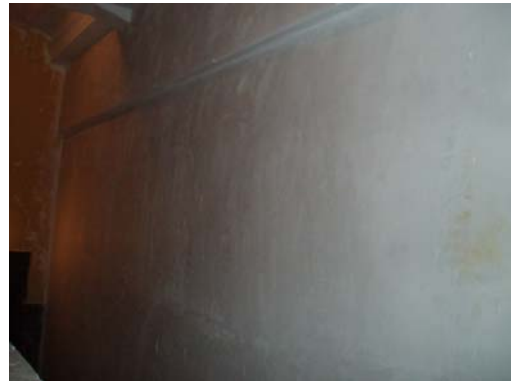
*figure 70: Restored wall*
