**BUILDING'S RENOVATION AT  
CONSERVATION AREA  
CASE STUDY: HOUSE IN TEUKU UMAR STREET 51,  
MENTENG JAKARTA.**

**DAVIS SYARIEF  
DEPARTMENT OF ARCHITECTURE  
INSTITUT TEKNOLOGI NASIONAL - BANDUNG  
INDONESIA**

**ADVANCED TRAINING PROGRAMME  
CONSERVATION & MANAGEMENT OF HISTORIC BUILDINGS  
26 SEPTEMBER - 13 OCTOBER 2005 IN LUND UNIVERSITY-SWEDEN  
20 FEBRUARY - 03 MARCH 2006 IN PNOM PHEN-CAMBODIA**

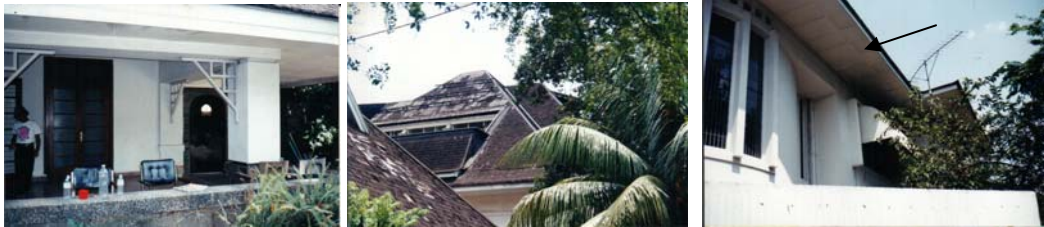
Generally the condition of building is still good. Bearing wall structure used as a main structure still could sustain the load of structure. The problem is the material, it was not enough good anymore because of age and less maintenance.

Shingled wooden tile used as a roof cover material is not in good condition any more. This is because of the climate, tropical country with heavy rain. This material made of wood sheet and not easy to maintenance. At previous time this material was a symbol of status because expensive material. Basically wood roof is not strong enough to bear the heavy rain, it will easy damp and damage.

Picture 10: Bearing wall structure, roof material and the damage of ceiling caused of leakage.

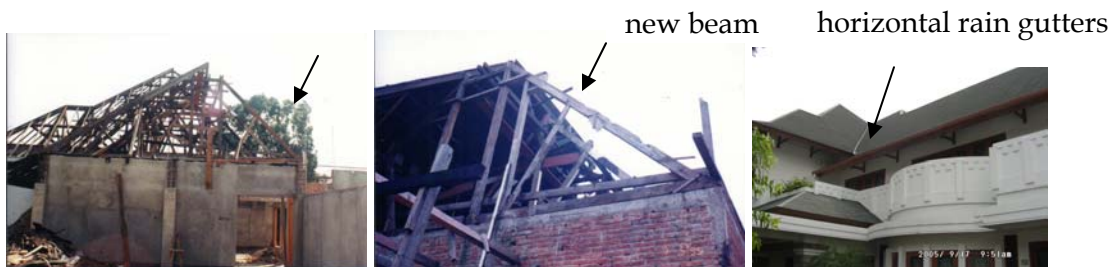
Picture 12: Roof construction process and the horizontal rain gutters.

After the roof support construction was ready, and then multiplex wooden sheet were laid over it, as a base for the roof tiles. The fiber-concrete roof tiles were nailed to the multiplex layer. Under the multiplex sheets sound proof wool and heat resistance aluminum sheets were installed, this is to prevent heat from the direct sun and also to minimize the rain falling on the roof sound.

Horizontal rain gutters was installed to prevent the rain water free fall from about 6.75 m high, with the vertical in hidden positions to minimize elevation distortion.

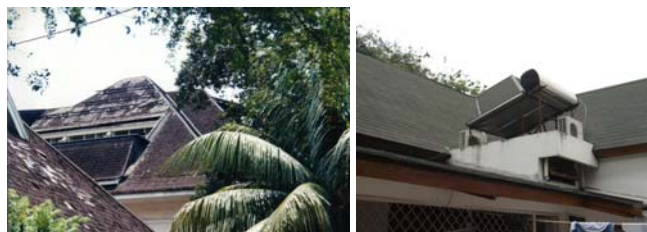
The old roof construction was in a fair condition, most of the wooden beam's were in good shape and could still hold the roof, only a few of its should be changed due to rotten and decayed condition. The wooden tile's, roof cover material (shingled roof) also was out worn and should be replaced.

Picture 13: The old and new roof cover material, shingled roof removed to fiber-concrete.

The conservation regulation does not allow changing the original roof shape but the construction and roof cover material could be changed. Wooden roof tile's were removed and then some wooden beam support's, whilst the still in good condition beam's were maintained.

All wooden roof beams (old and new) should be treated with anti termite control liquid, so all wood beams were sprayed before the assembly of the roof construction. The old beams were sprayed on location, whilst the new ones were sprayed before they were pulled up to the roof position. Some temporary beams were positioned near where the replacement beams should be located. Some of the temporary beams were taken from parts of the roof that will be changed in shape or construction and after that were reused on other locations.

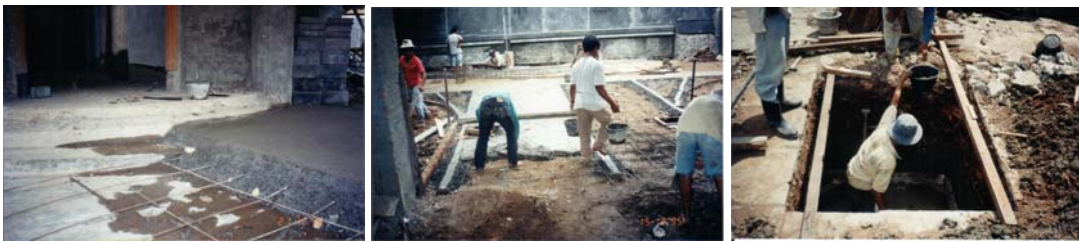
The old original floor tiles were made of cement, had beautiful pattern's and dimension 20 x 20 cm and 30 x 30cm, but were out worn and broken in many parts from the heavy furniture and equipments used before. Only a small part of the floor tiles could be used and it was very difficult to make them shiny as new, polishing would only nibble away the shiny surface, leaving the cement layer on the top. The whole old floor tiles were removed, including the terrace, the service area and also the car port and drive way because the owner wanted to change with the new material.

Picture 14: Floor construction and drainage ditch under car park.

For replacement on the 1<sup>st</sup> floor, 60 x 120 cm size cut Italian marble tiles was put on. But before that to ensure the stability of the floor tiles a 10 cm thick sand layer and an 8 cm layer of concrete reinforced with a single layer steel carcass was put on the ground. On the 2<sup>nd</sup> floor wooden parquet tiles was used, to ensure that the base to glue the tiles was flat a 5 cm layer of cement was leveled over the concrete slab.

For the parking area, car port and drive way, layer combination of boulder's, sandstone, sand and 15 cm thick reinforced concrete slab was made, after that the surface was covered with small 10 x 10 cm cut pebbles. There was drainage ditch under car park which should be done before the floor construction.

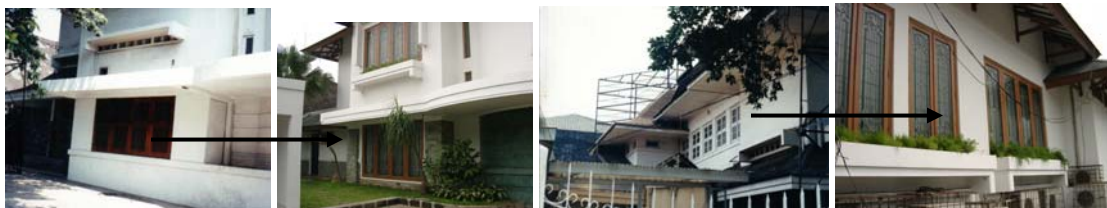
The old door and window frames were made of teak wood, still in good condition but out of date in model, more likely it was not matching with the architectural design view.

Picture 15: The old and new window style.

To minimize the budget of this project, the old frames was removed and reshaped, it cut the frame budget to  $\frac{3}{4}$ 's, new design did not change much of the frame shape, it affected more to the door and window style it self.

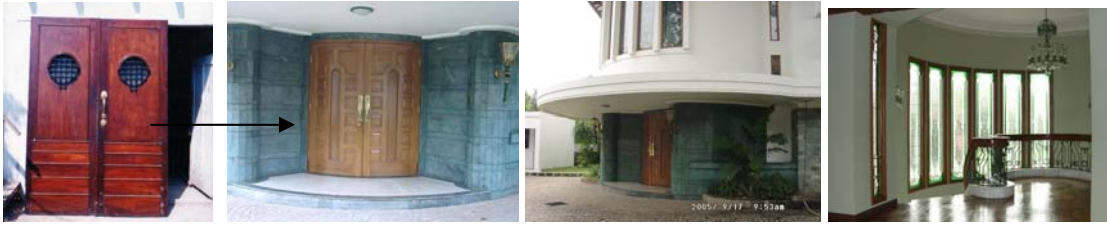
The main entrance door, located on the round hall or stair area had a unique shape, but because it flat shape, a new door was made, with the round shape like the walls surrounding it.

Picture 16: The old and new main entrance door and the art glass on window.

The window glass was replaced, from 5 mm thick plain glass to art shaped with led glass (art glass). It gave a different effect especially inside the building with different colors.

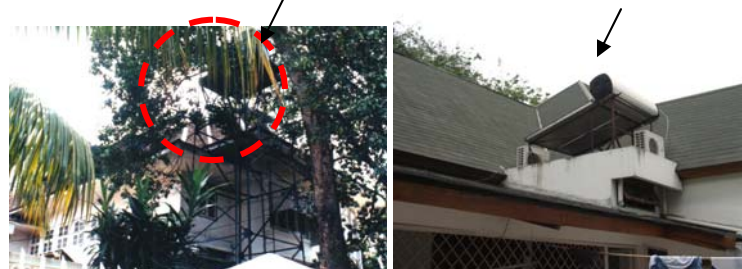
Picture 17: The old water tower at front side and the hidden equipment at back side.

The plumbing system was also renewed. A tall water reservoir in front of the building (about 8 m high) does not help the appearance to the better one. As known in Jakarta, the city clean water supply has a limited debit so water storage (reservoir) is inevitable. But it should be positioned someplace that it is not bothering the building appearance or it could be an interesting decoration of the

building. All clean water was moved to the back part of the building, and a new deep well (over 100 m) was drilled for back up water supply.

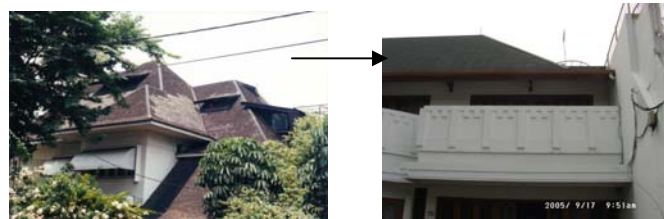
Picture 18: The old and new roof material.

The new roof material should be strong, durable and 'good looking', able to absorb hard rain noise and also easy to maintain, easy to find and after a long time still available in market. The choice was on a fiber concrete tile from Japan; it was an asbestos free, hard surface material, used on many houses in Jakarta and had the thin tile shape, easy to apply on multi layer and different angle roof (adjustable). The problems are expensive, need special skill to install and need extra material (multiplex wood as a base construction) to be attached to.

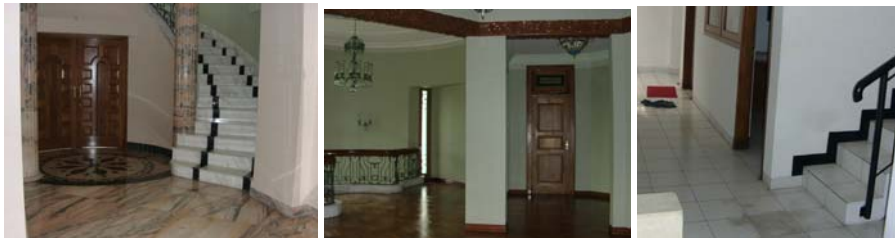
Picture 19: New floor tile: marble, parquet and ceramic

The floor tile criteria was beauty, lofty, minimal maintenance, durable and long lasting obsolesce. For the 1<sup>st</sup> floor, especially for the main rooms marble was chosen, the cool character and prominent image of this material was the reason. This was important for the owners because the lower part was for guests and relatives.

The service area, use ceramic tiles, easy maintenance and not too expensive to replace if broken was the reason.

The 2<sup>nd</sup> floor uses wooden parquet tiles, to arouse cozy and intimate atmosphere. This area is for family and close relatives.

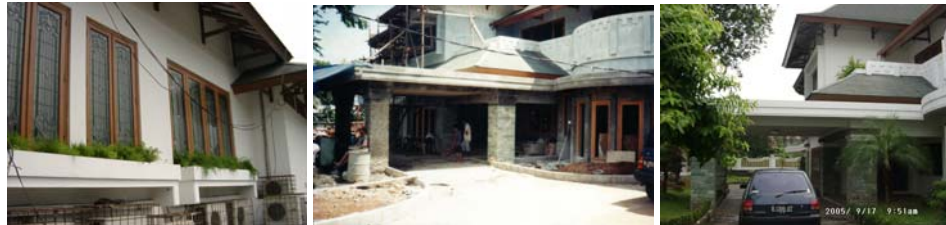
The old air conditioners were not only heavy electricity consuming window units, but also makes lot of noise. Changing to the split system, where the indoor blower unit is separated to the compressor outdoor unit, makes it easier to place the indoor blower. It could be placed over a door or window, across the room or on the ceiling (cassette system) to adjust with the interior design, furniture arrangement or as wished by the owner.

Picture 20: The outdoor units of air condition and the new car port.

The outdoor units are positioned and poled in the back part of the house, easy to maintenance but hidden to others

A canopy is built at the outside of the guest room to accommodate the receiving of guests and relatives as well as the owner themselves. This is useful to avoid rain or direct hot sunlight during arrival by vehicles. This car port is made of reinforced concrete and has a stretch of about 5 meters and the top is concrete slab.

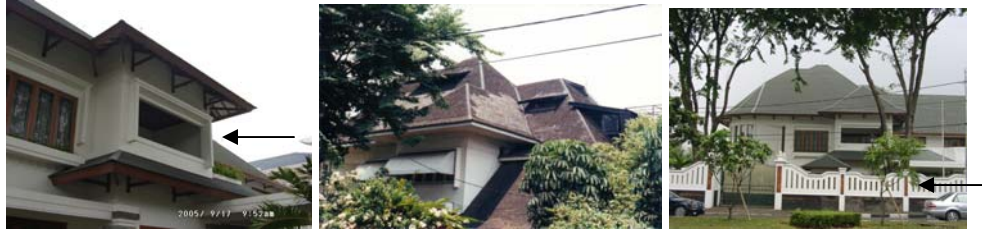
Picture 22: The new balcony and fence.

The balcony at front side second floor is new addition. Previous was part of bed room.

The fence is also renewed from filament covered by plants to brick wall to accommodate the house new style.
