CONSERVATION & MANAGEMENT OF HISTORIC BUILDINGS

Lund University

CONVENTION CENTER *CAXA REAL*

Work done by: Gustavo Bueso

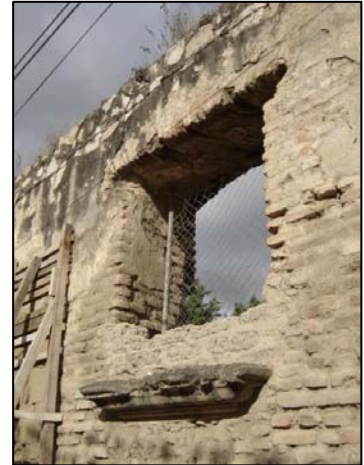
Constituted in great measure by a sediment type of rock of brown-yellow color, which comes from the same zone and cut in similar ways more or less regular on the corner and of different dimensions and forms totally irregular compare to the rest of the wall.

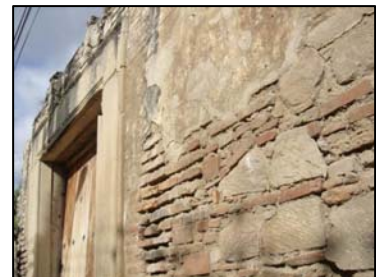
Mortars relaying:

In the most part the wall has been lost, remaining only a fine film in determined zone next to the cover.

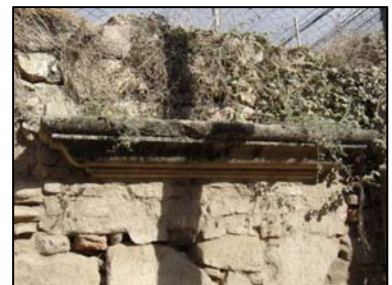
Base mortars:

The mortars of lime of the stone wall are encountered in a bad shape in cause of a combination of atmosphere agents, contamination, dust that has favored the retention of humidity and transmission that follows towards the internal part of the wall.

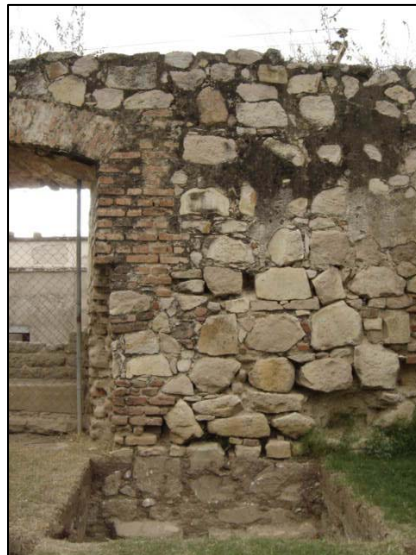
Rocks and bricks:

The stony material has been degraded equally showing different types of alteration physical, chemical, biological and human. It is difficult to define the causes of the origin, since they generally act all the same time that started one or ended in the other.

1. elimination of mortars of relaying
2. superficial cleaning of dirt
3. pre consolidation
4. in clean depth
5. consolidation
6. reintegration and re growth
7. final protection

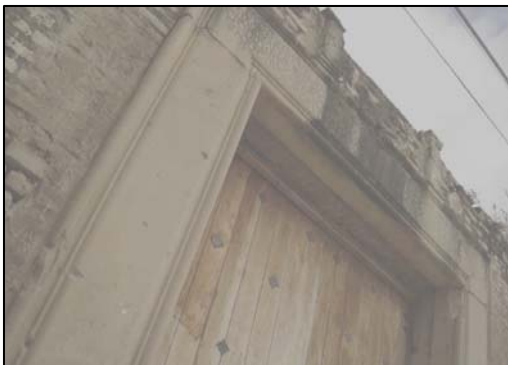
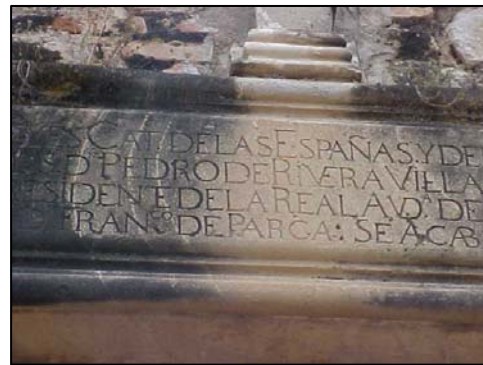
The cover is lifted at point of the rock of cantor and of major quality as far as mechanical properties that are conformed by stonewalls. In both cases it is about a type of sedimentary rock, of the caliz group, composed mainly by calcic carbon.

A temperature increase on any material generally produces a volume increase; however, it is after the following cooling, in the process of volume contraction, when micro fractures are developed.

In this case, some circumstances especially aggressive increased the speed of deterioration due to fast cooling of the hot surface of the stone when raining.

In this case these chemical alterations are related to mechanical factors as micro fractures that produces an increase of porous ness.

Humidity is the second cause of secondary lesions, now that is the agent that sets in motion the pathological process initiating the degradation of the constructive materials that ends in loss of its aspect.

1. superficial cleanness
2. pre consolidation
3. in depth cleaning
4. proof of presence of hydro soluble salts and elimination of the same
5. proof and elimination of insoluble and salts
6. clean and touched by reunions
7. sealed of fissure
8. re integration of the lines
9. tore of the façade
10. consolidation
11. hydro fugation
12. treatment of humidity

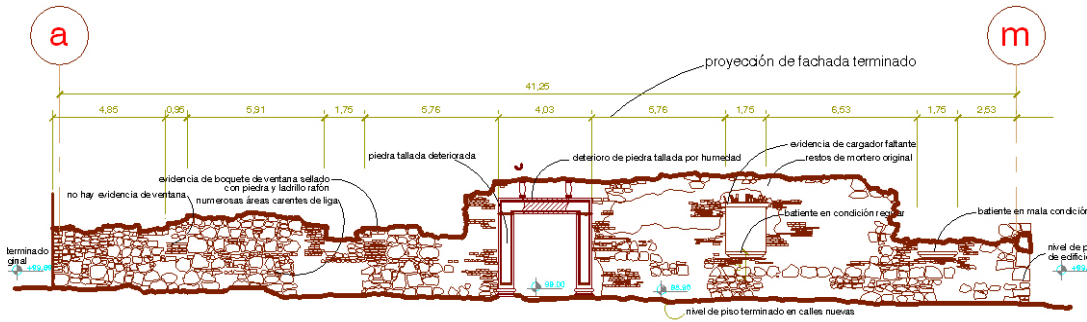
Present condition of frontal facade

Of the old antique Caxa Real or *Royal Box* only approximately 60% of the frontal façade is conserved, same that are encountered in a ruined state with a pathological problem reflected in the full towards the exterior of approximately 30 cm in the sections more critical of said façade. Given the state of abandonment of these ruins, a process of erosion, fungi and humidity has been generated on the stone wall due to the inexistence of repairs and the lack of treatment of seal of the unions in a base of soil and lime. Added to these problems, also the vegetation contamination stands out in the ruins and the pronounciation of the crumbling caused by the roots of the trees that grew next to this wall.
