CONSERVATION AND MAINTANANCE

A Report For Bara Katra

**Submitted by:
Mohammad Sazzad Hossain, Architect .(Bangladesh)**

**Housing Development And Management
Lund University,sweden**

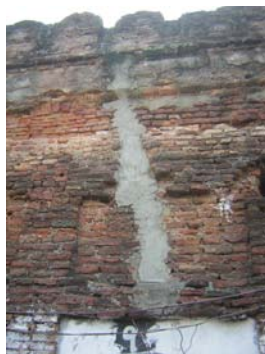
Fig. 22 Major crack on wall

Between the entrance and the octagonal turret at the east a prominent crack seems to bisect the entire southern wing. The crack is clear at elevation and both side of the slabs. The crack is now filled with cement mortar.

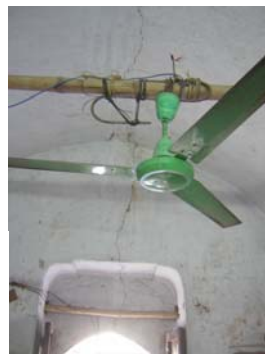
Fig. 23 Continuation of the major crack inside.

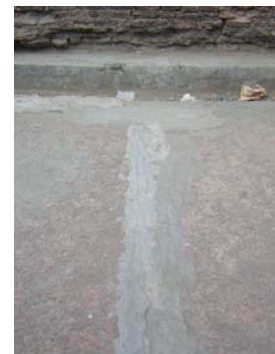
Fig. 24 Continuation of The major crack on floor

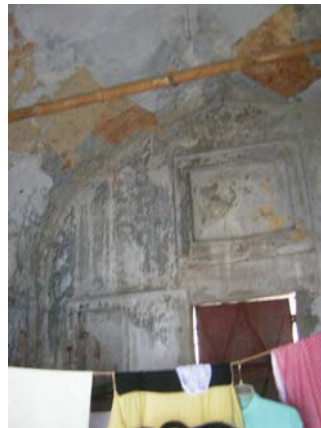
Water leakage is found at the vault roof of 1st floor of east side. Moreover dampness is a common problem in most of the vault and flat roof.

Fig. 26 Water leakage through roof

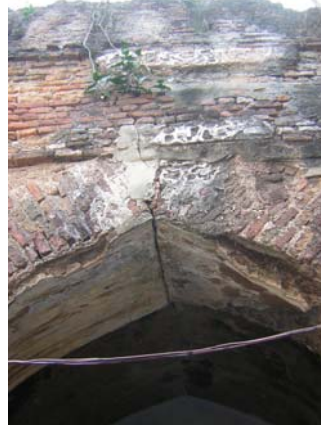
Prominent cracks run through the center of the barrel vault from one end to another. The free end of this vault takes the form of archway that shows the depth of the continuous crack bisecting the whole vault roof.

Fig. 28 Crack on arch

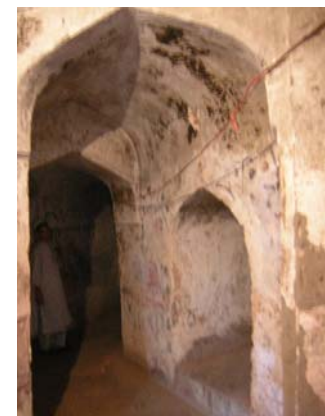
Fig. 29 Damp on wall

Trace of huge moisture at the floor and wall at ground floor indicates capillary action. Though dampness and moisture is a common problem for old buildings in tropical climate the excessive presence of moisture and dampness in most of the floors and walls shows serious lack of maintenance work.

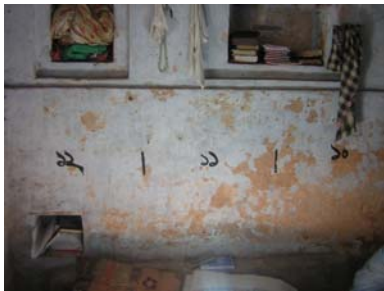
Fig. 31 Moisture on wall

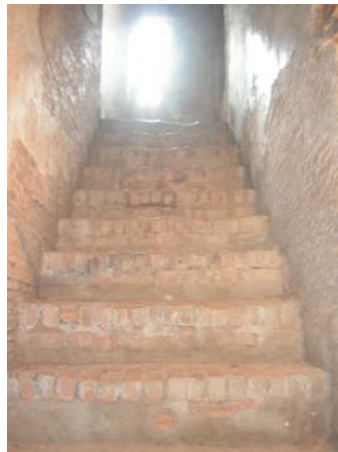
The two major stairs leading to the 2nd floor from the ground floor are severely damaged. The eastern one is reconstructed but the western one is standing with exposed surface of bricks.

Fig. 34 Damage stair

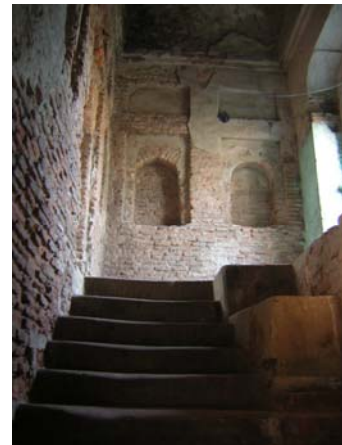
1) Most of the original plaster has come out and in many cases traces of different layers of original plaster is exposed. In some places the original plaster is still there with hair cracks and termite attack.

Fig. 36 plaster removed from wall

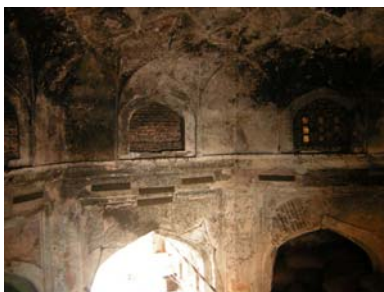
Though the building has got small openings of traditional *Mughal style* entrance of ample natural lighting was ensured by raising the number of windows. In the ground floor and staircases most of the openings are sealed that prevents the usual access of light.

Fig. 32 Openings sealed

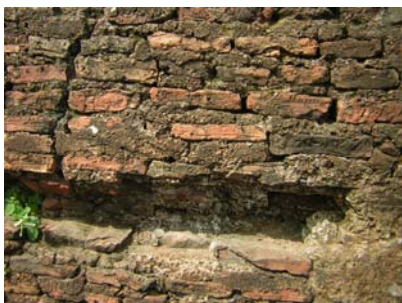
3) Presence of vegetation is found in resulting in cracks through their spreading roots.

Fig. 33 cracks on wall caused by plant roots

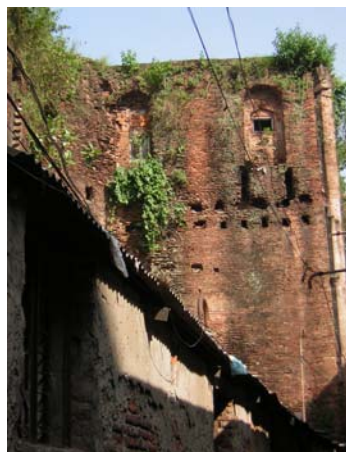
Fig. 35 plaster removed from wall

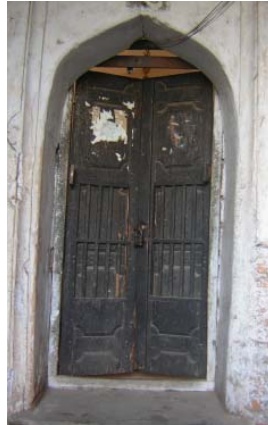
- 1) The old door and windows that are considered original are found in poor condition. Color, Polish and most of the iron grills have disappeared. Rots in iron and deterioration of wooden surface are a common feature.
- 2) Alternation is made but there is a similarity between the old and new one.
- 3) *Gorjon* timber is used as frame and teak is used for rest of the wooden part of the original doors and windows.

Fig. 39 Old Door

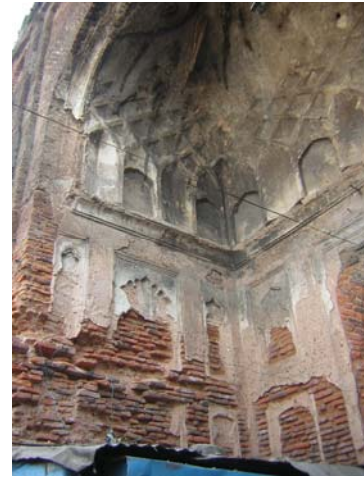
- 1) Decoration work on plaster at outer wall is partly present but the internal decoration of domes at the top of the octagonal tower and entrance is still intact.
- 2) Different colors have been used in doors, windows and wall surface recently without considering original parches or schemes.

Fig. 44 Damage of plaster detail
