St. Paul's Cathedral in Kolkata, India

Restoration, Rectification and Maintenance plan

Individual study by Unmesh Kirtikar

**as part of the SIDA course
“Conservation and Management of Historic Buildings”
conducted by Lund University, Sweden.**

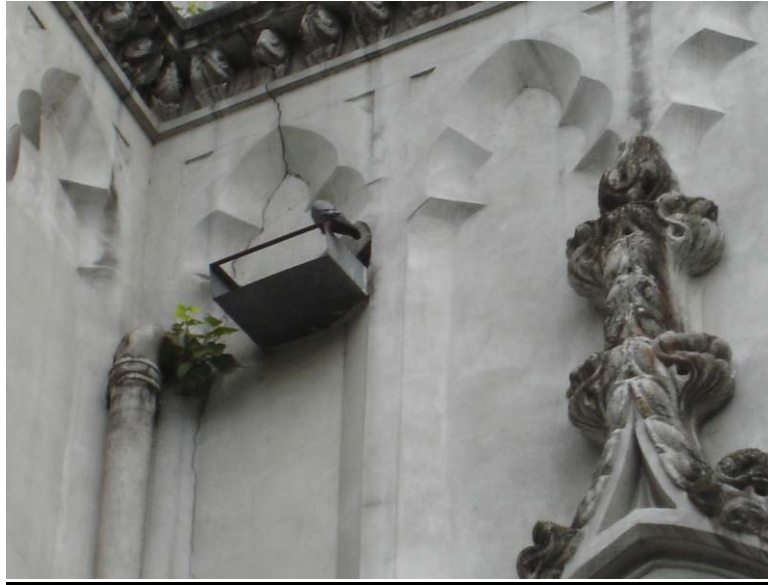
iii) Drainage System:-

The drainage system had deteriorated right from its collection point upto the sewer. The rain water pipes and spouts were broken at places. The surface drains required reconstruction and renovation. A proper connection with the Municipal sewer line was also required to be provided.

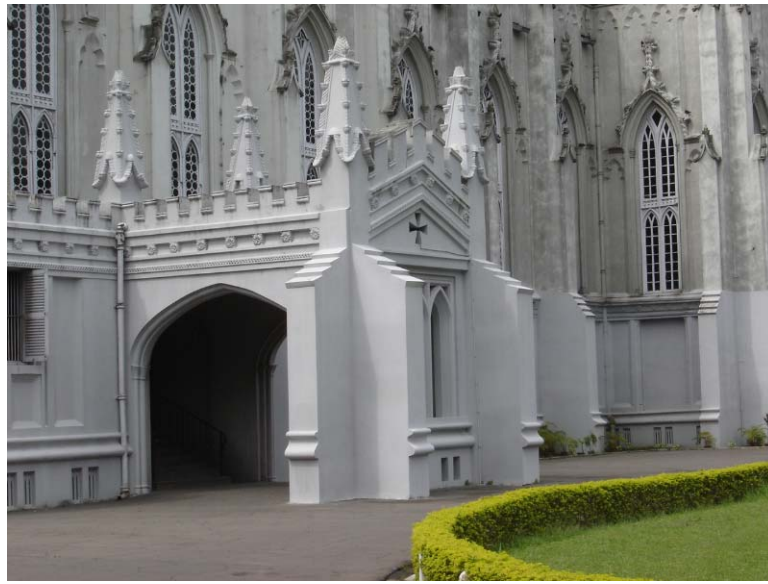
The original Timber beam under the large window on the western façade was in a poor state. It was replaced by a set of steel joists, after cleaning them with acid and further treating the same with a weatherproofing and rust proofing epoxy resin compound.

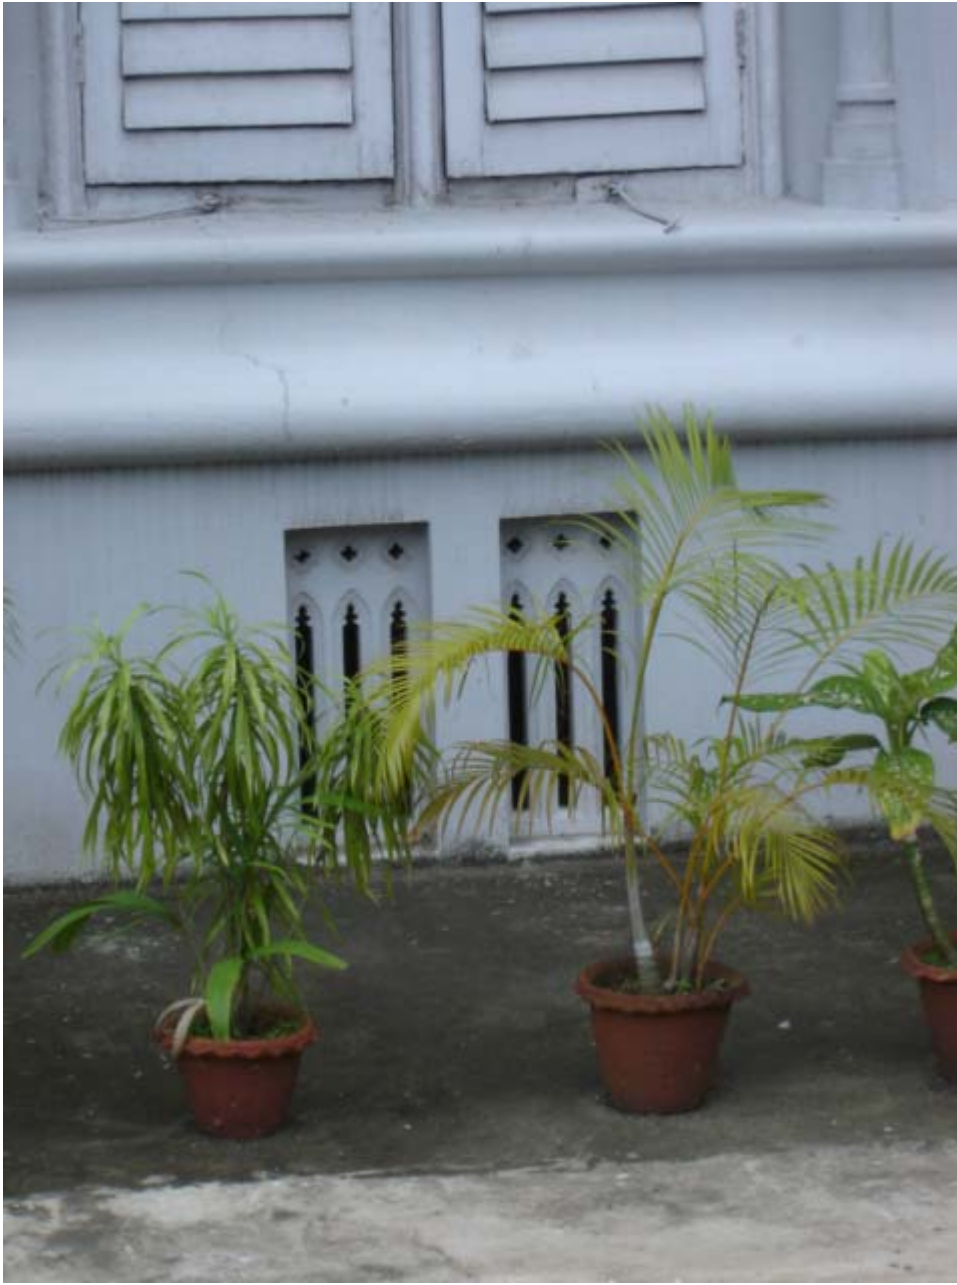
The basement was originally provided to facilitate ventilation and non-accumulation of moisture below the ground floor slab through tunnels running across the Cathedral from North to South. The Fenestrations to these tunnels were of cast iron gratings some of which got damaged or

lost over the years. Moreover, due to reasons unknown, these tunnels were filled up at some time.

The tunnels were completely opened, cleaned and ventilated in order to revive its original function. The fenestrations were provided with precast concrete gratings replacing the old damaged cast iron gratings.
