Ressaca Farmhouse

Maintenance Program & Plan

Mauro Sanches

Department of Historic Heritage – Municipality of São Paulo

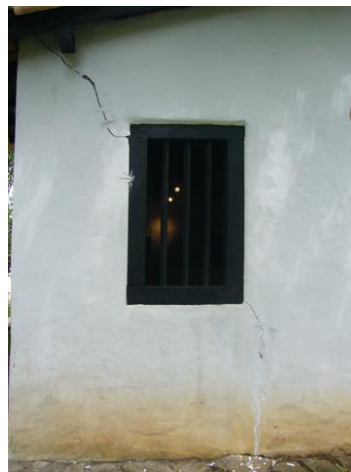
In 2007 cracks appeared on the walls in one of the corners of the house. Those cracks are under investigation by gypsum spies. This monitoring will last six months. After this period, the study of the reports will provide the possibility of adopting effective measures. As precaution, a tree that was very close to the house has been removed and a work of drainage of the ground was held to eliminate the accumulation of water just by the wall and changes in the accessibility were made so that there are no obstacles to the flow of water.

Figure 9: Cracks on the south-eastern wall.2007 Photo: Aline Carvalho

9. Repairs on cracks. Since November 2007 a monitoring to verify the evolution of cracks is being carried out fortnightly. Until February 2008 there was no movement. The monitoring will continue until April 2008 when, through the data collected, will be held the appropriate procedure.

- Every cracks must be monitored through gypsum spies *twice a month* during *six months*, generating reports and tables, analyzed by technicians of the DPH, providing data for possible works.
