CONSERVATION & MANAGEMENT OF HISTORIC BUILDINGS

PROJECT: conservation plan of the "Hospedería indígena San José chapel"

FINAL REPORT

Presented by: John Vinueza

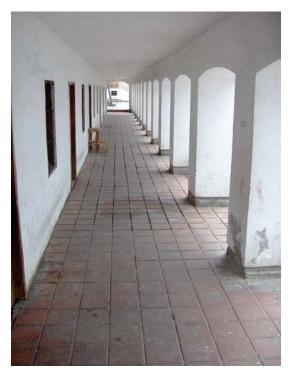
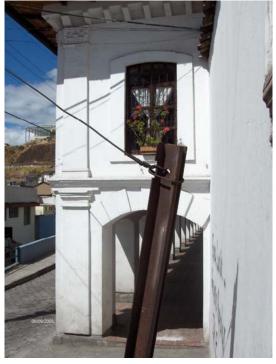
This is constituted by two facades seen from outside, in addition to another blind one and a third one that gives back to the cemetery. Of the two visible facades, one of them has arcs in the ground floor, on which is a second floor, is of white color and maintains the same height in all its perimeter, two floors, the finished one is of white lime and stone molón (of 20x 20cm approx.) in the part corresponding to the San José Chapel.

The other facade is a blind wall with a minimum aesthetic value and made with poor finish, however the used material creates an architectonic language that allows understanding what type of construction it is.
