Cine Mussi Theater

Conservation Programme Plan

Ariadne Marques de Mendonça

IPHAN (National Historic and Artistic Heritage Institute) - Brazil

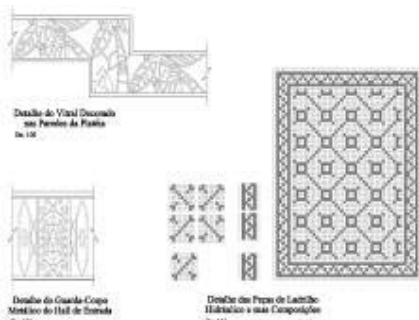
Figure 16: Details of tiling, wall finishing and railings (IBA, 2004)

The building is set in a triangular site, with its three façades occupying the whole site. The main façade (north) is curved, smoothening the visual impact. Its structure is made of ceramic brick masonry, with reinforced concrete beams between one floor and another. The windows are made of wood and are characterized by having a series of “false openings” covered with wooden “venezianas” and glass. There are also steel railings in some external windows.

The three façades have marquees and are coated with “mica” small parts. It has a wooden roof structure distinguished by its sophisticated system of joints and constructive details. The roof has ceramic tiles called “french tiles”. Its main access is composed of a marble staircase that leads to the Main Hall. There are interesting steel railings for the staircases, detailed wooden panels on the walls and ceilings in the whole building.

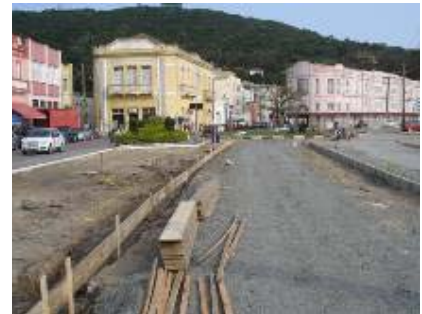
Figure 19: Pavement renewal with concrete blocks (september, 2007)

The city is currently under a huge reurbanization project, with investments from the Ministry of Tourism, IPHAN and BNDES. The project aims to revitalize the city, by organizing the public space, improving the accessibility of pedestrians with the installation of ramps, pedestrian stripes, new sidewalks, new and resized bus stops, execution of a plaza by the docks and renewing the pavement of the main street with concrete blocks.

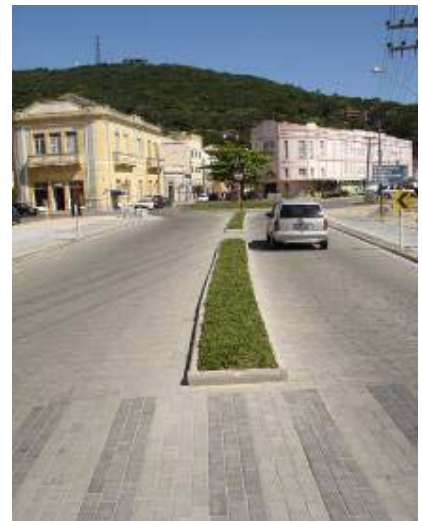
Figure 20: Finished new pavement with concrete blocks (january, 2008)

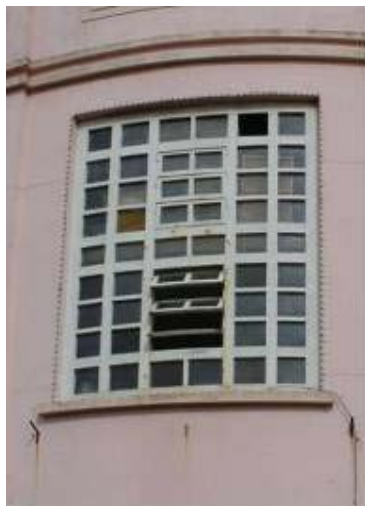
Figure 21: Window detail with missing glass

- Lobby’s rounded lamps fixtures are damaged due to past infiltrations (one of them fell down right before the building was interdicted);
- Broken or missing glasses on windows and doors;

11.1	Wooden doors and windows (review / restoration)
11.2	Steel railings (review / restoration)
11.3	Restoration of hinges, lockset
11.4	Glasses
12. PAINTING

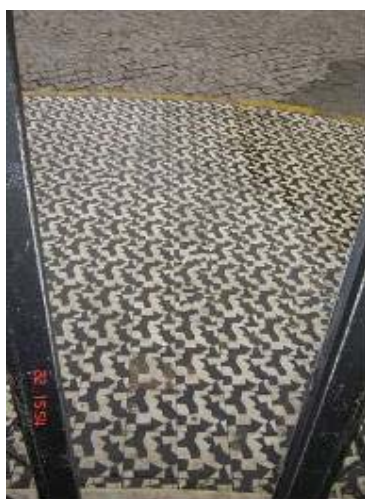
Figure 22: External hydraulic brick flooring is dirty, spent and presenting many missing tiles

- Broken and scratched stone floorings;
- Internal hydraulic brick flooring darkened due to lack of maintenance;
- External hydraulic brick flooring is dirty, spent and presenting missing tiles;

5. ROOFING	
5.1	Review of wooden structure
5.2	Review of ceramic tiles
6. MASONRY	
6.1	Brick wall - consolidations/restorations
7. FLOORING	
7.1	Restoration of wooden floor, ceramic tiles, hydraulic bricks, stone floor, cement floor

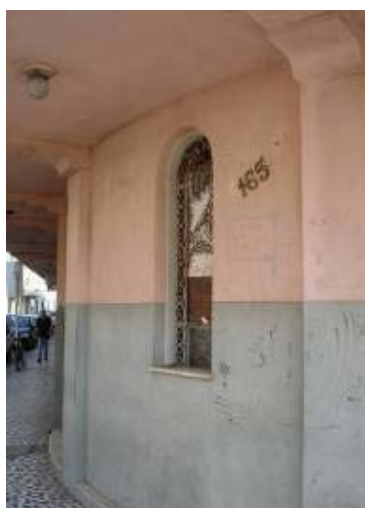
Figure 23: View of exterior wall and window with missing steel railings

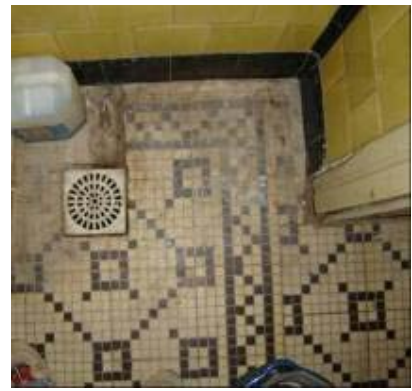
Figure 24: Bad condition of internal hydraulic bricks (2007)

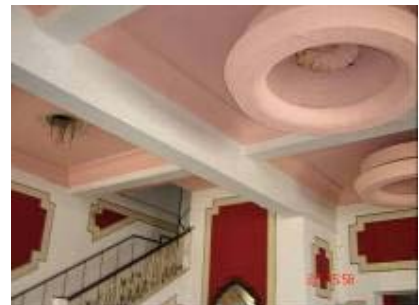
Figure 25: Lobby's rounded lamps fixtures (2007)

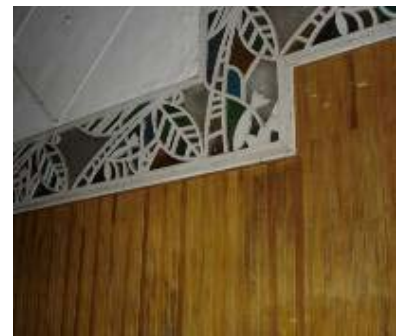
Figure 27: Details of wood and glass on the theater walls (2007)

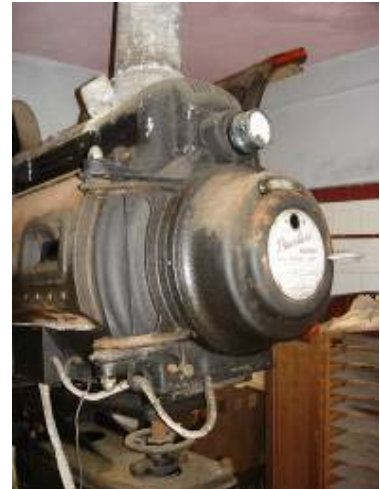
Figure 33: Original projectors of the 40's are still inside the building
