# Conservation of Traditional Roof in the Historical Center of Quito

Study of the technical interventions of the municipal program “Put your House in Shape”

*Jacobo Herdoíza Bolaños*

Architect

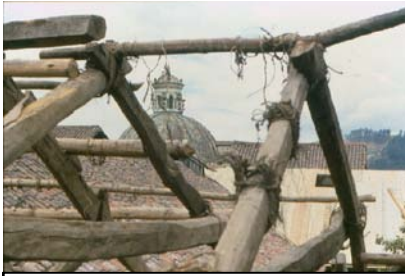
Figure 6: Roof tradicional system. Hospital San Juan de Dios, 1987.

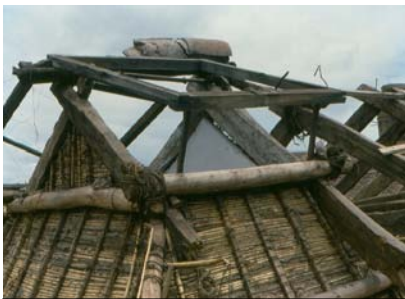
Figure 7: Skylight. Note the wood structure and "chahuarquero" battens. The soffit is supported by a layer of vegetal fiber made of reed or "chacilla".

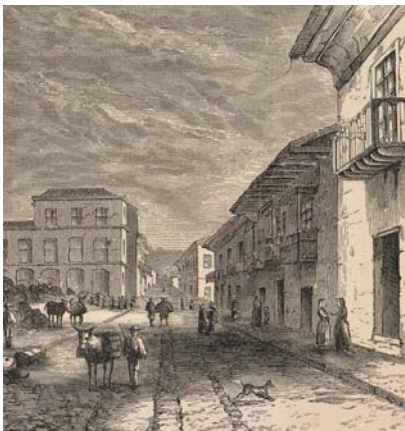
Figure 8: Etching by James Orton, XIX century. Note extended eaves and cornices of Quito's architecture.

Substantial modifications will affect over the time the great eaves and soffits (see fig. 8) that use to cover the passers-by, eliminated to give passage to the cornices and decorative railings of the republican facades. The arrival of the railroad will mark the use of channels, metallic gutters and other accessories for water collection.

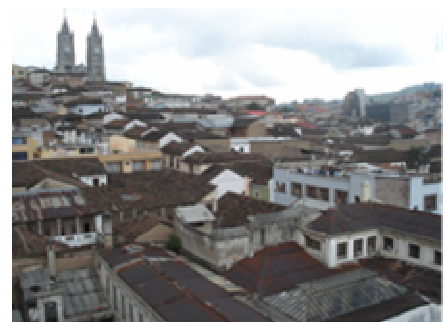
Figures 13: “Roofscape” from Manabí Street towards the Basilica. Note roof deterioration in first plane of the image.

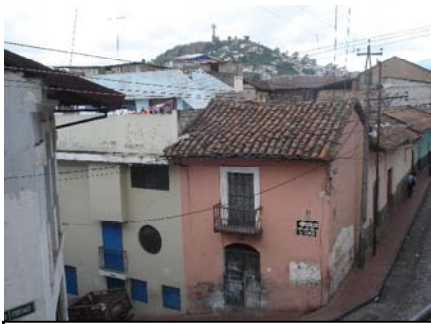
Figures 14: "Roofscape" from Chimborazo street towards el Panecillo Hill. Note intrusion of informal construction at terrace levels.

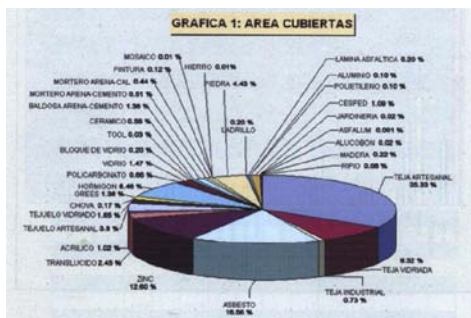
Figures 15: Pie of covering material in QHC, 2003. Traditional clay tiles represent 33% of used materials for roof covering

A pilot survey cataloguing the state of roof conservation in the central nucleus of QHC was conducted in 2003<sup>7</sup>. The evaluation was effectuated in 34 blocks or "cuadras" where around 400 properties were analyzed. Data collection was appraised trough cataloguing methods that allowed later analysis for determining roof typologies and morphology, the state of conservation. The survey also served to evaluate quantitatively and qualitatively the main materials and pathologies. It also included important proposals for roof rescue and its suitable rehabilitation.

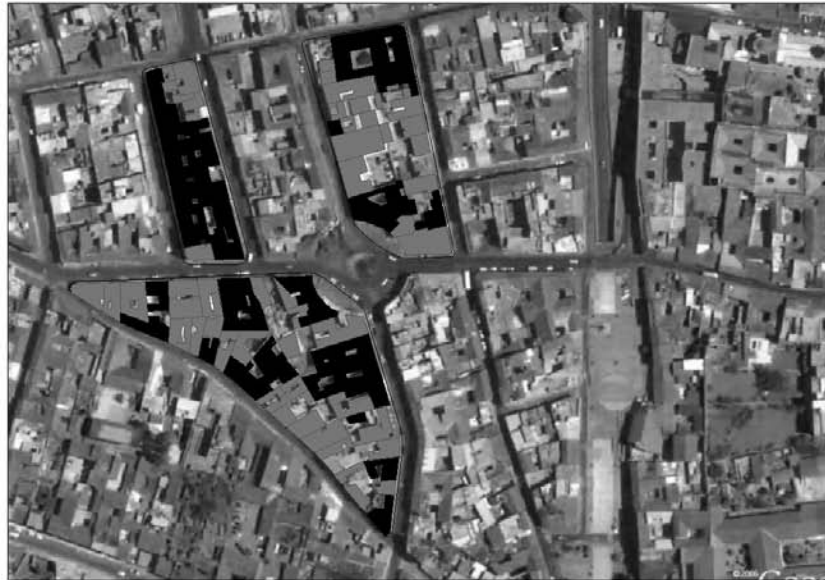
## SAN ROQUE (Around Plazotela Victoria)

Figure 18: Analysis of tile roofs around La Victoria Plaza

A noticeable substitution of traditional clay tile caused by other materials is advancing both, in the historical nucleon and in surrounding neighborhoods. Such phenomenon is accelerated in locations characterized by an intensified mobility and land use.

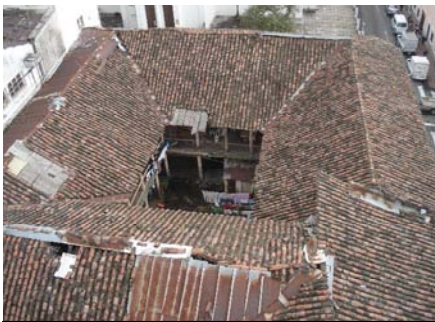
Figures 18: Traditional typology of roof configuration. Note the unity of the architectural system but also factors of deterioration..

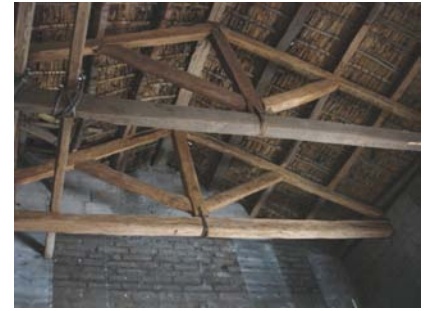
Figures 19: Wood trusses, roof battens and “chacla” system as support of clay tiles covering.

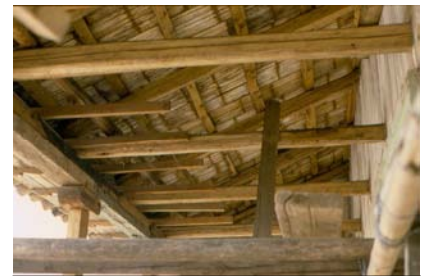
Figures 20: Similar system than described in previous figure, this time applied in a Galleria. The eaves are cantilevered in both directions and clay tile is supported in a reed mat.

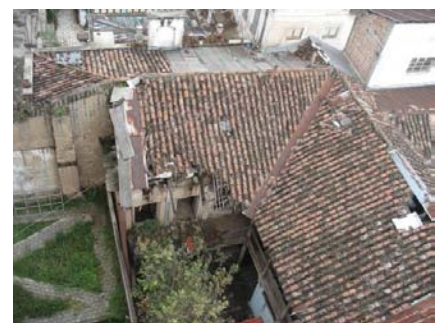
Figures 21: Alarming levels of deterioration and introduction of modern materials to patch tiles dissemination.

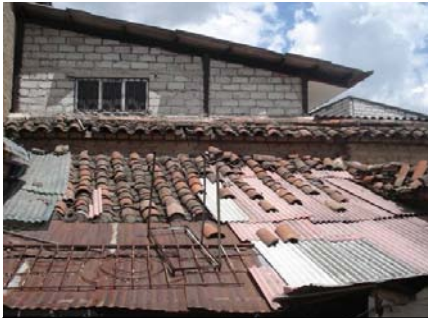
*Figures 22: This kind of destroyed panorama is more and more often. Tiles become a pathetic vestige among new materials chaotically used.*

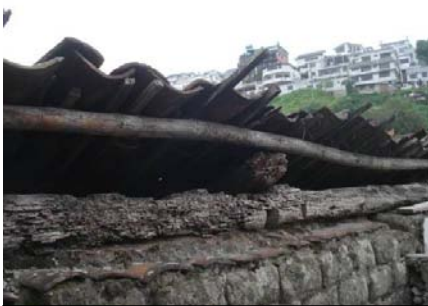
*Figures 23: Ridge, “chaguarquero”, wooden chords on adobe walls. Typical damages and deteriorations due to weather exposure and lack of adequate architectural details.*

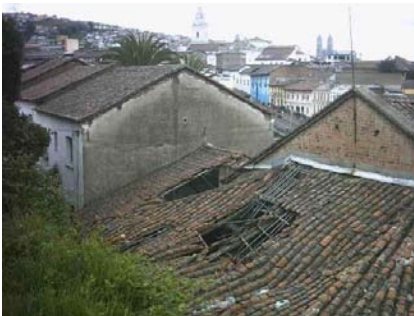
*Figures 24: Partial Collapse of roof due to clay sliding, progressive infiltrations and consequent lost of structural integrity. No subsidy or specific intervention is implemented by the Municipality to address this common case of alarming affection.*

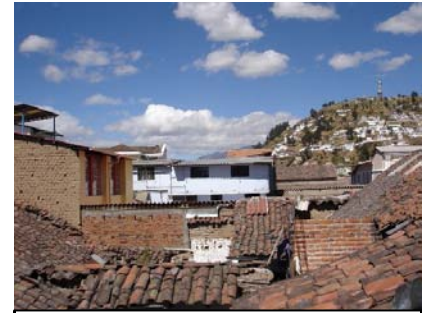
Figures 25: Roofscape in chaotic process of transformation. New constructions do not often follow regulations and control from city officials.

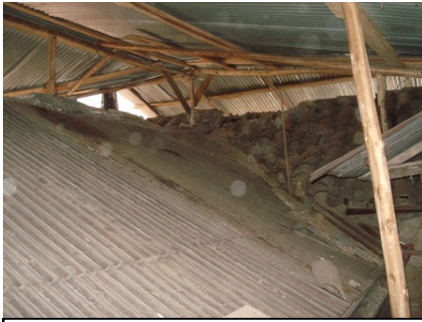
Figures 27: Roof intervention under temporary zinc cover.  
Note the utilization of fibrocement sheet as waterproofing layer.

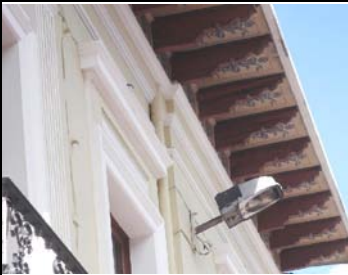
Type of Intervention	Inventory of used Technologies	% of utilization	Cost average \$USD/m2	Advantages	Disadvantages	Images
<b>Repair and Maintenance</b>	Repair and painting of eaves	2.12%	5.49 by meter linear	It reduces the damages and deteriorations	Constant maintenance, Possible annoyances in the daily life

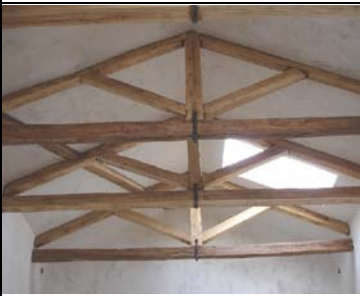
Preservation of wood	4.25%	6.00 by Linear meter	It allows to conserve the traditional technology Financial and environmental savings Conservation of the intangible values of the construction

**Wood preservation** is the most common repair and maintenance operation; roof rehabilitation has privileged **wood and tiles recuperation** conjointly with the introduction of waterproofing layers and **skylights**. In more than 38% of total substitution operations, the constructive system employed **eucalyptus wood structure, fibrocement sheeting and clay tiles covering**. Nonetheless, more than **43%** of roof substitutions used a **steel structure**.

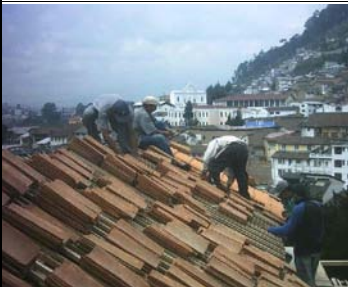
Replacement of roofing clay tiles and supports	2.12%	17,40	Authenticity and integrity of the built cultural heritage

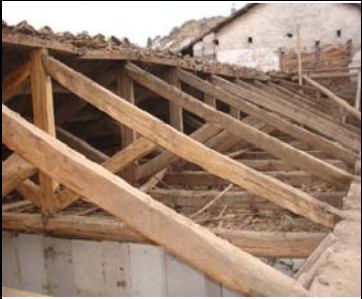
<b>Rehabilitation</b>	Partial replacement of wood structure and clay tile	2.12%	20,80	<p>Conservation of typologies, constructive systems and traditional materials.</p> <p>Recycling of the materials.</p> <p>Savings of economical and environmental resources</p>	<p>Constant maintenance,</p> <p>Annoyances in the daily life</p>

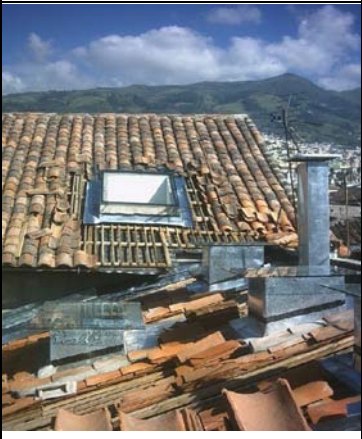
<p>Recuperation of wood structure</p> <p>Waterproofing with geo-membrane.</p> <p>Recuperation of the clay tiles</p> <p>Installation of skylights</p>	4.25%	44,85	<p>Recycling of the materials.</p> <p>Technological improvement of the roof</p> <p>Improvement in the illumination and ventilation of the interior spaces</p>	<p>Possible alterations in the morphology and texture on the fifth façade</p> <p>Non calculated effects of condensation due to geo-membrane</p>

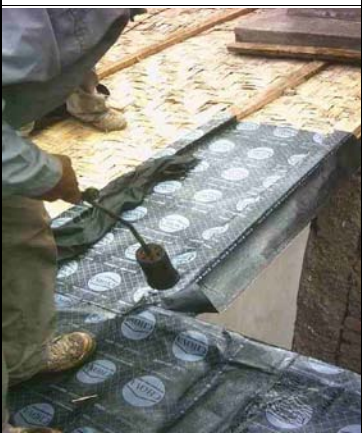
<p>Replacement of some structural elements</p> <p>Waterproofing, with asphalt membrane, supported on mats of "totora" (reed),</p> <p>Replacement of tilling battens.</p> <p>Replacement of clay tiles</p>	2.12%	42,50	<p>Recycling of materials</p> <p>Recuperation of vegetal materials as part of the roof system</p> <p>Saving of economic resources</p>	<p>Obligation of periodic maintenance</p> <p>Thermal modification by the positioning of asphalt membrane</p> <p>No calculated effects due to asphalt membrane</p> <p>Labor intensive technology</p>

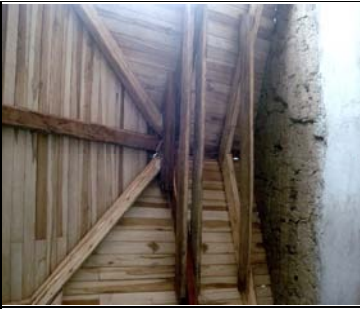
<b>Total Substitution</b>	Structure made of Eucalyptus wood of	10.64%	57.13	Typological conservation of the constructive systems and traditional materials	Need periodic maintenance  Thermal modification by the positioning of chova

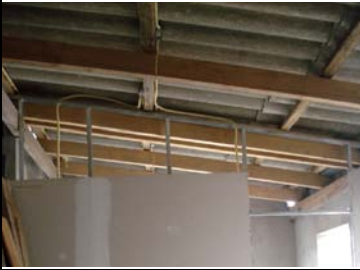
Waterproofing with asphalt membrane (chova) on triplex or wooden stave surface.  Tiles supported by tiling battens

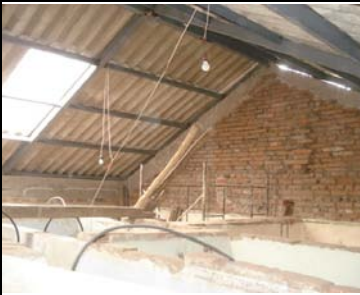
Wood structure of treated eucalyptus.  Waterproofing with fibrocement sheet  Tiles over sheet.	31.91 %	51.10	Low maintenance and durable systems  Fast construction  Simplified technology that uses industrial materials  A lot of suppliers  Accessible costs	Potential modifications of slopes may imply modifications in the landscape and generate problems due to inadequate water harvesting.  Probable structural problems due to the increase of weight and loads  Incompatibility of roof materials with adobe walls  Modification of thermal characteristics of the cover: too much heat in day hours and cold in night time

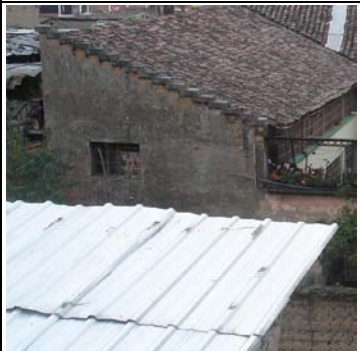
Structure made of steel: G profiles  Waterproofing with fibrocement sheeting  Tiles over sheet.

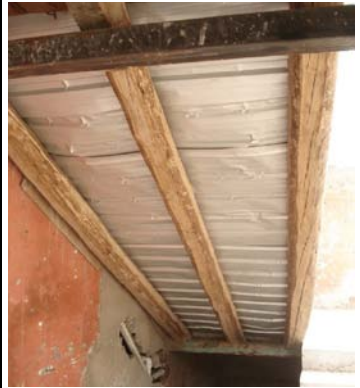
<p>Structure made of steel: G profiles or wood</p> <p>Waterproofing made by using a thin (7cm) reinforced concrete slab (easy slab)</p> <p>Tiles supported by tiling battens anchored to the slab</p>	8.51%		<p>Greater durability</p> <p>Availability of manual labor and materials</p> <p>Does not require maintenance nor periodic repairs</p>	<p>Modification in the volume and slopes of the roof.</p> <p>When used without covering tiles, it becomes a strange element to the landscape.</p> <p>Greater economical investment</p> <p>Disappearance of the traditional techniques</p>

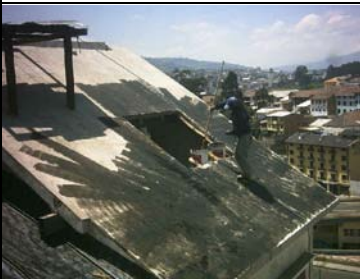
<p>Roof made of a thin reinforced concrete slab</p> <p>Covering made of tiles supported by tiling battens anchored to the slab</p>	2.12%	81.76		<p>Probable structural problems due to the increase of weight and loads</p> <p>Incompatibility between roof materials and adobe walls</p>

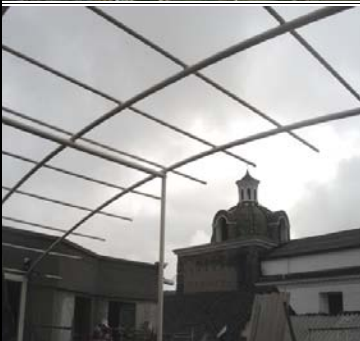
<p>Translucent covers of patios and terraces</p> <p>Metallic structure</p> <p>Polycarbonate</p>	2.12%	75	<p>Patios used as living space during all year</p>	<p>Changes in the volume of the building</p> <p>Modification of the microclimate</p> <p>Disfigurement of patio's typologies</p> <p>Modification of the urban historical landscape</p>

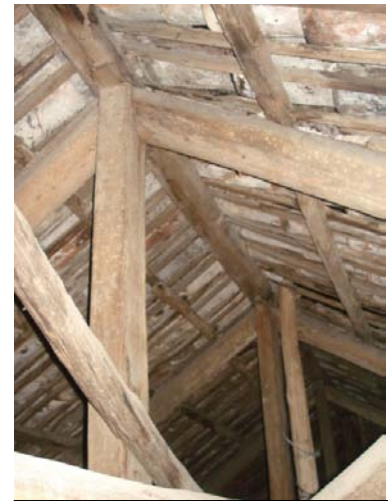
*Figures 29: Roof at risk. See the trusses knot system and tiling battens. Dots are indicating xylophage's activity.*

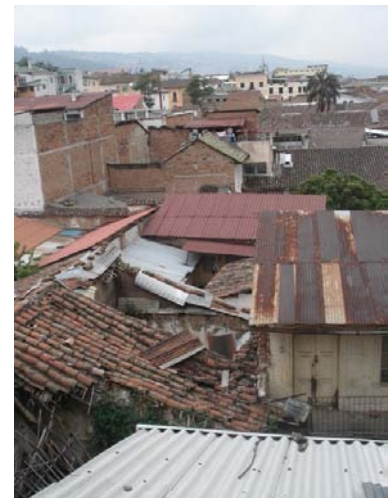
*Figures 30: Multiples roof damages: replacement of coverings by metal or fibrocement sheets, collapse of traditional clay tile roofs.*
