# Vinces Old Town Hall

Coastal Traditional Architecture in danger

The present investigation is about The Vinces Old Town Hall (1909), perhaps unique in the Ecuadorian coast because of its architectural and construction characteristics, where the use of traditional tools, materials, techniques and processes are evident.

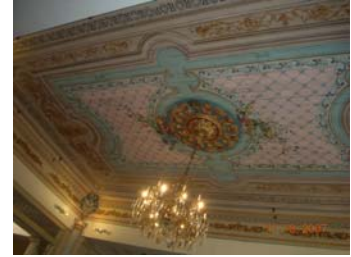
*Decorated ceilings (Casa Julián Coronel)*

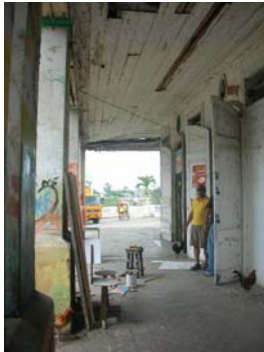
*Street loggia*

In most of the cases, the walls should be cleaned up and painted and do some ceiling repairs. The lower level floor is covered with its original tiles which are dirty and stained but still in good shape. In this part of the conservation project is also included the loggia surrounding the street level which is one of the most attractive characteristics of the building.

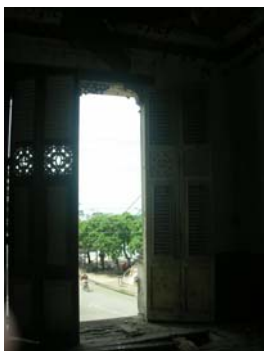
The Vinces town hall has the characteristics of this architecture. The facades had a lot of ornamentation: classic columns usually topped with Corinthian type capitals, woodcarvings, windows made out of wood with the typical “chazas” (wood blind windows). The street level loggia was so useful to protect one self from rain and sun and avoided that the façade get the direct sunrays that warmed up the interior rooms. All of these elements were painted with bright, brilliant colors that enhanced all of these details.

*“Chazas” wood blind windows*

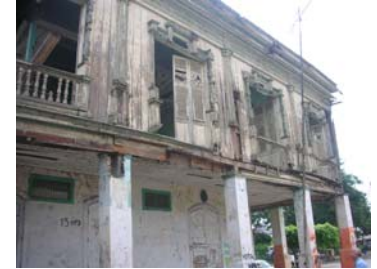
The building has been abandoned for so long and the lack of maintenance has enlarged its problems. The most important problems are:

- Humid weather and its impact on wood (structural elements, walls, windows, doors, etc.) and ornamentation such as wall paintings, ceilings and facades.
- The presence of insects (termites, bees, wasps, xylophages, etc.), microorganisms, fungi in structural elements and ornamentation as well.
- Animals such as bats and rats that are now the frequent inhabitants of the building and are part of the big problem now.
- Leakage problems in the roof that affects structure, paintings, ornamentations, floors and even facades.
- Structural problems in the building and roof as well. Some parts are missing and some in poor shape.
- Previous intents of restoration without the proper knowledge, which have contributed to increase the damage.

*Side facade*

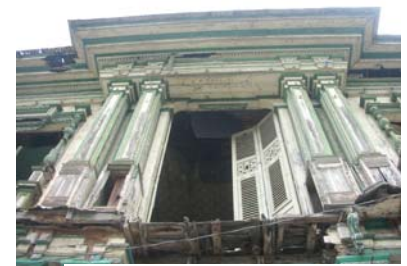
*Main Façade central panel*

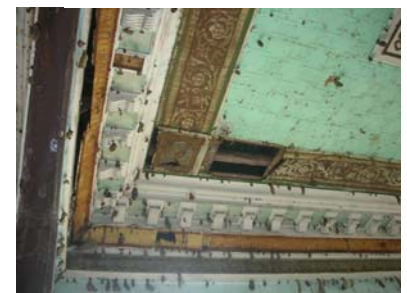
Ceilings attacked by insects and bats ca 90%

Leaking roof covering ca 70%

*Ceiling infested by wasps' nests and damaged by rain water leakage coming form the roof*

In the main rooms the ceiling is made in embossed tin. Some of them are damaged by rust or by wasp nests or bee hives. It should be cleaned up and then replace the most affected ones and restore and paint the rest. In the rest of the building wood ceiling is found. This is also affected by humidity and by animals. The most damaged ones should be replaced following the original patterns and the rest, restored and repainted.

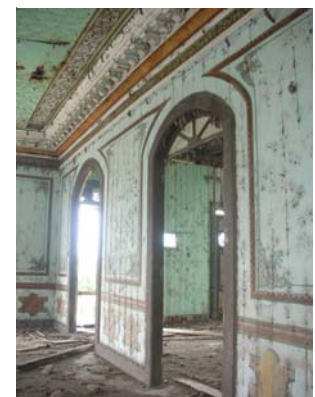
*Walls covered by wall paintings*

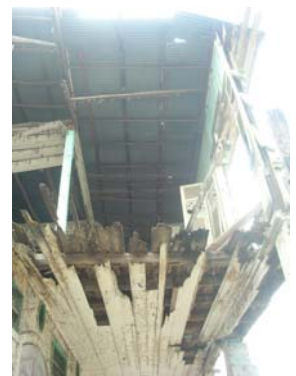
Due to its material and reasons explained before, some of the walls in different façades have fallen apart. The most damaged is the back façade, which is totally gone. Corrugated zinc sheets were the original material. The use of this material was rather popular in the early 20<sup>th</sup> century because it was helpful as a fire retardant material. This façade today is totally gone so it should be closed.

Part of the material of the roof is gone or damaged with holes produced by rust. This has allowed rainwater to go into the building, damaging the roof and ceiling structure and ceilings as well. In addition, these openings permitted animals like bats turned the attic into their "home". The big problem here is that bat's excrements are very harmful to wood and the rest of materials, not only causing losses of the material but also staining it.

*Side facade*

In this particular case, the missing parts of the roof should be replaced or at least closed and then get the attic disinfected and cleaned to take the bats out.

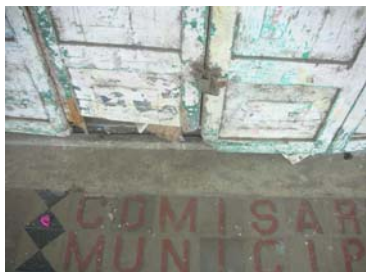
*Original Floor tiles with inscriptions*

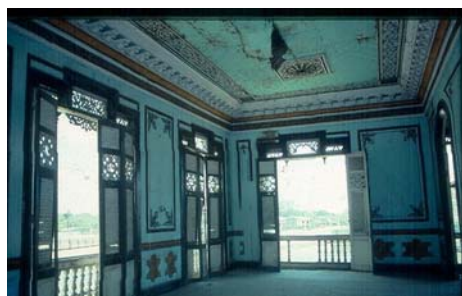
*The hearing room*

In the upper level is where the most beautiful and important rooms are, not only because of their sizes but also because of the ornamentation used in the ceilings, walls and paintings. The original use of these rooms was different, for instance: main lobby, hearing room, meeting room, the mayor's office, etc.

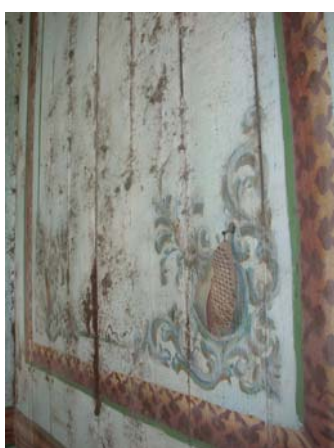
*Wall painting in Hearing Room*

The main rooms of the building have beautiful wall paintings in which are shown the skillfulness of the artists who worked them. The topics are different and are easy to appreciate designs that go from figurative to non figurative items. One of the mostly used techniques was that of making believe wood was actually marble by painting the marble texture on top of it. This technique is not easy to achieve, but there are some artisans that still work it. These paintings are affected by stains from humidity, animals' nests and excrements, wood support damage, etc.

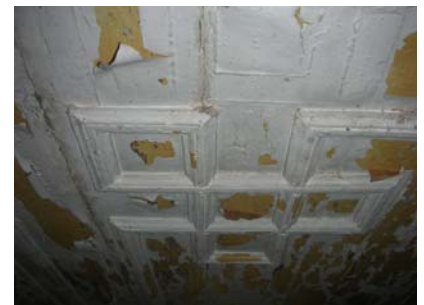
*Wood ceiling*

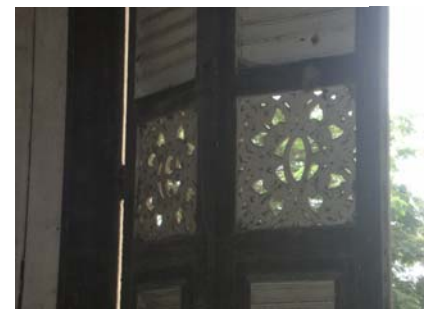
These elements are made in wood, usually oak for frames and laurel which is very easy to work with and mostly easy for carving and details that were customary in decoration in those days. Most of them are in regular shape, partly damaged by humidity, insects and termites and missing elements such as locks. The main entrance has a double door which allows you to go upstairs to the main part of the building; this door has to be repaired as well as the blind windows of the upstairs rooms. These windows have beautiful carvings which include not only design but also the date of the year of the building construction.

*Wood carvings in blind windows*

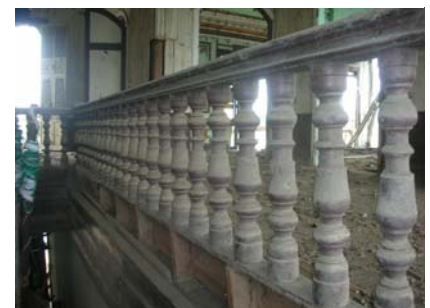
The stair railing uses wood balustrades which have lost painting, are loose and partly attacked by termites. The most damaged ones should be replaced and the rest should be polished, treated and fixed.

*Main stairs' balustrade*

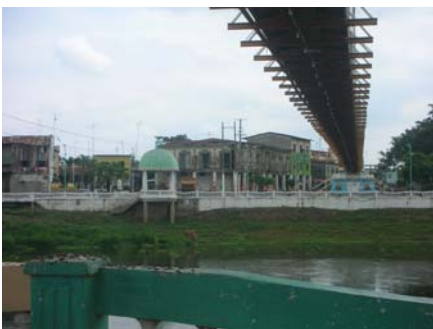
*View to Vinces Town hall from Balzar de Vinces with the summer house and pedestrian bridge that have a negative impact on the building*

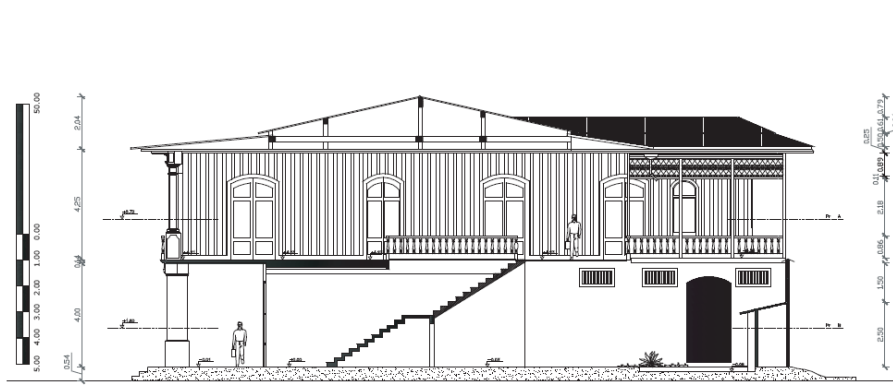
Section

LA CASA MUNICIPAL DE VINCES  
1909  
ARQUITECTURA TRADICIONAL DE LA COSTA  
ECUATORIANA  
SECCION TRANSVERSAL A - A'  
CORTE

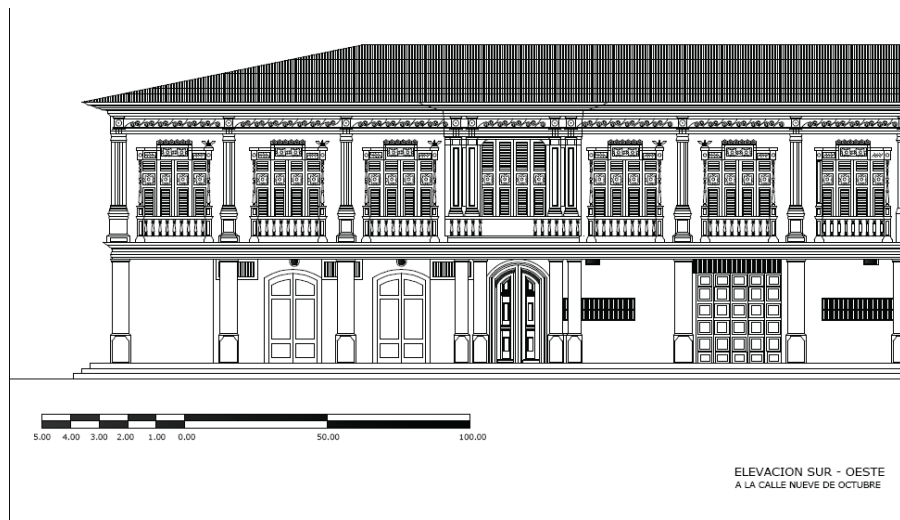
Main Façade

ELEVACION SUR - OESTE  
A LA CALLE NUEVE DE OCTUBRE

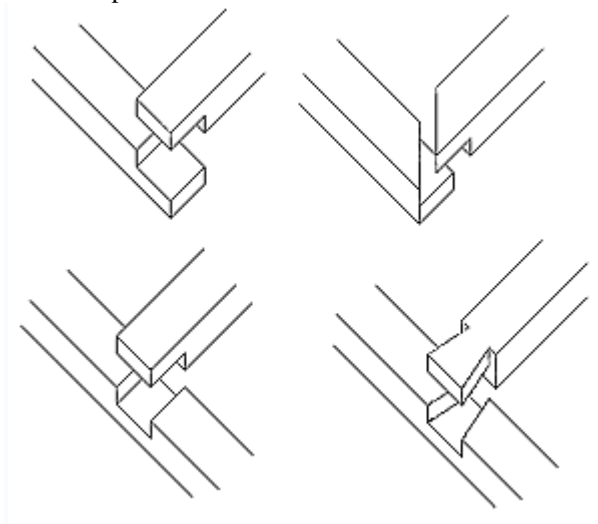
Clockwise from top left: End lap, mitred half lap, dovetail lap, and cross lap

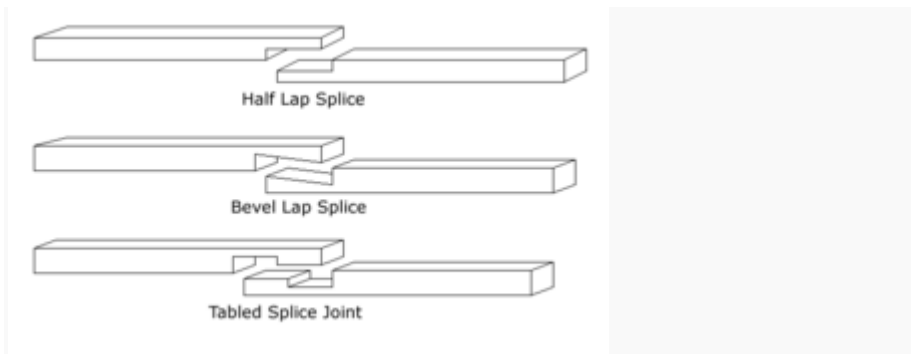
### Half Lap Splice, Bevel Lap Splice and Tabled Splice Joint

There are four main types of splice joints: Half lap, Bevel lap, Tabled, and Tapered finger.

The bevel lap splice joint is a variation of the half-lap in which the cheeks of the opposing members are cut at an angle of 5 to 10 degrees, sloping back away from the end of the member, so that some resistance to tension is introduced. This helps to prevent the members from being pulled apart.

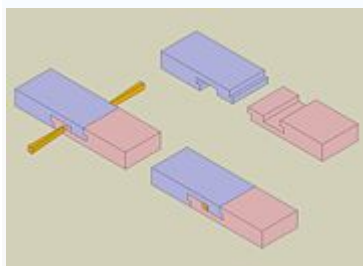
### A wedged tabled splice joint

The tabled splice joint is another variation of the half lap. The cheeks are cut with interlocking surfaces so that when brought together the joint resists being pulled apart.

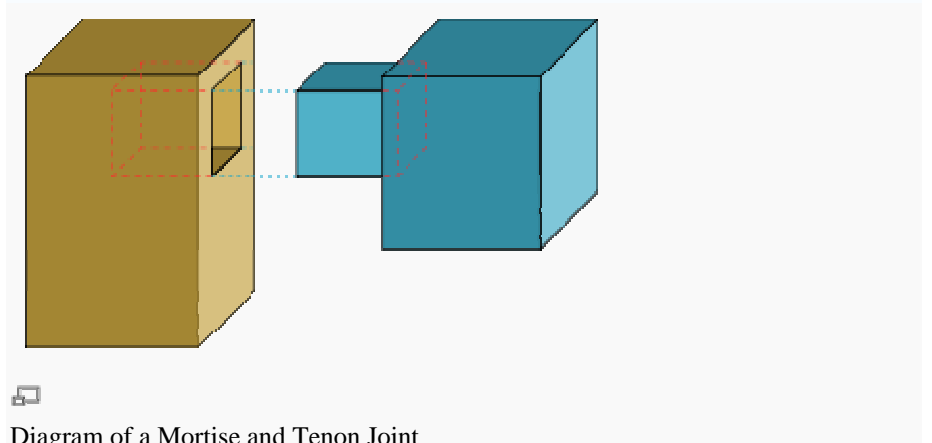
Diagram of a Mortise and Tenon Joint

Simple and strong, the **mortise and tenon joint** (also called the **mortice and tenon**) has been used for millennia by [woodworkers](#) around the world to join two pieces of [wood](#), most often at an angle close to 90°. Although there are many variations on the theme, the basic idea is that the end of one of the members is inserted into a hole cut in the other member. The end of the first member is called the **tenon**, and it is usually narrowed with respect to the rest of the piece. The hole in the second member is called the **mortise**. The joint may be glued, pinned, or wedged to lock it in place.
