# Conservation of Historic Buildings

## Case Study of Mondorakan Street Kotagede Yogyakarta Indonesia

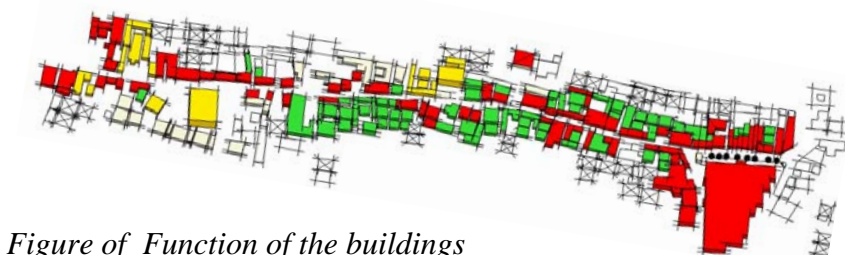
Figure of Function of the buildings

Commercial function dominates the buildings in Mondorakan street. In north side there are 37 commercial buildings, 3 residential buildings, 2 educational buildings and only 1 social building. While in the south side there are 22 commercial buildings, 10 residential buildings and 1 social building.

The red colour indicates the commercial function, green colour indicates residential function and yellow colour indicates social function.

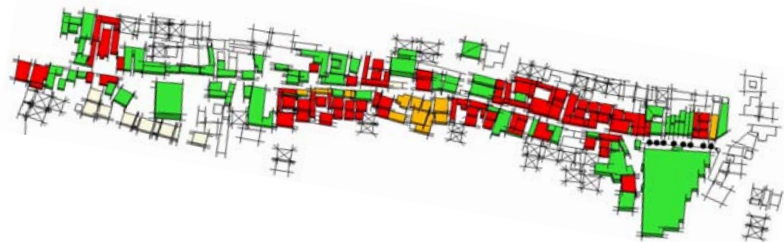
Figure 3. Age of buildings

In north side of Mondorakan street there are 22 new buildings and 17 old buildings (more than 50 years old). The number of new buildings bigger than the old ones since the new ones have smaller parcel as the result of subdivision of the old building parcel. In south side of the street there are 11 new buildings and 19 old buildings.

The red colour indicates than 50 years old buildings, yellow colour indicates between 25 and 50 years old buildings and green colour indicates less than 25 years old buildings.

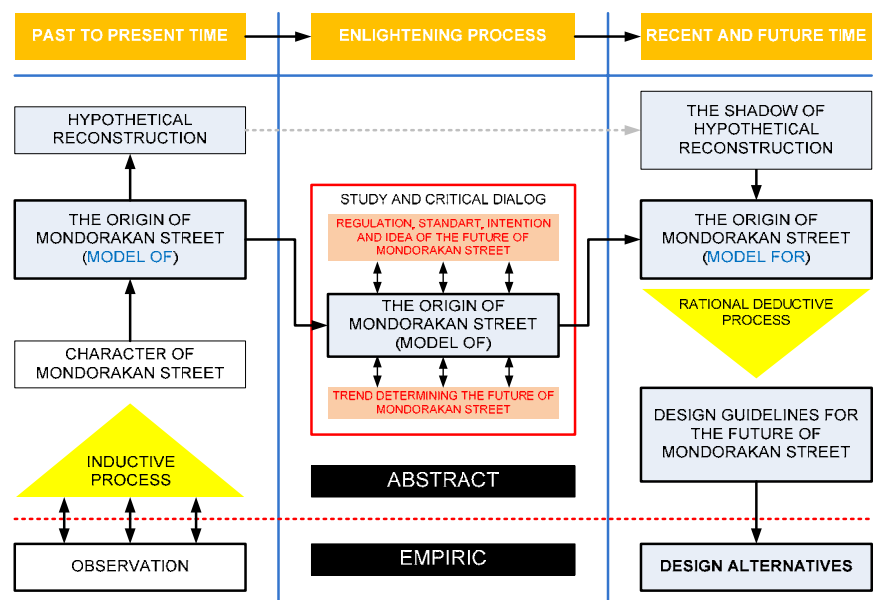
The analysis of this study uses a framework developed as follows.

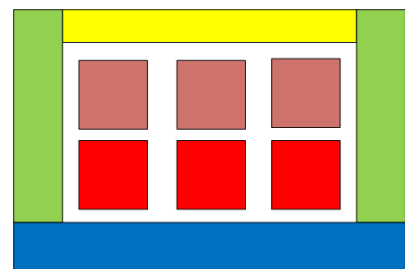
Initial building layout

This is the case of shop building which is located in front of the Kotagede market. It was built in 1930s as a single big shop. However then it was inherited and divided into 6 small shops with different owners. The figure at the top is simulation of the building facade before the earthquake in 2006. The figure underneath represents the condition after the owner finished in reconstructing their shops after the earthquake. Apparently they did not pay any attention to the unity of the building. Some of them reconstructed into two storeys shop, some reconstructed still in one floor. However, following the discussion with the team then local people were guided to express their idea. Since based on the historical tracery, the big shop building always had two gable roofs at their edges, the first design was made with the two gable roofs as can be seen in the following picture. But then the owner of shop number three from the left stated that he did not want to reconstruct his shop in that way. Finally the design was changed and it can be seen in the following picture.

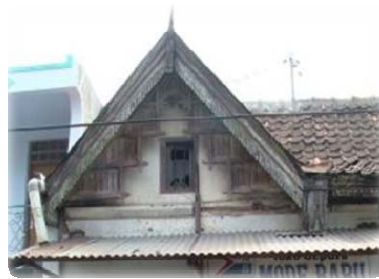
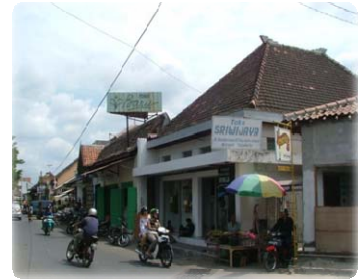
This building is also located in front of Kotagede market. The building was initially a compound house consists of three houses. When it was inherited than the building in the right constructed as a single shop and changed the composition of the roof shape. Only one gable roof is left. Based on deep interview with the local people who still have memory of the past, the team tried to reconstruct the initial design of the building. As it is stated before, the big building like this should have two gable roofs at each top. As a result a new gable roof is added in the new design. So in order to find its original facade the computer drawing simulation is utilised. This method try to convince people that they will not lost anything and in the contrary they will find something more
