Tanzania: Juliery Kagya Mtobesya

DESIGNING A RESTORATION PROGRAM FOR THE 'BOMA' A HISTORIC BUILDING IN BAGAMOYO, TANZANIA.

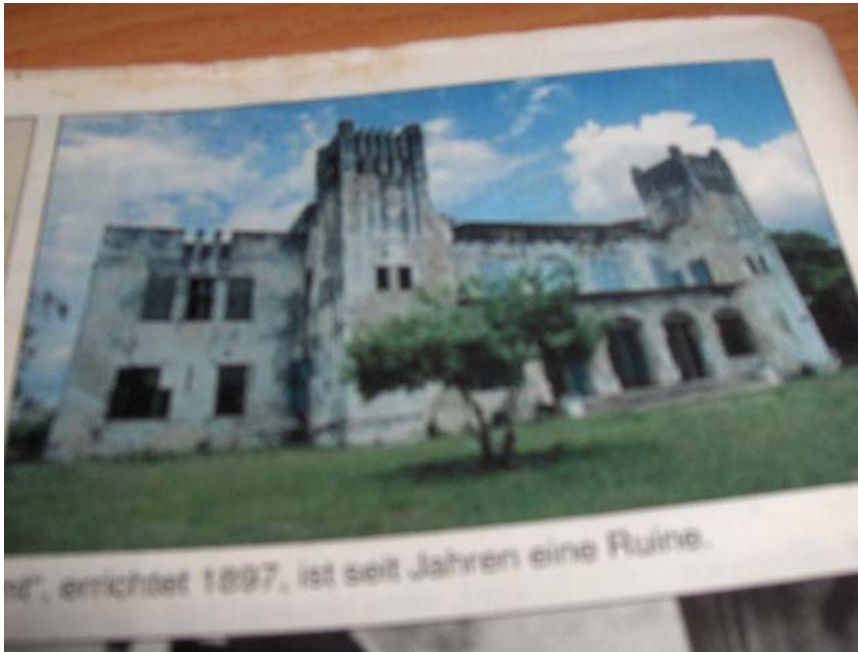
Figure No.3 Front part of the BOMA

During the Germans Colonial rule in Tanganyika they established administrative, economic and social infrastructure. Thus, the BOMA was built in Bagamoyo in 1895-1897 and it was the administrative centre for colonial rule. The name is English named by the British who took over the building after World War II but to Germans it was 'German Colonial Administrative Building'. The Germans had dual use of the building, the first floor was for administrative purpose and the upper floor was for Governor's residence. The towers were for communication. It was the same uses to its two successors.

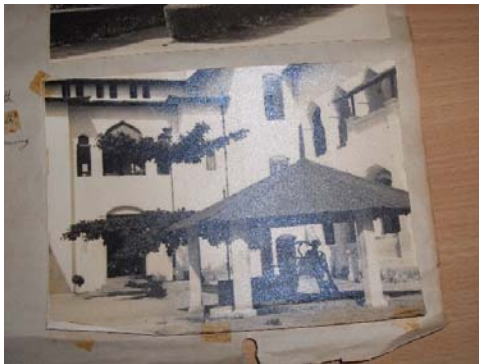
Figure No. 4 U courtyard – Swahili Type

The Swahili culture is depicted in the corridors, the verandah and the U form that opens in the backyard. The Arabic style is in the decorations of pillars, towers, walls and some of the doors.

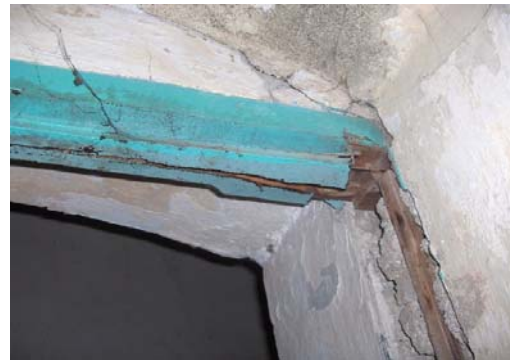
Thick walls – German Architecture.

The German style is found in thick walls. The main entrance is facing the Indian Ocean. There are thick walls made up of coral stones bonded with lime mortar and finished in lime wash.

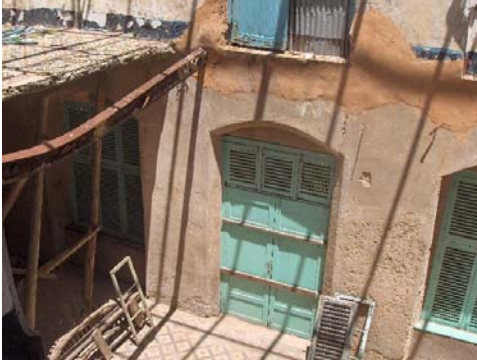
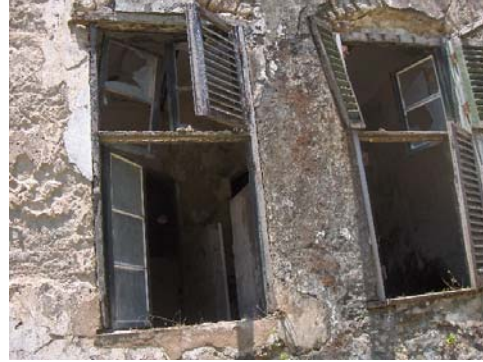
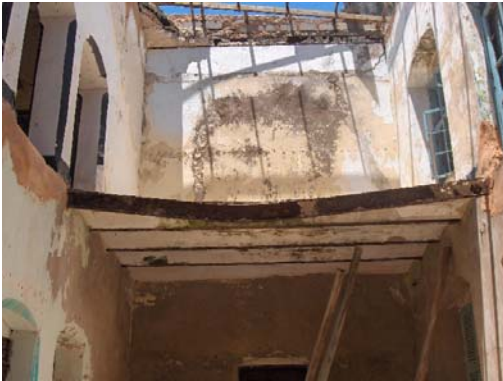
Figure No. 6 Deteriorating conditions

The building is decaying at a tremendous rate if nothing is done in two years time the building might crumble down into ruins.

The floor was once made of striated floor tiles but are now dilapidate and removed or broken in big quantities. The walls have been color washed several times. The roof is constructed a series of small vaults supported by I beams. In some area the I beams bent due to heavy concretes used in the restoration done earlier. The doors and windows are in dilapidated state. All bathroom and toilets have been vandalized.

- The structural Engineer, the Environmental Conservation Engineer, Conservation Architect quantity Surveyor together with the German Counterpart are studying the building to establish technical details on the damages of the building. Then they will prepare drawings and advise on what should be done to restored the building and establish materials and tools to be used.

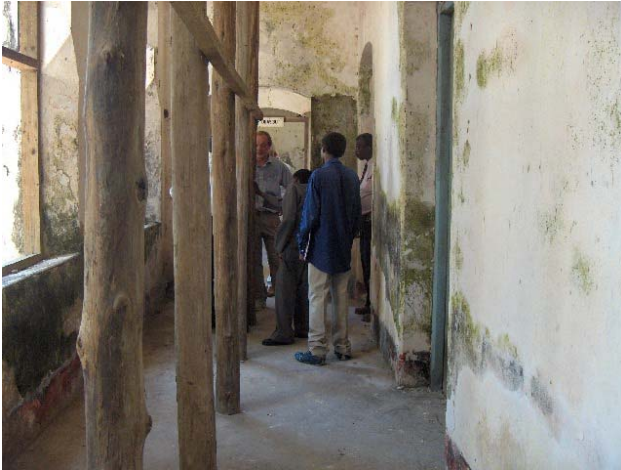
Figure No. 7 Simple preventive measures

Temporal corrugated iron sheet have been put on the building and poles have been used to support a roof that is in danger to collapse. The ceiling have rusted beams and sometimes bent thus causing more problems. The roof collapsed because the I beams bent due to heavy load of concrete added during restoration. Poles have been used to support the roof temporarily.
