Project of Putting of Value

“THE HOUSE OF THE 13 COINS”

Diagnostic Study, Evaluation and Proposal of Intervention

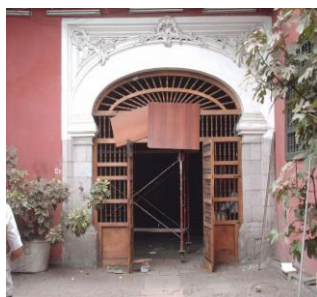
The House conserves its original colonial and republican architecture and its style is Baroque and Rococo. It has two levels, 1st level 521m² and 2nd level 148m² built. Its cover is elegant and slender with delicate cornices with motives of flowers that frame the doors and windows, as well as the small lateral consoles with ornamentals carvings. The House present a hallway and in its interior it has two courtyards connected to each other through a corridor. In one of them still there is an intact cannon and a singular chaise.

There is also doors, windows, ceilings, floors,coffered roofs, stairs of wood cedar and mahogany with their respective moldings of the own style . From the courtyard we can acces to almost all rooms. The first level has sixteen rooms and the second level has six.

It also presents flanked balconies and eaves that frame the courtyards and three stairs. In addition it has a kitchen located in the rear part and a lateral corridor that connects the courtyard.

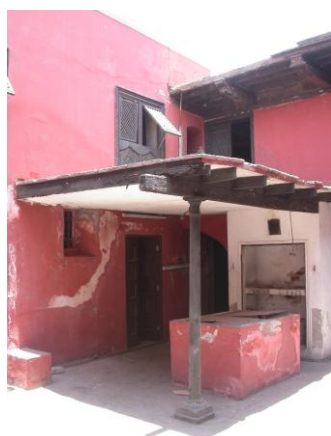
About techniques of construction were adopted the techniques with high mud bricks and the lime at the beginning during the Viceroyalty, like structural bricks 16th and 17th Century.

The techniques changed with "quincha"¹ and clay brick, that could resist the terrible earthquakes.

The walls measured $w=40$ cm and $H=5.40$ m. The majority of the rooms are of double height. $H= 5.20$ m The wooden is present in all the coffered roofs, ornamental doors, windows, floors.

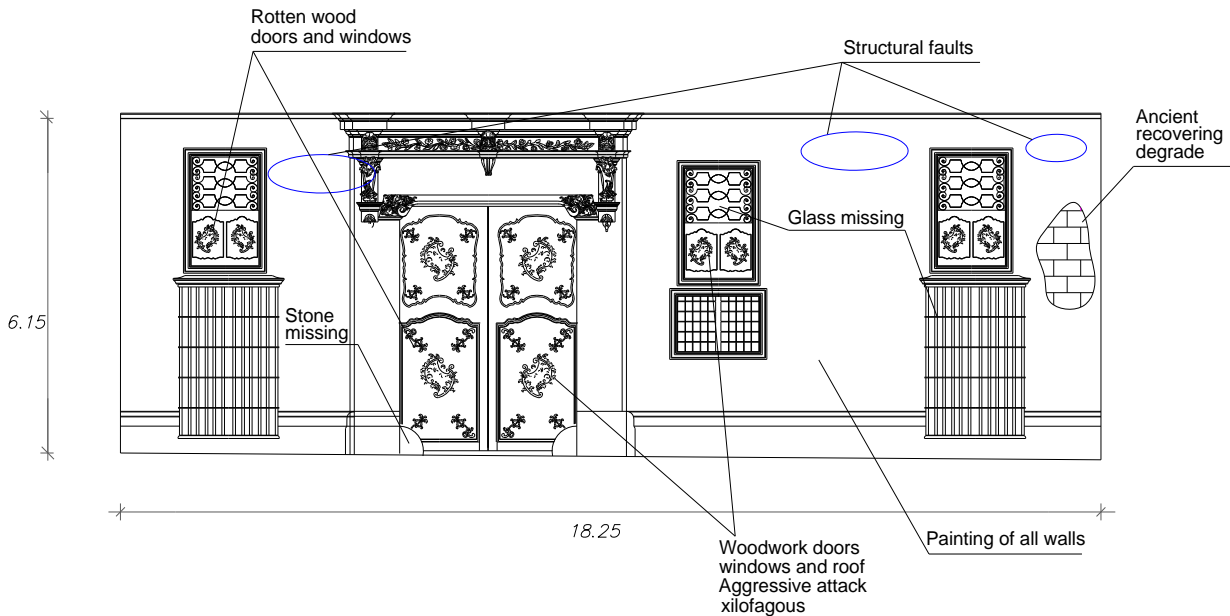
MAIN FACADE
The House of the 13 Coins

Nowdays we have some questions about the authenticity of four attic and a roof of the barbeque. We don't have information about the previous restorations. Twenty six ornamental doors were robbed two years ago.

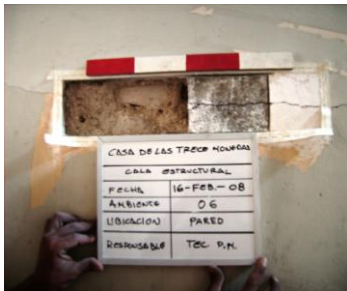
It was necessary to realise “pictographic coves” to recognize the variety of colours founded in the walls, wood joinery as well as mural painting. Also it was necessary to realise structural some coves in order to define and to interpret the faults in the walls.

Structural coves – mud and clay

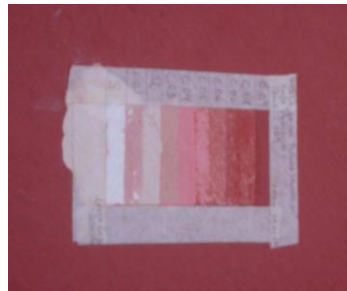
Pictographic coves
