Wooden church ensemble in village Donja Jablanica, Serbia

Conservation Plan and a proposal for revitalization

Architect

Institute for the Protection of Cultural Monuments of Serbia, Serbia

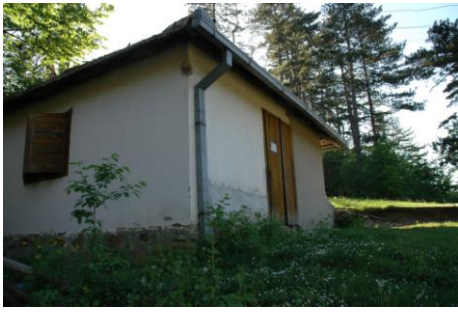
Figure 2. A refectory

Sobrasices were built as a wooden table surrounded by benches in an open space, sometimes with a roof, or a single room cottage, designed for the family to have shelter during a communal meal after service. Their main purpose was to have shelter and accommodate relatives and friends during a number of events related to the church. In different parts of Serbia these structures have different names depending on local traditions, but for the purpose of this paper I will call them **sobrasice**.

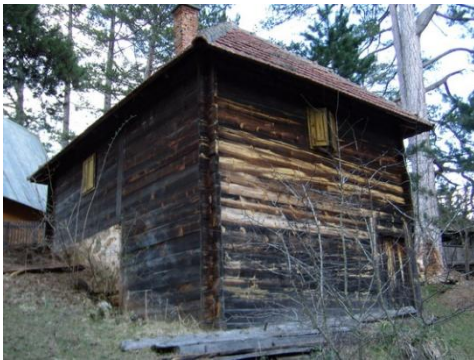
Figure 3. Parish house within the ensemble

Less than one kilometre from the village of Donja Jablanica, at the top of the hill, there is a sacred site comprised of one wooden church and a bell tower (Fig.1,4), one ancient cemetery (Fig.5,29), a refectory (1960's), (Fig.2), concrete fountain (Fig.25) and parish house (1936)(Fig.3). There is also a sobrasice within the church yard, designed for family gatherings and communal meal.

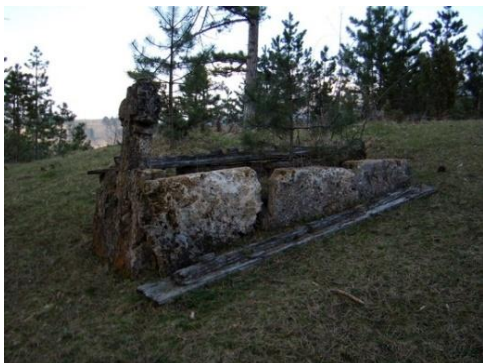
Figure 5. One of two graves on old cemetery within the ensemble

The area surrounding the church, is enclosed by a wooden fence. A belltower is isolated and located in the yard, probably built at the same time. A few meters from the yard, on the east side of the building, two old graves are located on the small hill (Fig.5). showing the remains of the old cemetery. A new graveyard is located about 150 meters to the west of the church, currently in use.

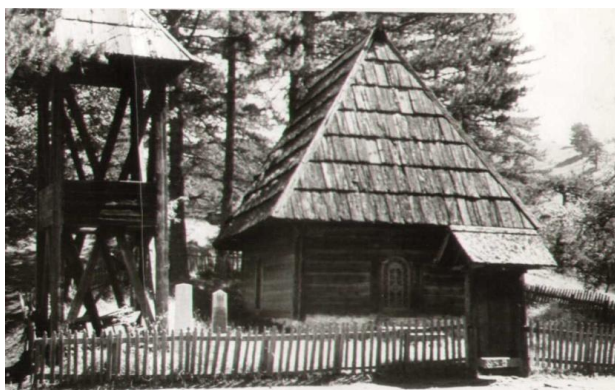
Figure 9. Condition before 1969

A wooden belltower is located in the yard close to the church, there are also three tombstones and a metal structure used for burning candles. The entrance gate to the church yard is topped by a gabled roof made of wooden posts. The belltower walls on the ground level were built with a timber technique. The first level of the tower seems to be used for the storage of church materials. The structure was supported by four posts and transverse beams until 1968 when it was enclosed (Fig.9). The bell in the tower dates from 1924.

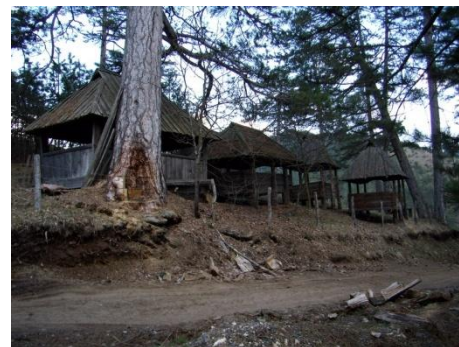
Figure 6. Present condition, view from the access rural road

On the South western slope, there are eight remaining sobrasices, situated on the both sides of the road (Fig. 6). These structures were built shortly after the church, around 1840. In that time, there were additional sobrasices, but during the years some were demolished. Sobrasice represent a type of structures which are disappearing rapidly over past fifty years, especially because of lack of use. Until the World War II, in Donja Jablanica, there were about 40 sobrasice. An official report from 1982 states that there were 15 sobrasice in good condition and 5 more in poor condition.(Fig.7,8)

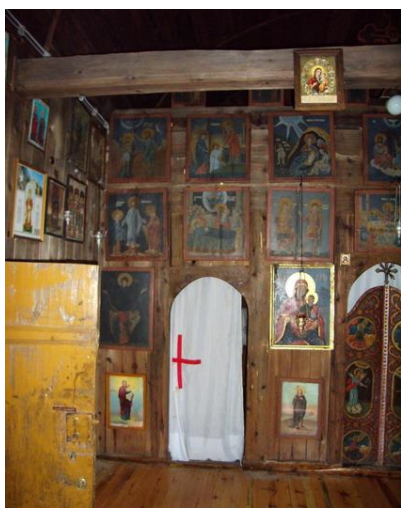
Figure 10. Iconostasis in the wooden church

The artistic values of the church are presented by the fine craftsmanship in the external details, such as decoration of architectural elements and the finishing in the front door(Fig.11,17,19). Also, the great significance have icons in the church, dating from the mid and second half of 19th century (Fig.10,30).

- In the interior of the church, vertical wainscot should be replaced with the horizontal pine planks. The width should be the same as the original plank. Floor should be removed and replaced with new planks, with the width about 20cm. For the protection and easier maintenance, it is possible to varnish the floor, but with matte varnish.
- In addition to works on the architecture of the church, conservation and restoration works are needed on the iconostasis, icons and on the western entrance gate.

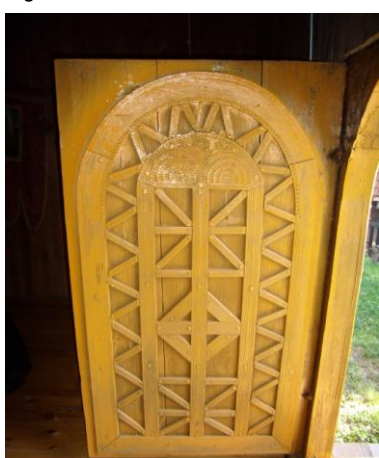
Figure 11. Main western door on the church

Often wooden churches have two entrances; the main access (Fig 11,17), facing west, with decorative doors, the secondary entrance on the northern wall of the church (Fig.12) usually has a smaller door and plain door. This is also the case with church in Donja Jablanica.

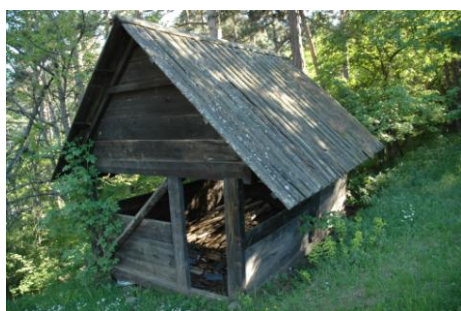
Figure 13. Sobrasice, half-opened type

Considering the limited number of sobrasice in Donja Jablanica, there are two types: cottage type (two)(Fig.15) and half open type with an entrance on the longer side (three) (Fig.14)or on narrow side (five)(Fig.13,15).

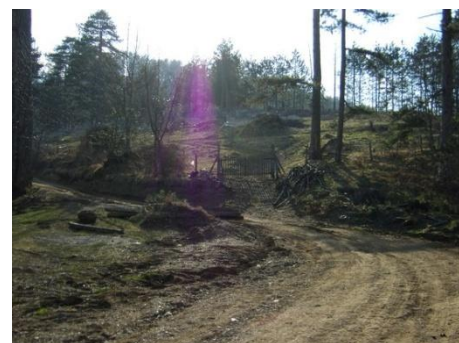
Figure 16. Rural road to the ensemble and new cemetery

of the cemetery is seriously affected with the formation of a new village road which damaged the part of a cemetery (Fig.16)

The rural road leading to the ensemble is passing through it, and leads further to another village. The great problem is the road that has not been designed for agricultural vehicles. There is a present danger that the cargo from the vehicle will fall down and damage site buildings (Fig. 16,22).

It is necessary to remove the segment of rural road which is passing through the ensemble or to reconstruct it so it would not be a threat for the buildings of the ensemble.

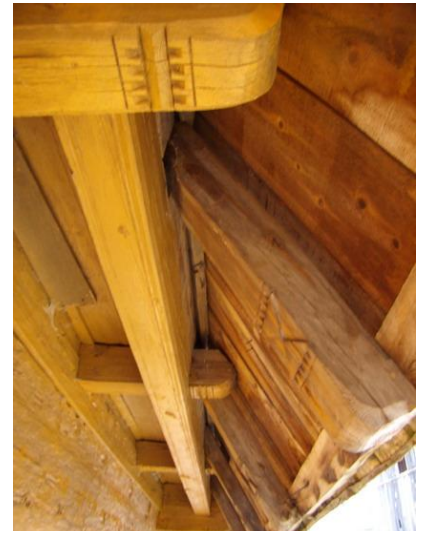
Figure 19. The church, detail of decoration

The roof forms a deep eave around 120cm long. Visible parts of eaves/wall plates, ceiling beams and rafters, under the eave, are decorated with geometrically shaped elements (Fig.19). The roof construction consists of straining beams, rafters and ridge piece. It is a steeply pitched roof with an angle of inclination of around 60° and galvanized steel roofing.

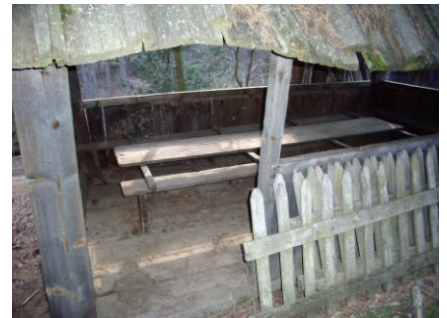
Figure 20. Sobrasice, half-opened type, interior

There were several types of sobrasice on this location: built as an open porch, rarely as a cottage, covered with planks. Instead of foundation they had corner stones as a base for pillars. Interior layout is simple- in the middle there is an elongated board, which was used as a table (Fig.20). This table was surrounded by

Remaining sobrasice are in bad condition (Fig. 14,20,21,23). The majority of roofs are covered in moss, timber construction is loose and it is not stable. Furthermore, the interior inventory is either destroyed or in poor condition. The last repairs on sobrasice were done in 1987. At that time the Institute for the protection of cultural monuments in Kraljevo made an inventory on technical and photo documentation, as well as the reconstruction of four sobrasice on south side of the church.

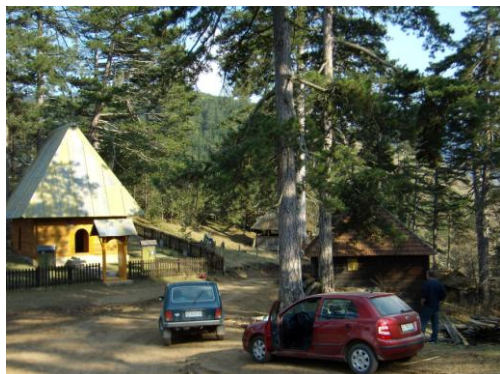
Figure 22. The church with surrounding

The church is in good condition and it is structurally stable, its appearance and authenticity is severely damaged. In 1969 villagers tried to improve critical condition of the building doing a number of changes on it (Fig.1,22,24). Authentic wooden shingles roof covering were replaced for metal sheeting, slacken stone foundation walls were fixed with concrete and also three concrete steps were added to the church entrance on the west. The entire facade was painted with dark yellow oil paint.

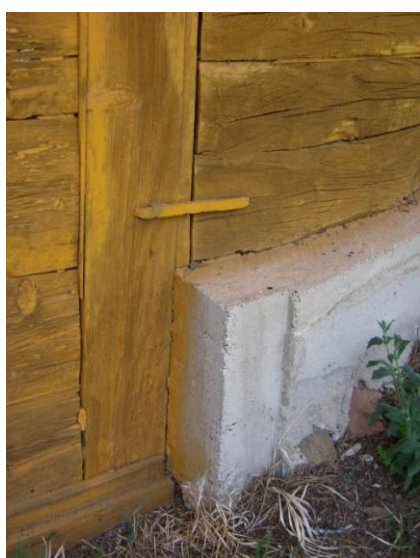
Figure 24. The church, detail of foundation wall

The church stands on a visible concrete footing in cascades, which extends around the entire floor plan. This base protects the building from moisture and is used to compensate the location for the inclination of a ground. Walls are made of pine planks, with thickness of 9-11cm, and with different mutual connections. The planks are curvilinear on the apse, on the east side.

- Taking off dark yellow oil paint from the facades.
It is necessary to remove all oil pain from the walls and from all other elements with an appropriate method
- Removal of concrete foundation and steps and using the material which was authentically used- stone
- Protection of wooden elements of the church from moisture and insects is a part of works that will be held as the repressive measures of the vulnerable, authentic parts, as well as preventive measures in the new elements

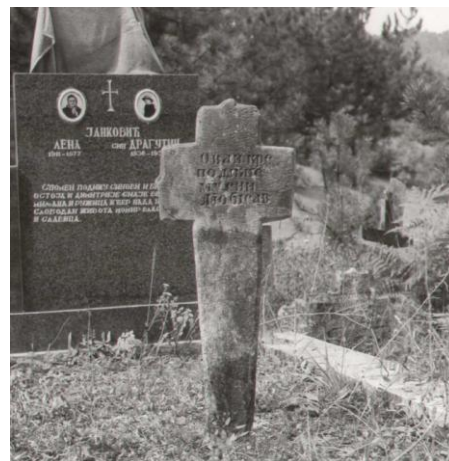
Figure 28. New cemetery, a view on the old and the new tombstones

The new graveyard does not belong to the ensemble itself, but it is situated near by and it should be considered as part of the ensemble. Many tombstones were relocated to the new one (Fig.28). In the last few decades it is spreading to the slope, distinguishing from the older part of cemetery by its bigger, concrete enclosed tombs and granite tombstones. The appearance

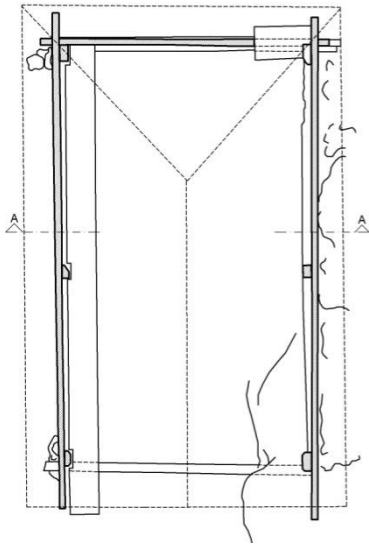
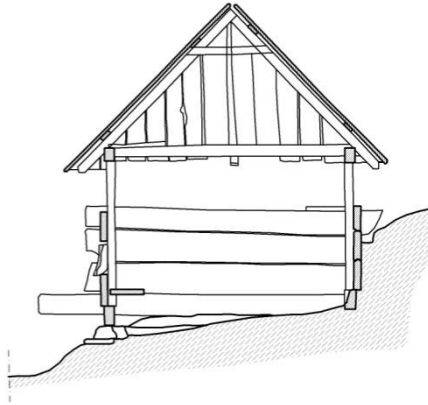
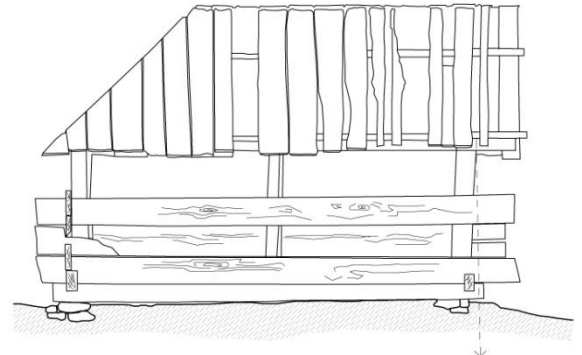
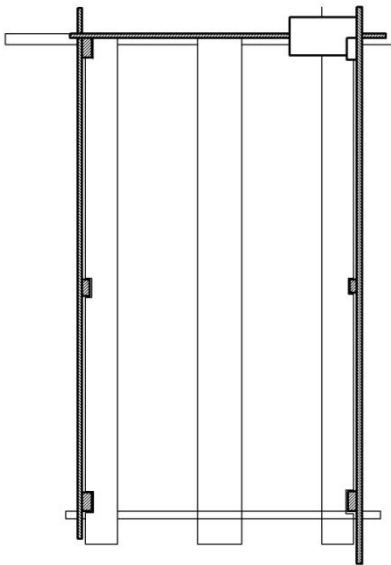
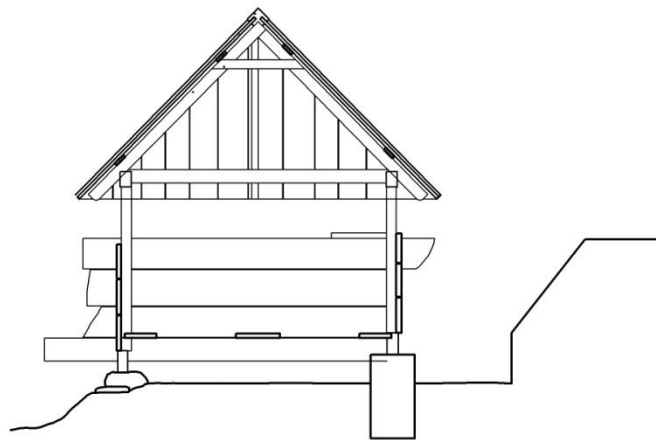
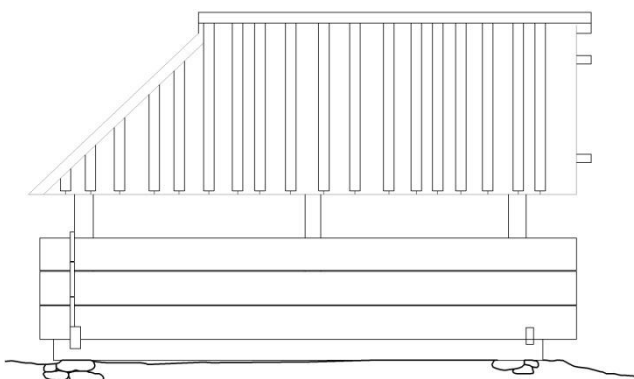
Reconstruction of sobrasice(down) based on drawings (above)

Also, there is an issue of two reconstructed sobrasice, which will be marked as reconstructed ones and presented together with others (Appendix 4).
