La Casa Solariega de Gil de Gumucio

Maintenance program for policy management of historical building

Inés Rosario Flores Guzmán

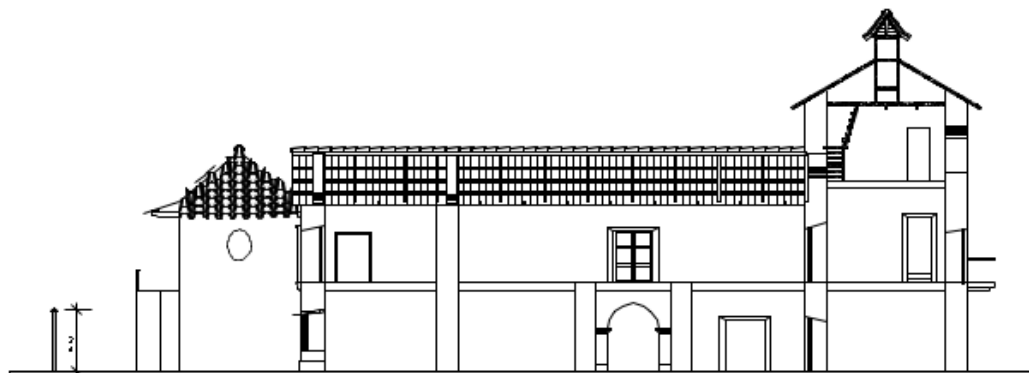
Fig. 2 The Casa Solariega de Don Gil de Gumucio. Section.

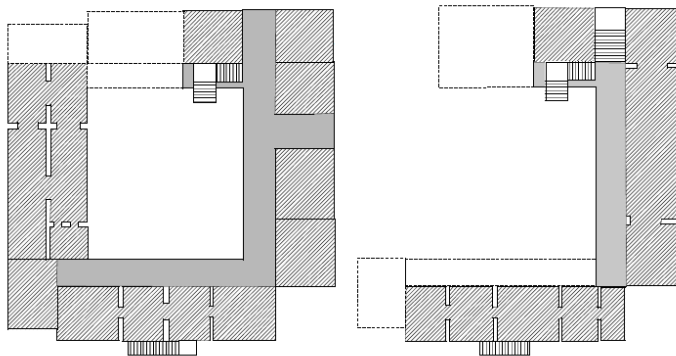
Fig. 4 La Casa Solariega de Don Gil de Gumucio: Typology. The House is organized around the courtyard

It has great honor staircase of carved stone that leads to the first floor. A discrete and steep service step [now demolished] in the south facade serves the domestic reparations. On the high floor there were spacious galleries (today no much conserved at all) that surround and define the central courtyard, the columns of this galleries are slender and they are made of cedar wood with stone base. To the left of the main entrance is an oratory or chapel dedicated to the Virgen del Carmen and in the upper floor – on the Chapel – *there was a big library that had old books of the sixteenth century, it was property of Don Gil de Gumucio who besides to be a rich landowner, he was an important mathematician.* There is a viewpoint area or a control tower that allows watches the valley and Cochabamba city. *In the north wing are vault and stables spacious [now missing] that open big grounds which served to dry and husk crops [of corn].*

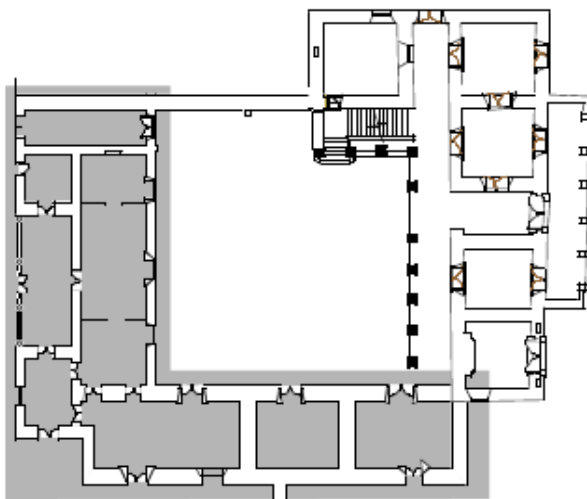
- The south blocks (two levels) and West (one level with a standard single and double height) have been affected by the collapse of roofs and mezzanines, causing irreversible physical decays. These blocks require on short term intervention to ensure their conservation.

Fig. 5 La Casa Solareiga de Don Gil de Gumucio; Area of maximum damage

a) Immediate steps identified for South and West blocks

- Removal of debris, vegetation and other objects at a distance greater or equal to 1 m. from the walls.

- Save the original material that can be recovered from mezzanine and deck floors (lift, clean, protect and keep indoors).
- Protect the adobe walls from the next rains.

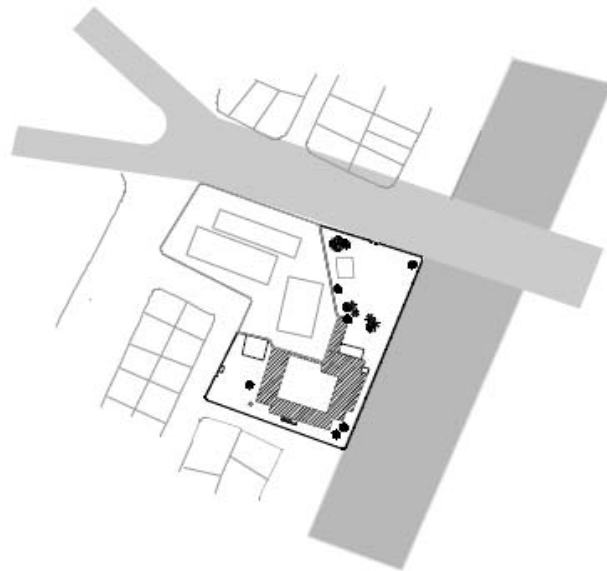
Figure 6: The current road project and La Casa Solariega

- Study damage by road: Place *witnesses* in the tower – lookout, to register the behavior of the deepest crack in the building and in the failures of the archery and determine whether this damage are still active (the owners have realized a small intervention). Considering the current road junction being currently in construction will start to function, it is important to record possible structural impacts on sensitive parts of the historical building.

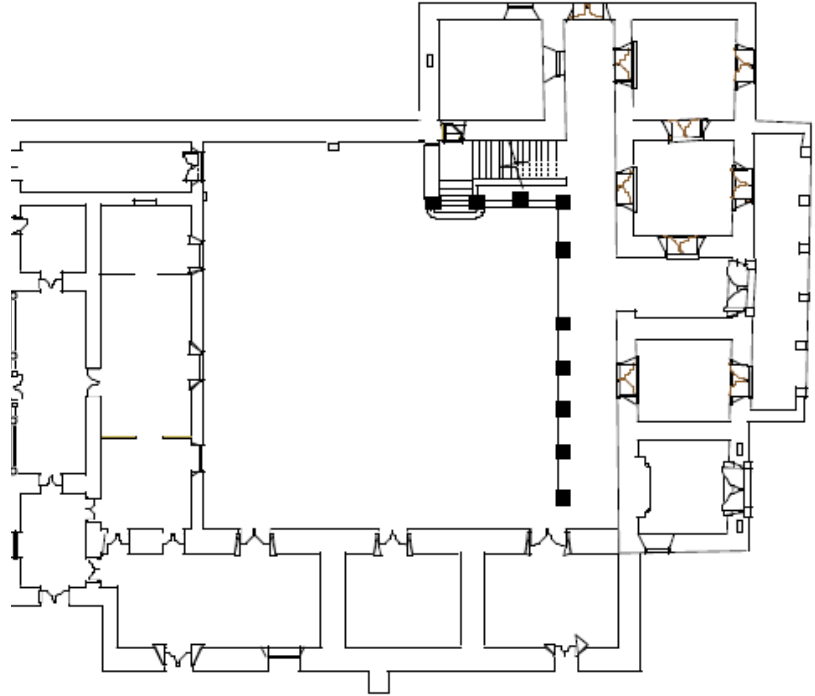
Ground floor

The ground floor has its organized around the courtyard, it was used in the economic activities (corn storage). In the actuality conserves clearly, the typology.

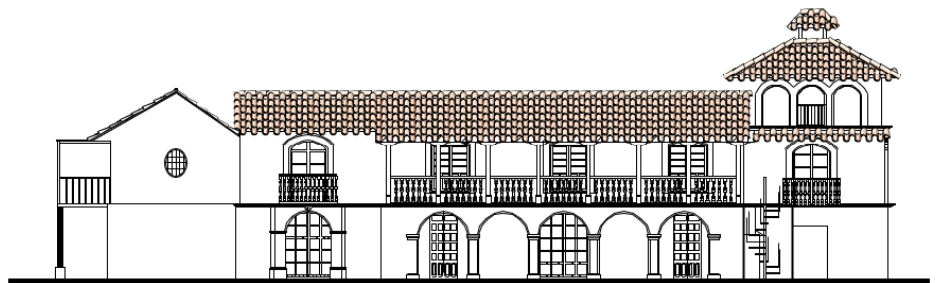
East elevation over the Rocha river.

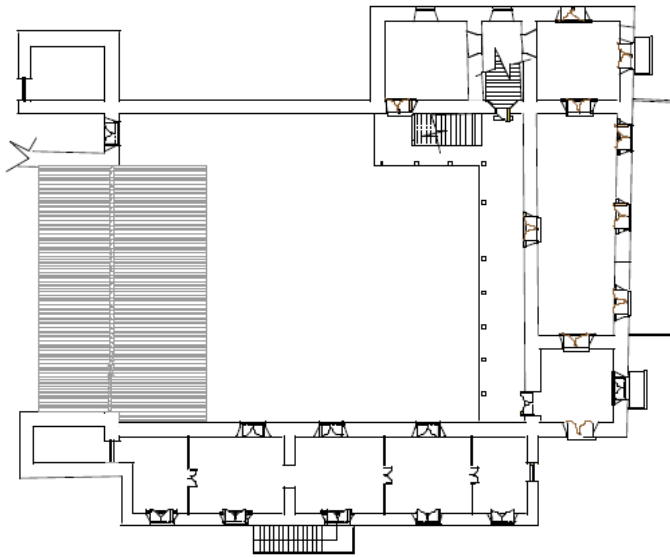
Second floor, In the second floor was used for the family activities, was the domestic space.

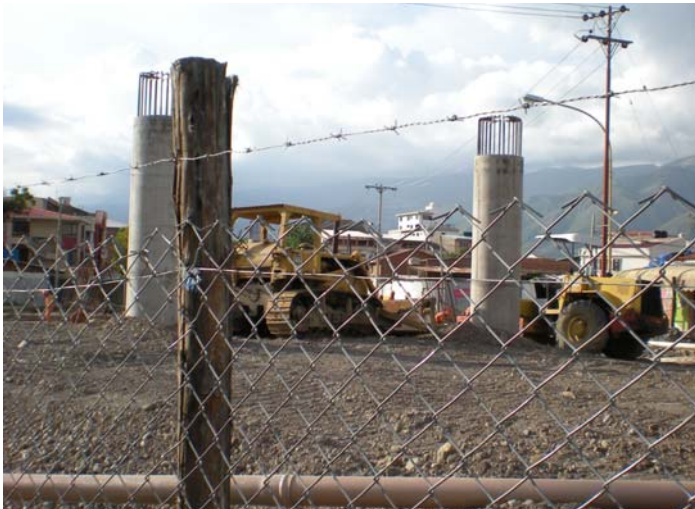
- A road junction in development located at 80 m. from the house with potential impact on its quality.
- Lacks a declaration of cultural heritage.
- The owners and the local government seem to ignore that the loss or destruction of this building will affect its economic value, on which they seem to endlessly discuss without reaching any agreement.
- The owners cannot apply for a bank loan to implement a Guest House.
- The building is facing a grave process of decay that has destroyed part of the roofs and walls.
- There is neither will nor institutional capacity from the Municipality to facilitate the conservation of historical buildings.

The actual project (a road junction) near from the Casa Solariega..

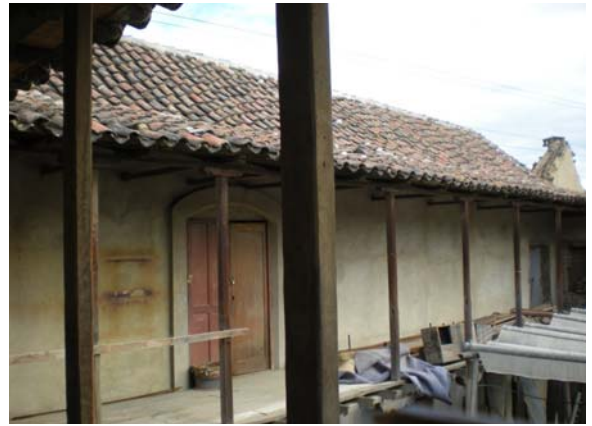
View of the gallerie in the second floor. See the absence of the floor.

Floor of the galleries: the changes have not been completed and the wooden beams remain exposed.

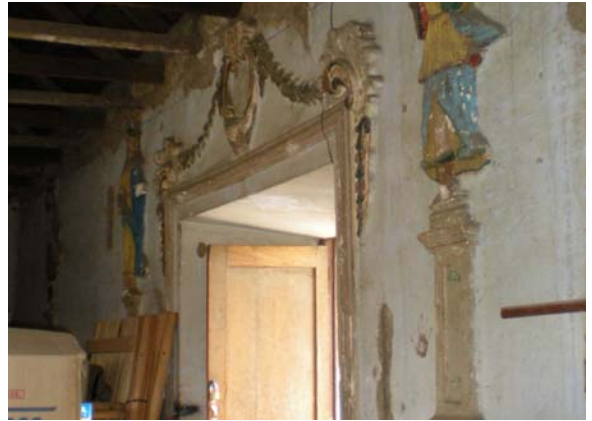
Interior view in the second floor, salón. View the decoration with natives figures.

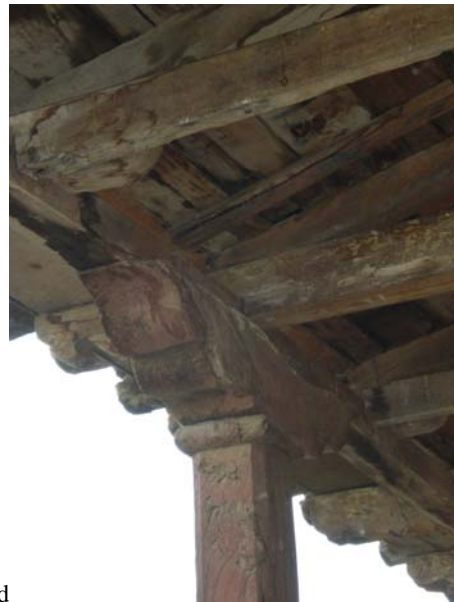
Detailed in assambled wood
