Conservation and Management Plan of Historical Buildings for a Monitoring System of Alegre and Concepcion Hills Area, part of the World Heritage Site

Karen Fried Agosin

Architect
Heritage Management Office
Valparaiso City Hall, Chile

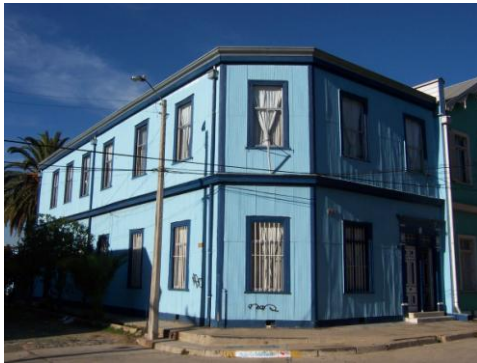
Figure 30. View of wood and adobe tipology.

This real estate is characterized for being constructed for the most part by structures of wood and *adobe*, covered by stuccoes of mud and lime. These buildings are composed by these materials in his interior and exterior. For which there possess structures of wood in exterior and interior walls of adobe which cover with diverse stuccoes. The completions of these buildings are changed being materials and furnitures in wood, iron and plaster-works.

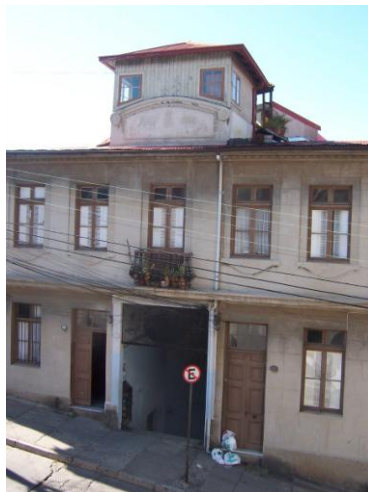
Figure 31. View of brick and concrete tipology.

This real estate is characterized for being constructed for the most part by structures of armed, concrete reinforced with rails of trains or other structures. These buildings are composed by rigid structures and in his interior they possess a structure not soportante frivolous as wall of *adobe*, decorations like plaster-works, paintings in walls, molding and furnitures in fronts. In his foundations they possess walls of stone, with ashlar and also they possess walls of containments consisted of structures of iron, stone and concrete.

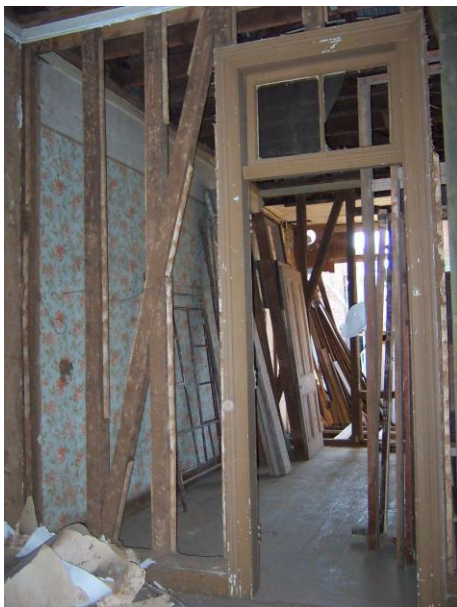
Figure 33. View of interior intervention.

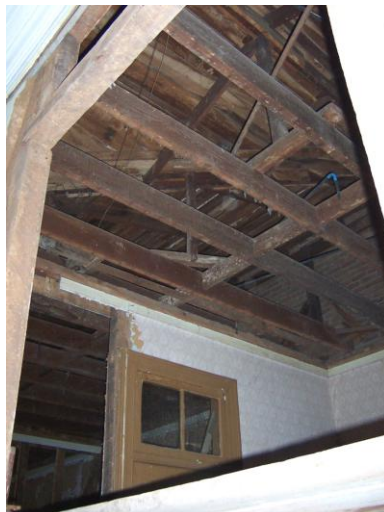
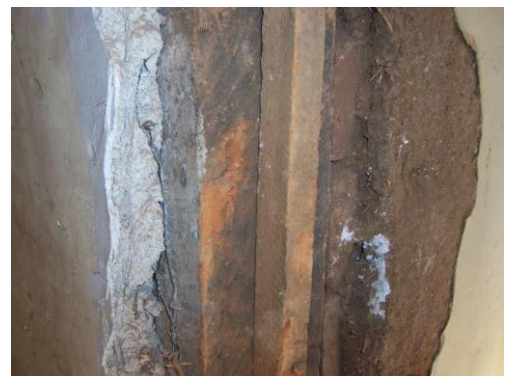
Figure 34 - Figure 35. View of interior damage's.

- Walls of basement and foundations: Condensation of dampness; there exists in the foundation of stone, high condensation of dampness owed wing lacking in ventilation and partial filtrations.

- Roof and cover: Rot of the wood, due to filtrations, condensation of dampness; thermites impregnate in the pieces of the roofs; corrosion of the coating of zinc for the salinity from the coast of the sea and breaks and fail of the pieces.

- Doors, windows: superficial wear, of the wood and paintings; railings, stairs; superficial wear of wood, steps, balaustrade of wood;skies and furnitures of plaster and wood: filtrations, rotting, thermites; pollution in adobe and wood, detachment of stuccoes and filtrations.

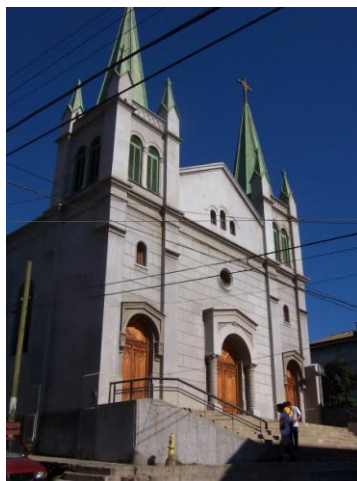
Figure 42. View of San Luis Gonzaga Church at Alegre Hill.

The neo-gothic inspiration of this church finds its expression in the tower's slenderness and verticality, in the buttresses, supported arches, ogival windows, as well as in the design of its ornamental elements. The church has stone foundations and had originally brick walls in its two levels; however, after the 1906 earthquake, the second floor was rebuilt with wood. The outer covering is of galvanized corrugated steel sheets. On the inside, the most remarkable feature is the exposed roof structure which comprises wood elements, both straight and curved, of artistic carpentry workmanship, fastened by metal tighteners.

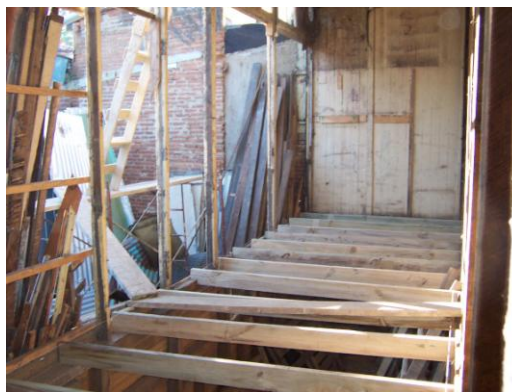
Figure 50. View of structural repair in interior.

When interventions are realized, the historical structure of wood must be considered to be as everything; all the materials, included the pieces of the framework, piers, shutters and shutters, roof, soils, doors and windows, they must receive the same attention. At first, they must preserve to the maximum the existing materials.

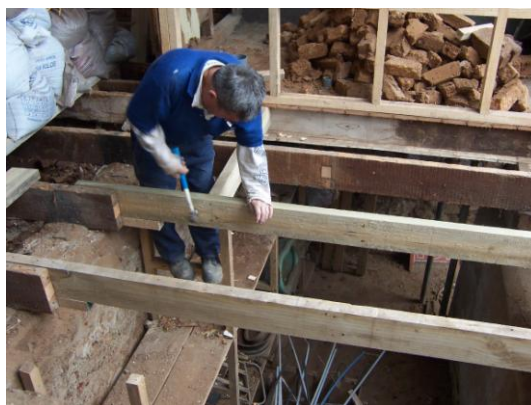
Figure 51. View of structural repair at basement.
