Escala Hotel Conservation Plan

Its Impact on the Regeneration of the Nova Luz District – Sao Paulo

Carlos Jaramillo

Heritage Management Architect

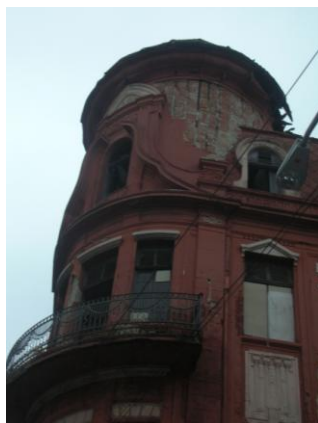
View of the cupola showing missing render on the brick walls.

Top Floor: The timber structure of the roof caught fire in the 1980's. Large extensions of the roof material is missing and other parts are severely damaged. The overall structure of the roof still exists and can be reconstructed. Carpentry of doors and windows were burned. Since then, the rain has worked its way through to the second floor.

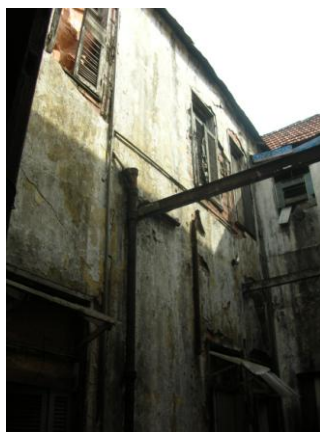
View from the central patio, showing carpentry condition and structural reinforcement.

First Floor: As in the ground floor, the skylight and the main staircase has been cancelled. The illegal occupation of this floor, has introduced new bathrooms and laundry spaces. The former dining room has been subdivided into three different bedrooms. Interventions are mostly related to the addition of wet areas with no safety standards whatsoever. The condition of floors and carpentry is very poor.

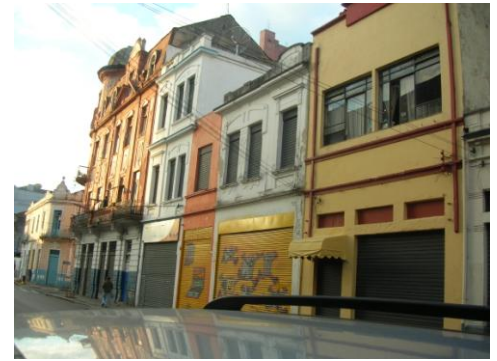
Figure 4: Adjacent land to the Former Escala Hotel.

Quadra 76 was designed based on the following principles: 1. Integration of the heritage building to the housing development. 2. Restitution of the public use of the former Escala Hotel. 3. Restitution of some of the activities related to the Triunfo street using part of the building as a cinema. 4. The new building to be sympathetic with the heritage item. See figure 4.

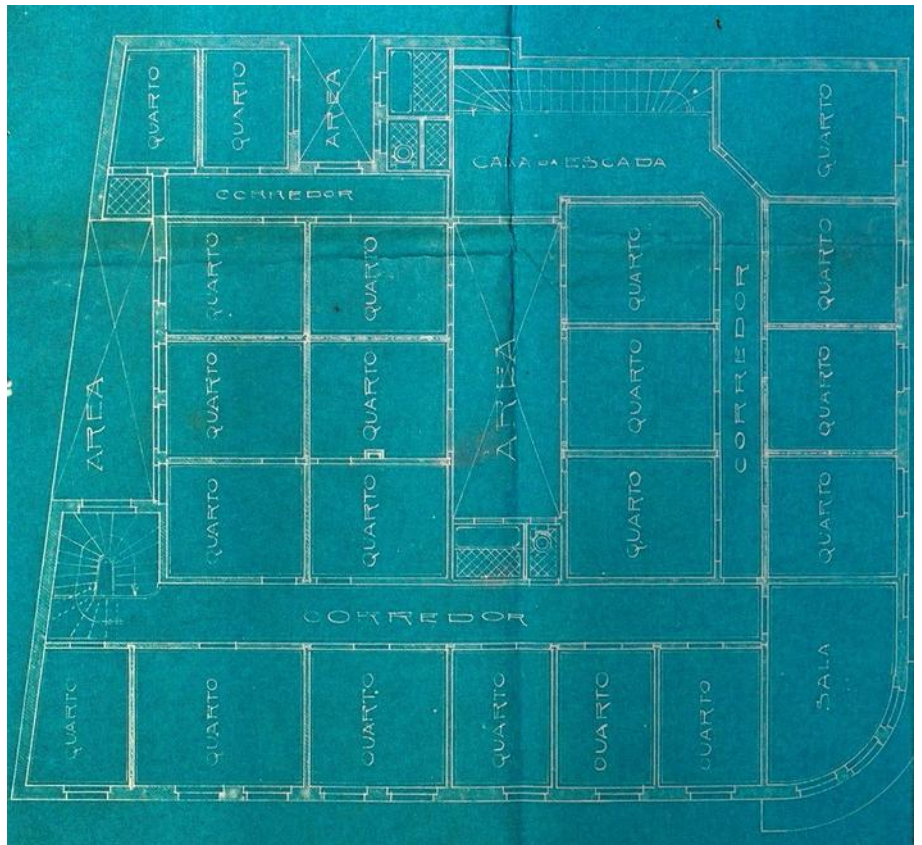
Second Level plan, showing original layout.

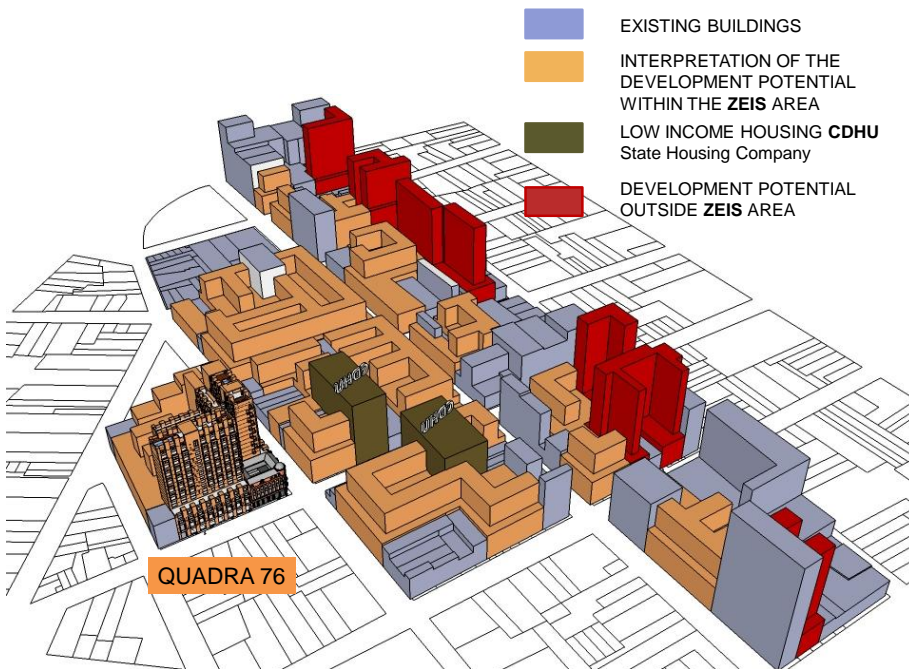
Interpretation of the Model in the Nova Luz District

ZEIS Area Nova Luz Regeneration Programme

The experience of integrating a heritage building into a development proposal (Quadra 76) has been tested in other cases, the ZEIS area and also other blocks within the Nova Luz Programme. The results of these assessments proved to be subject to replication in the majority of the lots with development potential with an average area of 2.500,00 M2 that have a neighbouring heritage building. See Appendix # 4 and 6.

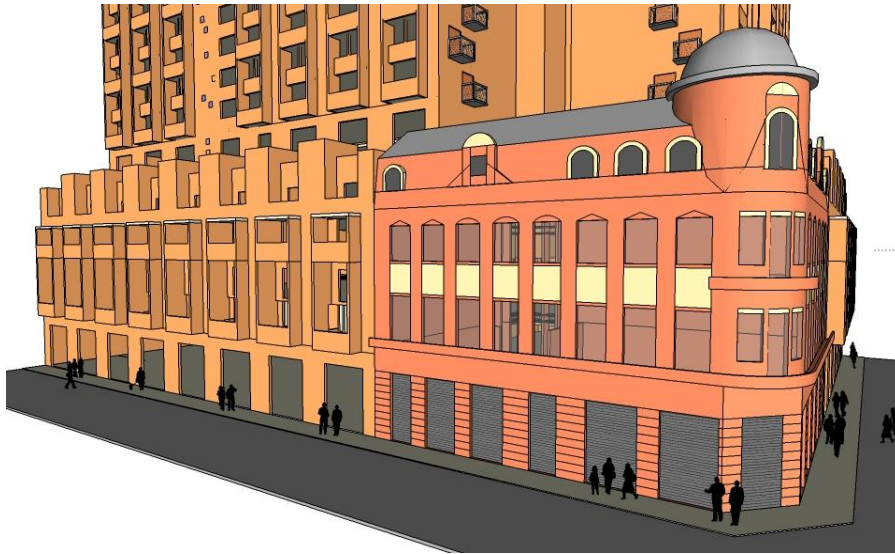
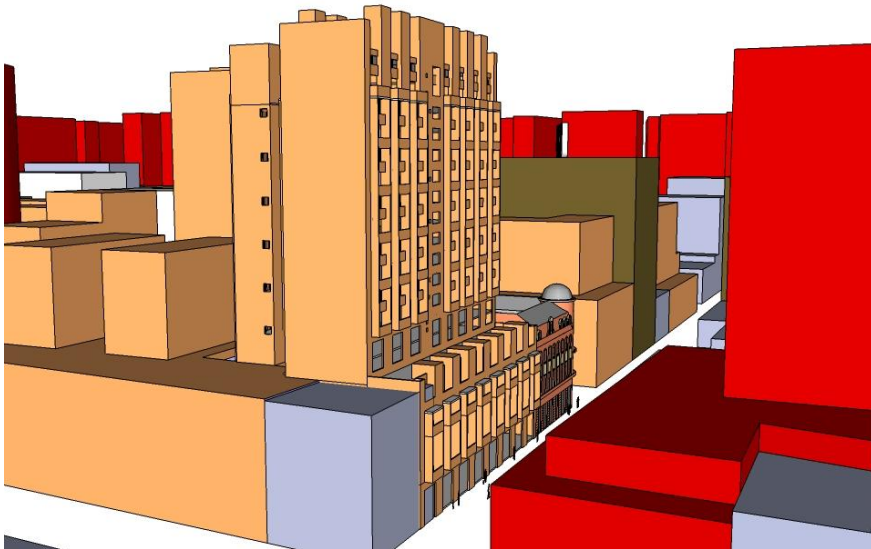
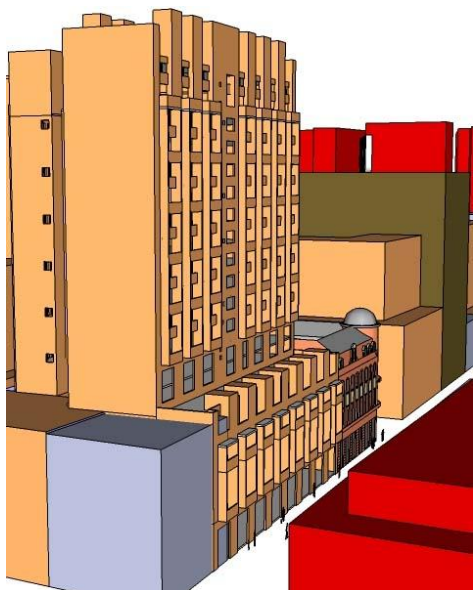
Appendix # 6

Quadra 76
