# Old Public Jailhouse

Guayaquil, Ecuador

## *Conservation Plan*

## *Florencio Compte Guerrero*

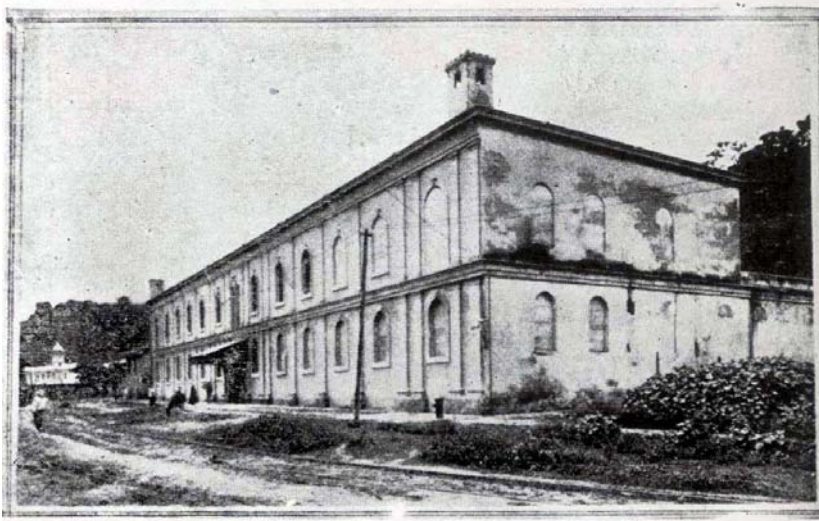
GUAYAQUIL—Cárcel de Mampostería de la Ciudad.

*The Public Jailhouse, c. 1909*

At the end of the 19<sup>th</sup> century, the authorities of Guayaquil, decided to build a new prison, built in reinforced concrete. The construction of the Public Municipal Jailhouse started in 1886, projected by Italian architect Rocco Queirolo Pinasco. The construction process developed slowly until 1896, but due to the *Great Fire* it stopped. On October 5<sup>th</sup>, 1903 it was decided to call to continue the construction that was assigned to the Venezuelan engineer Francisco Manrique Pcanís, who finished the construction in October 8<sup>th</sup>, 1905.

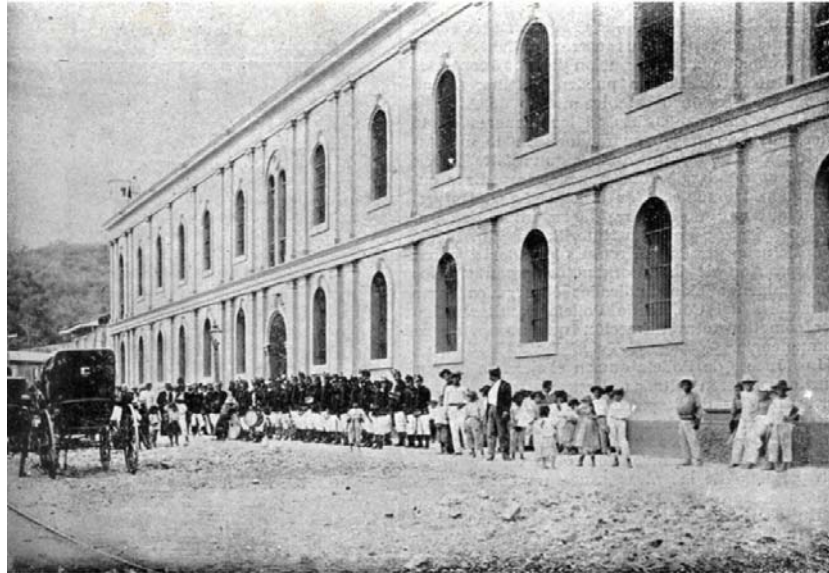
*The Public Jailhouse,  
Exterior view, c. 1920*

The building occupies an area of 2036, 40 sq. meters, and is close to one of the most important historical areas of Guayaquil, now a cultural and touristic circuit.

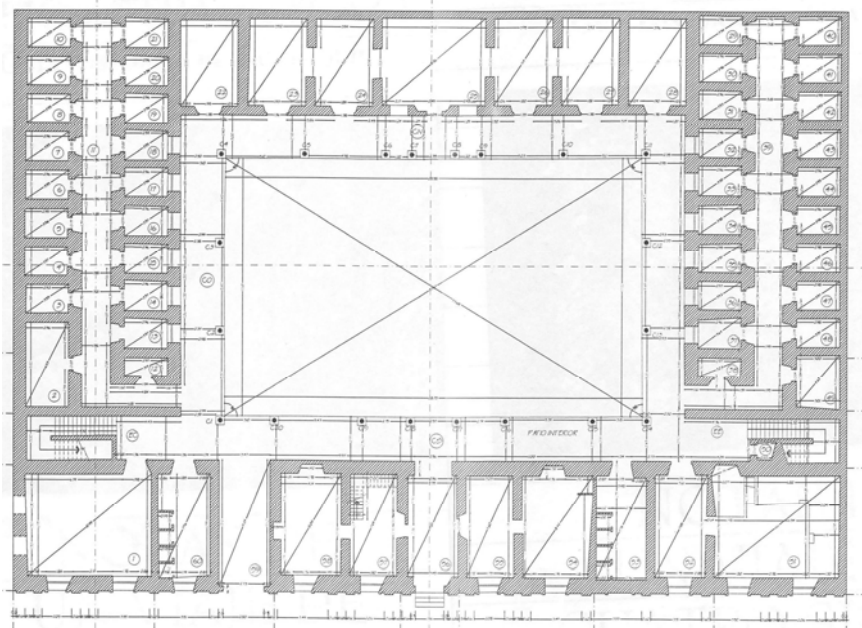
*Ground floor plan*

The building is a two stories block, while inside the pavilions are presented as a solid block with a central courtyard around which are the cells, and a gallery is presented as a cloister. The main facade is flat, where a cornice marks the division of the two floor plants. The towers stand out in each of the corners.

Structurally, the building is solid brick and one meter thick concrete walls which rest on a flat slab of reinforced concrete.

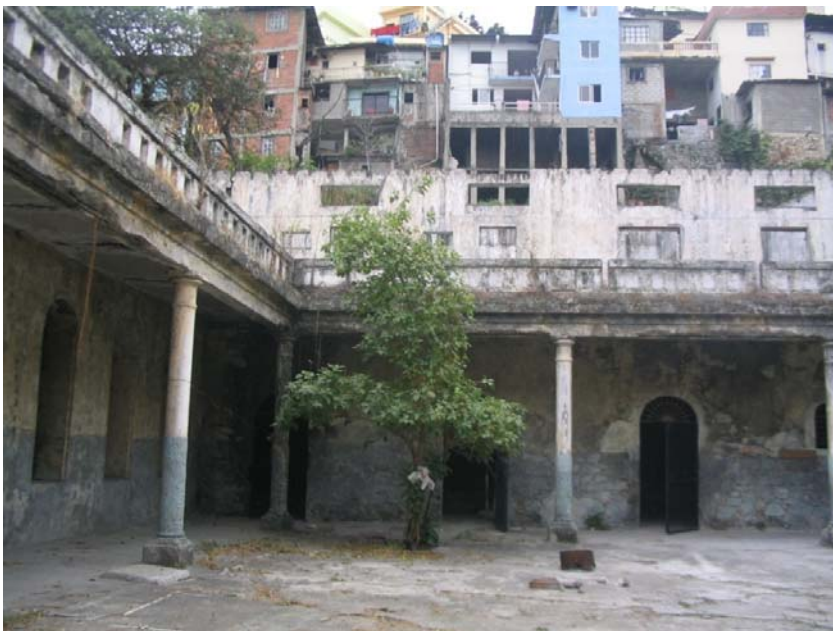
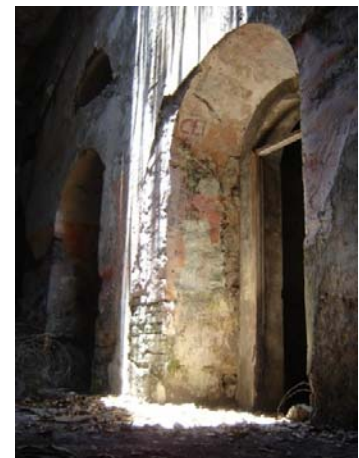
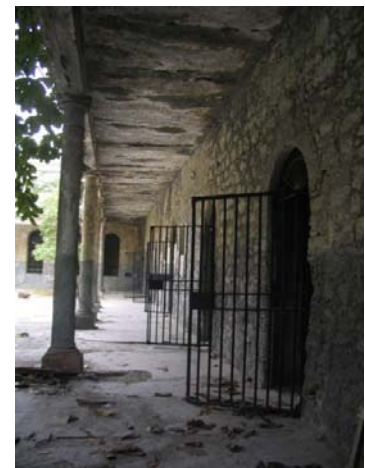
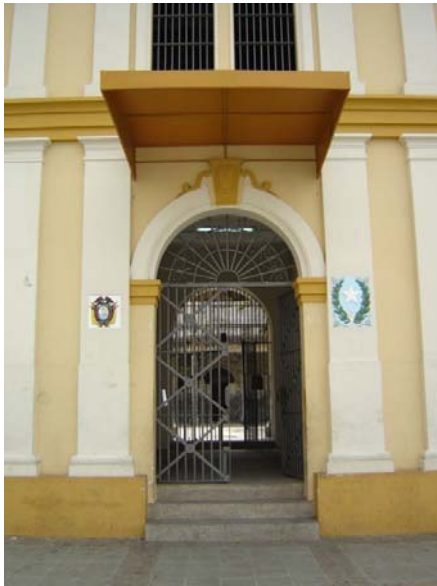
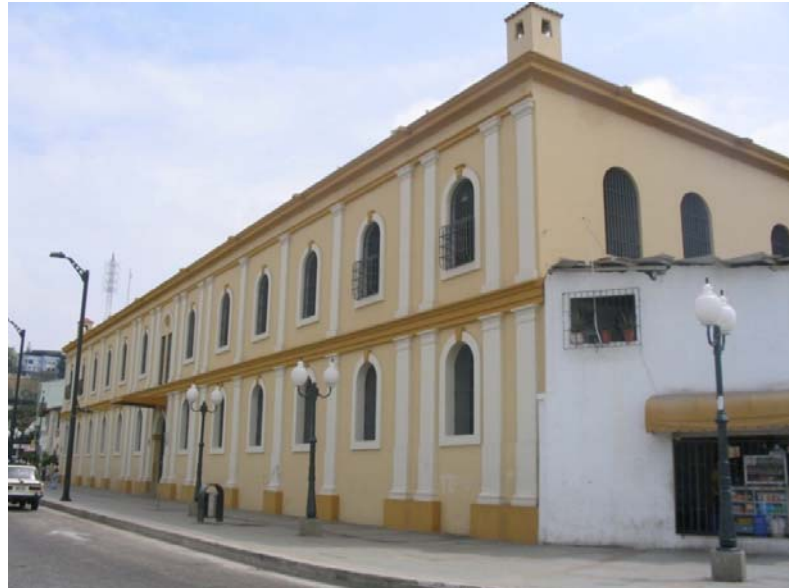
- Changes in the interior spaces and constructions added on the top floor.
- Serious structural damage in the floor slab and roof slab, steel structure exposed, which also is affected by corrosion
- Serious impact on the facilities, exposed electrical installations and inadequate sanitary facilities, potable water and sewerage, pipes completely collapsed
- Loss of iron doors in the cells located on the ground floor.

*Different views of the interior of the building*

The main problem presented by the building is the damage in the slab, both floor and roof, this is mainly due to the system that is made of reinforced concrete flat slab.

Use of this system is typical of the early structural slabs made of reinforced concrete in the late nineteenth century, which, with the years suffer from internal oxidation of the structure and wear out the coating, leaving exposed the structural skeleton. In this building sit on the slabs bearing walls of brick and concrete one meter thick, this is in good condition.
