Sustainable revitalization of the traditional old urban mansion: Ruplal house

**Conservation & Management of historic building (CMHB),
Advanced International Training Programme, 2009/2010
Lund University-Sida**

Sanjida Ahmed Sinthia, Lecturer
Ahsanullah University of Science & Technology (AUST)
Dhaka, Bangladesh

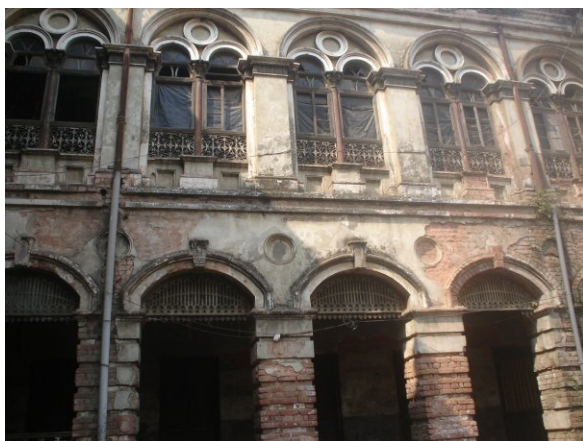
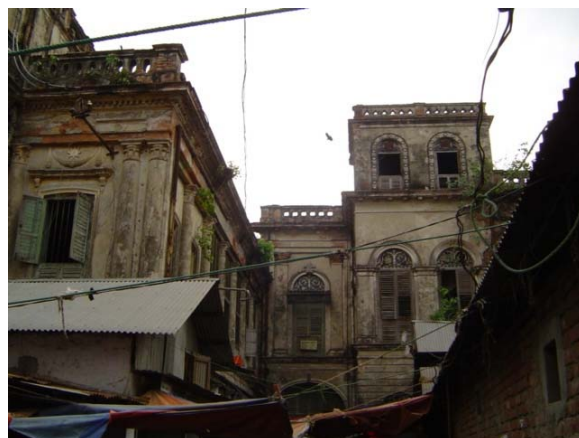
Fig: 09 Neo-indo classical complex: window & column detail (Source: Authors collections) Fig: 10 Window & column detail of Raghunath block (Source: Authors collections)

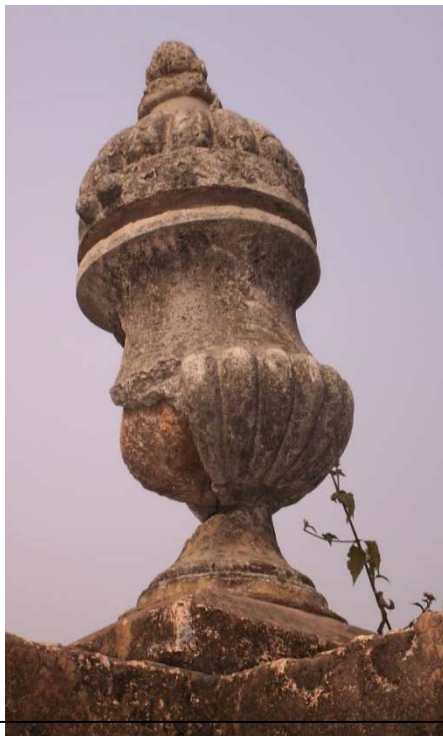
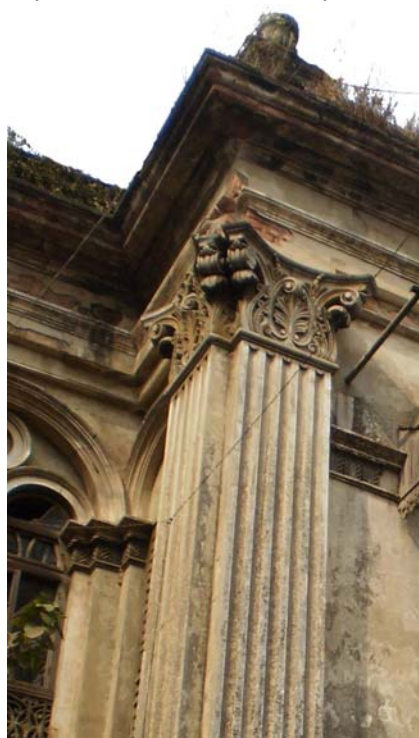
Fig: 11 & 12 Ornamented Kiosk & Corinthian

column

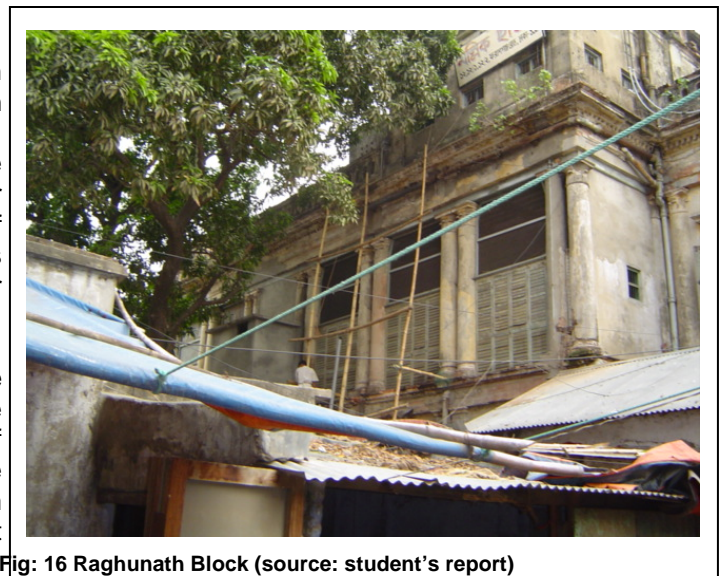
- 22" Load bearing brick masonry as Ruplal Block.
- Brick and lime mortar are used here.
- Walls are finished with lime plaster and paint.
- Floors were constructed with burnt clay tiles covered with lime concrete finished and red oxide.
- Ceiling supported on wooden beams which run along the length at one tile length apart. This frame is fixed in the walls with steel plates.
- Absence of steel I beam.
- The roof has a layer of lime terracing.
- Brick arches are used. (student report)

Fig: 16 Raghunath Block (source: student's report)

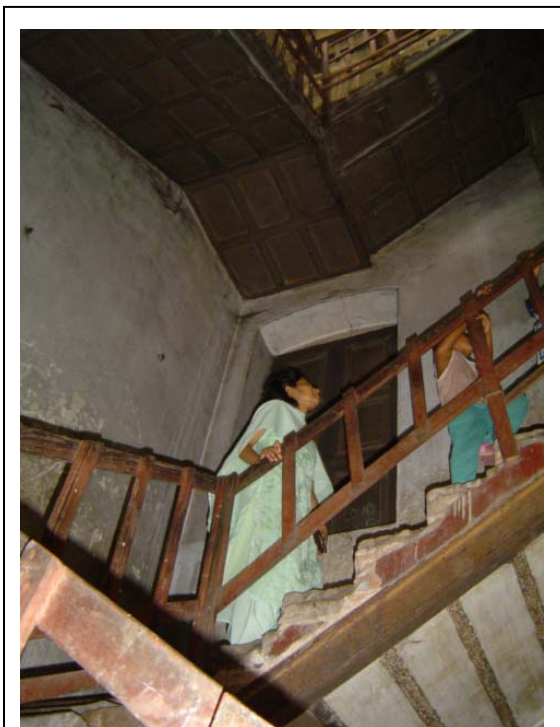
- The roof was found to be leaking in many parts of the building. One section of the roof has caved in. Roof repair is obviously the first line of action. [Ahmed & etal , 1990]
- The timber beams are slowly decaying and are termite- ridden. Also the I beams are rusted.
- There appeared to be fractures in the fabric of the building at certain points ,either caused by earthquake or by differential settlement .If this is found severe, under-pining of the foundation may have to be under taken.[opcit]
- Plaster and mortar of columns are deteriorated.
- At several places bricks have been dismantled.
- At the 1st floor level the floor and ceiling of room no 3 has broken down.

Fig: 18 Vulnerable Wooden Stair

- The plumbing line, electrical wiring, water supply pipes may be concealed without hampering the structure. [opcit]
- The dilapidated wooden stair cases could be replaced by steel or RCC.

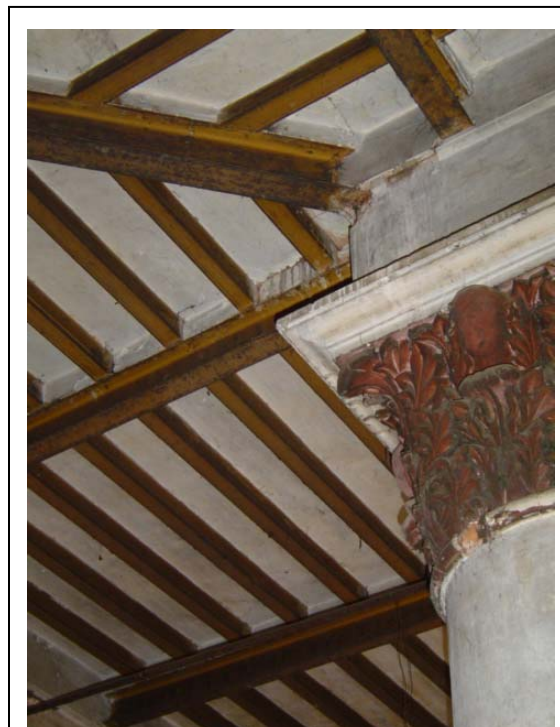
Fig: 19 Ceiling with I beam and decorative column

- As the structure is still in a good condition [foundation has much high factor of safety] different alternation or addition may be possible.
- To maintain its traditional structural system the dimension of the I - beams could be increased according to the increment of load. Welded steel I -beam can be used in this purpose. [nipa,1992]

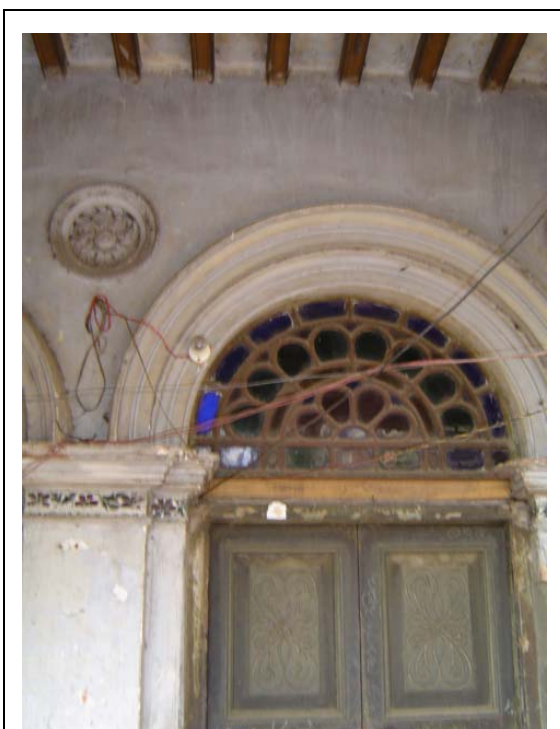
Fig: 20 Decorative Door & unplanned electric line

- Deterioration of wooden surfaces are a common feature.
- Most of the decorative portions are disappeared and others are in poor condition.
- Electrification is done by surface wiring without proper planning. So, it is difficult to identify the original fitting and fixtures.
- There are additions of service block time to time so it is also difficult to note down the original features.

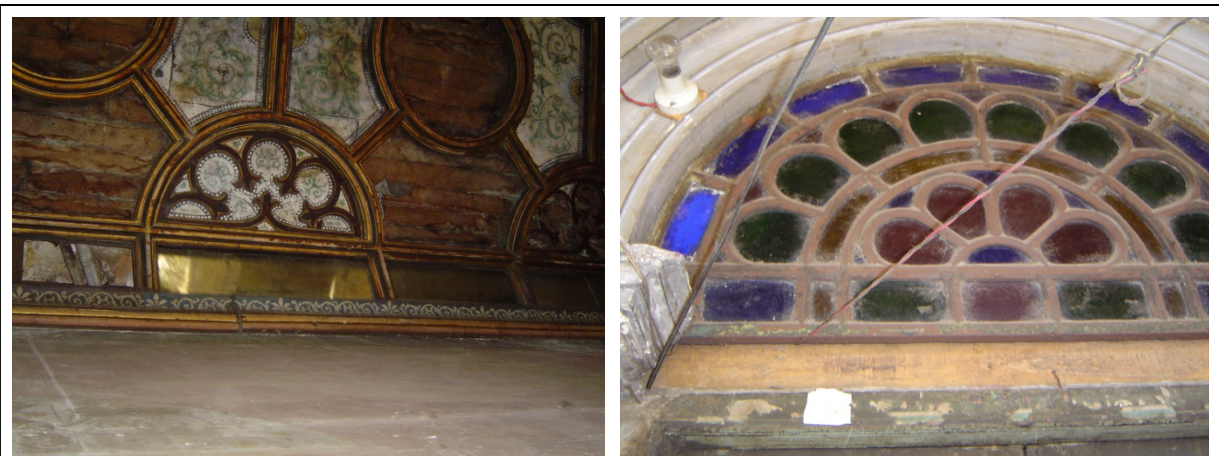
Fig: 22 & 23 Decorative Ceiling work & color Glass (source: student's report)

- Any unplanned rearrangement, removal, addition or repair of historic glass is not acceptable. The treatment of glass requires full documentation and recording as a precaution. Best possible measure should be considered for their protection.
- To avoid deformation of iron railings addition of plates, doublers or strengtheners can be recommended without causing any visual change.
- Dislocation of joints can be solved by welding with expertise
- Installation of adequate sewerage and drainage to prevent the water table from rising further and creating more structural damage. [Ahmed &etal ,1990]
