Conservation Educational Facility

Academic Program and Building Conservation of a Historic House in Bogota, Colombia

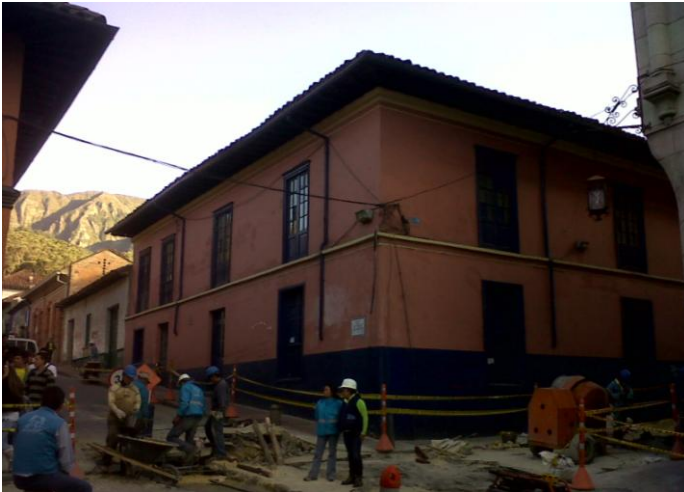
Figure 2: Current aspect of the house today

Outside it has been painted with pink and blue paint which was not typical of such structures during colonial times. The wooden frames of doors and windows have also been painted in a manner that does not respond to the original design and customs of the time. See figure 2.

The expected needs of repair range from structural aspects as parts of the roof are falling to more superficial aspects like paint recovery and wooden details repair. It would be ideal to have an interdisciplinary team of masons, carpenters, architects and engineers to evaluate the current state of the house and come up with a comprehensive solution.

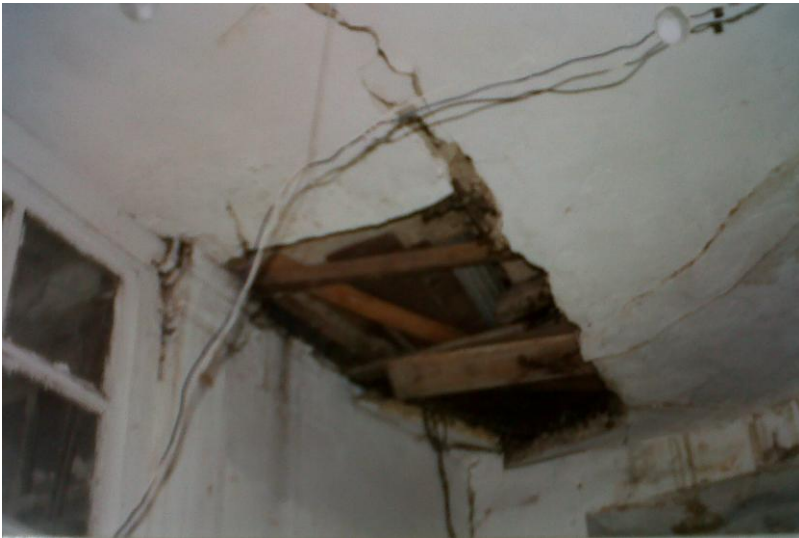
Figure 5: First floor ceiling.

The main materials utilized for this residence are wood, adobe and stone. Some adobe walls are cracking and need intervention, also ceiling structures as seen on figure 5 are in great danger of collapsing. Wooden columns also need to be treated and some of their bases

replaced. Wood relief work on windows and door frames is covered with many layers of paint making their profile indistinguishable.

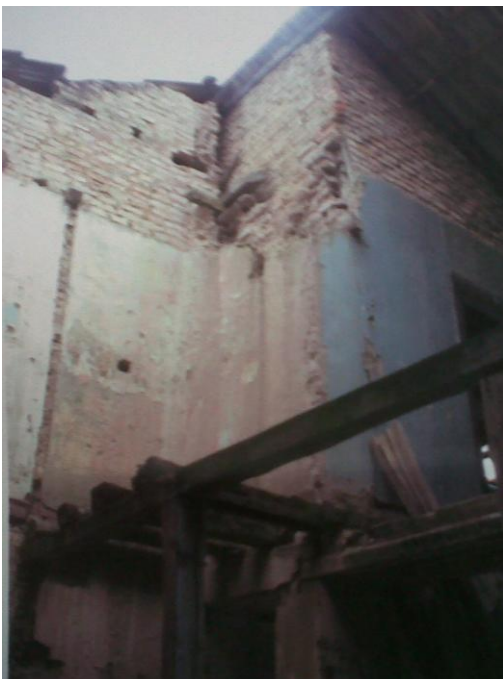
Figure 6: Framework of building

There are parts of the building such as the vestibule shown in figure 6, that need a major intervention, some of the wooden beams are corroded or missing, and some columns are under stress.

Similarly to columns, the beams and roof rafters are in poor conditions. Some beams might be reused but others will have to be

replaced. There are also some cracks on walls, adobe structure should be inspected.

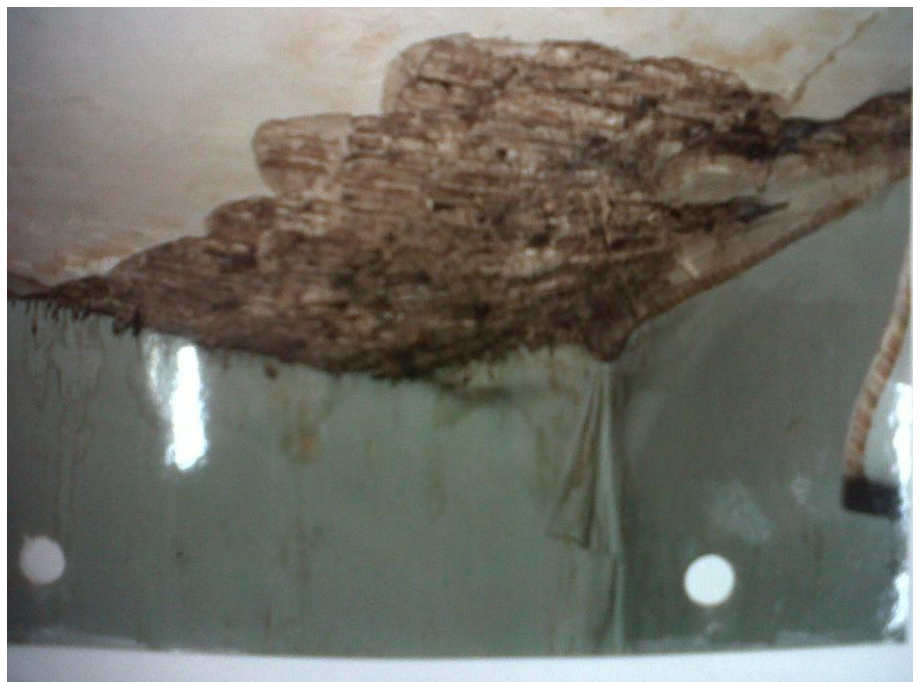
Figure 7: leaks seen on first floor ceiling deteriorating structure.

There seems to be problems with humidity, missing moldings and damaged woodwork. The current state of decay is a result of human and environmental agents. Many of the wood frames have been replaced and many are deteriorated, others have been coated with many layers of paint.

In terms of prevention of deterioration, there needs to be an assessment of the source of humidity to stop decay on walls and wooden elements. Also an integral reformulation of the electrical and water systems needs to be developed in order to prevent fires or floods. Water spouts and water drainage should be revised too.

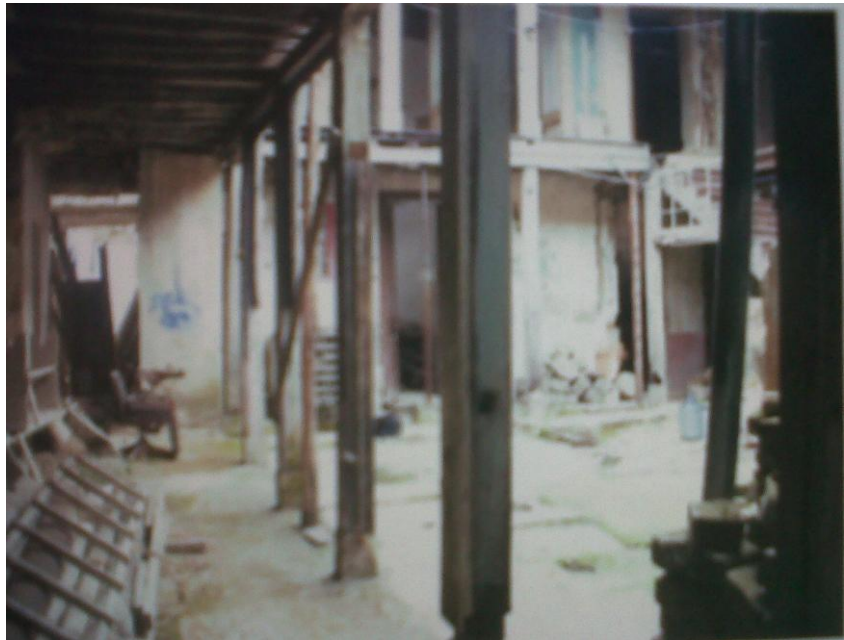
Figure 8: Interior open space, wooden columns have to be replaced or treated to guaranty stability of upper balcony.

In order to ensure its continued durability or structural integrity some additional materials will have to be added. This pertains mostly to structural elements that would be needed to sustain the wrap-around interior balcony and the the missing columns and rafters. It is important to note that the utilization of traditional skills will be preferred, and when this approach is inadequate given the structural problems, new technology would be used while guaranteeing reversibility.

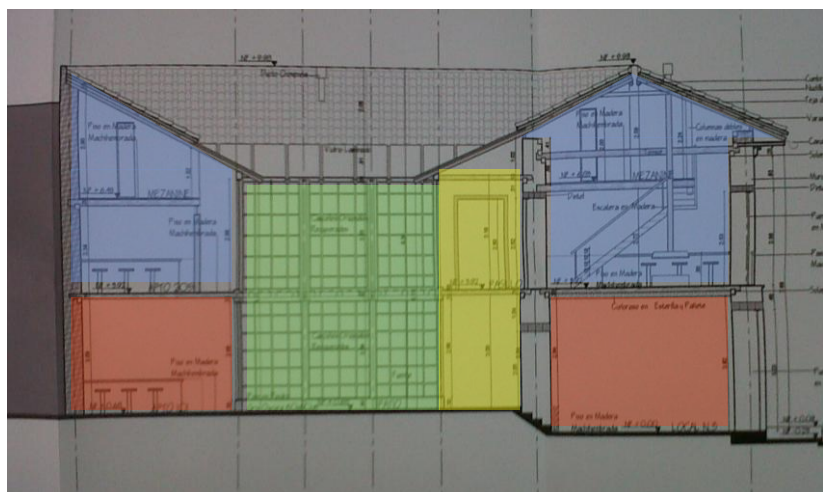
The initial schematic design proposes the following: offices and services on the first floor and classrooms and studios on the second floor. Below is the preliminary schematic design for the house:

- Open Area
- Offices and Service
- Classrooms and studios
- Circulation
