THE PROPOSAL PROJECT

Rehabilitation through new use of the historic building “Nun convent Santa Clara” in the historic center of Tunja (Colombia).

**Conservation & Management of Historic Buildings, Advanced International Training Program
2009 – 2010, Lund University - SIDA**

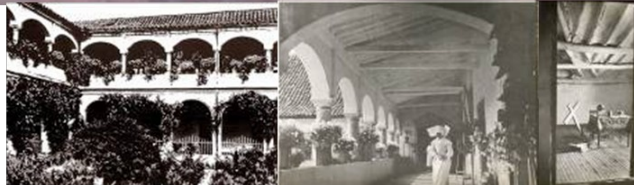
Image 3. Historic cartography of Tunja 1900

In a later representation (image 3) is displayed a widening of the block perimeter in where is inserted the Claustro, this extension try to reach a variant of “Gallinazo river”. Along the time about the historic chronicles the tree buildings, which formed the “Convent Santa Clara”, were changing of owners. However these changes did not transform the initial urban concept. The way to split the block, inherited from the colonial period forming four land parcels for housing and one “solar” or backyard, has been still now an important landmark in the urban heritage.

Source: Archive of Servicio Geográfico del Ejército, Madrid (España) en: Cartografía Histórica de los Territorios Boyacenses Banco de la República 2003.

In this representation from the XVII century is possible to see the block, where the convent is arose although it is shown only the church Santa Clara la real with its name written on the roof. But comparing this map with the following from 1900 (image 3) it is observed that the city, even with its densification process, did not expand a lot its urban grid since its foundation to the beginning of the XX century. The Convent land property suffered additions in the back side (the “solar”) and its north façade due to new changes forced by the new uses changes required to the building. However these changes did not modified the external appearance and façade patterns.

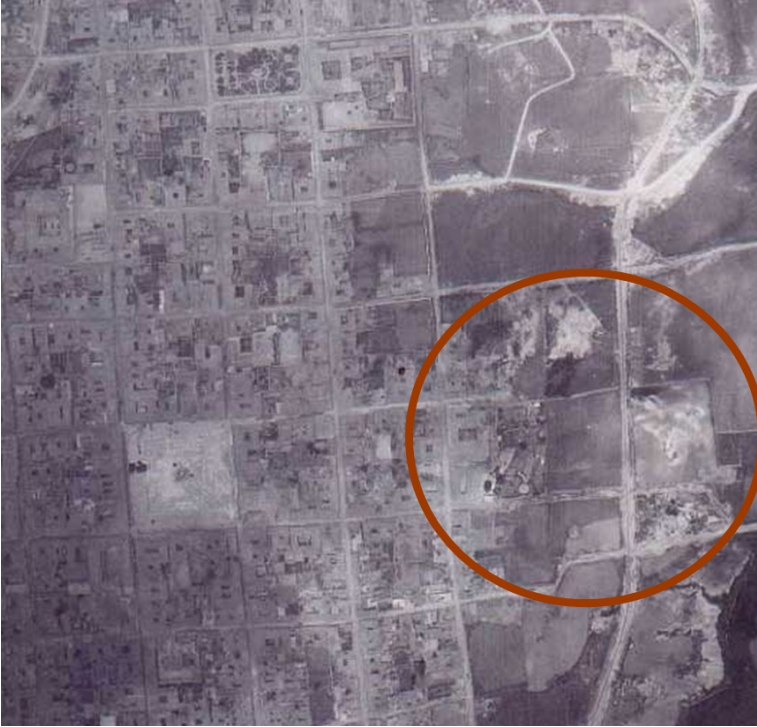
Image 4. 1939, Implantation of the

The air photography below (image 4) shows the complete group (Claustro, Church and old house with façade to Calle 19) configuring the block to Cr. 7. The block lengthened, by period of time had already undergone a first fragmentation due to the construction of rail track. The air photograph of 1957, image 5, shows the leveling land along the posteriorly called “Avenida oriental” of the city. This transformation leaves as result a huge fragmentation of the previously lengthened block by creating short urban strips. In the air photography of 2005, image 6, are displayed these new land totally parceled and built with low quality popular architecture. In this image is show in addition the paved vehicular way next to the block to east side (Cr. 6) which at that time created one spontaneous pedestrian way without any urban quality.

"Claustro de Santa Clara" in the Tunja historic transformation in the twentieth century

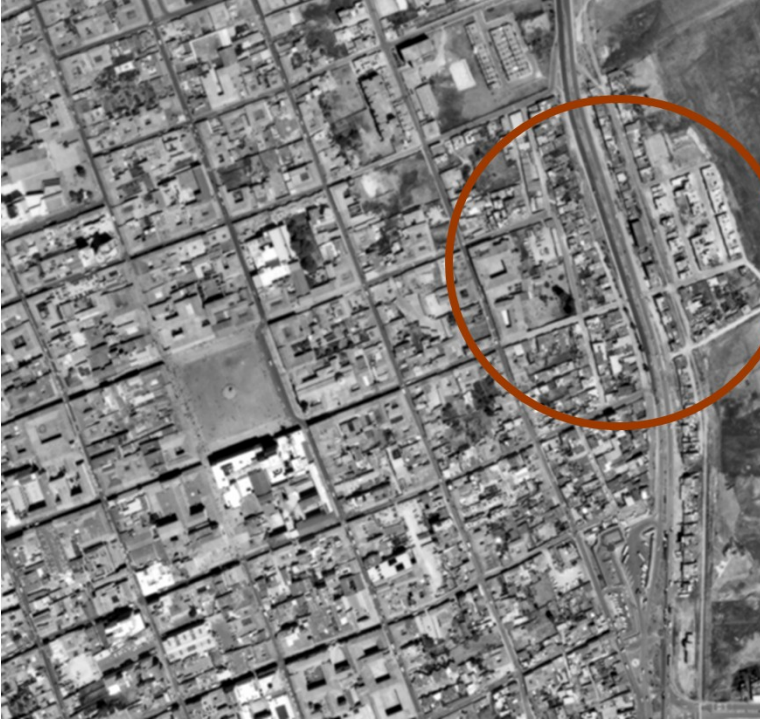
Image 6. 2005 Source: IGAC

The historic building is located as it mentioned before, in the east border of the historic core of the colonial city like it is shown in the image 6. The building presents uniform urban values displayed trough their profiles, their architectural language and the managing of material, textures and finishing belong to traditional architecture of the Tunja historic center.

Currently a set of houses were built next to the Convent block by configuring an improper border for the historic sector and this is the face that the city show to who those cross the area¹. On the opposite way the buildings and streets, located at west border from the block, reflect centuries of history and the relation between open spaces and the building scale.

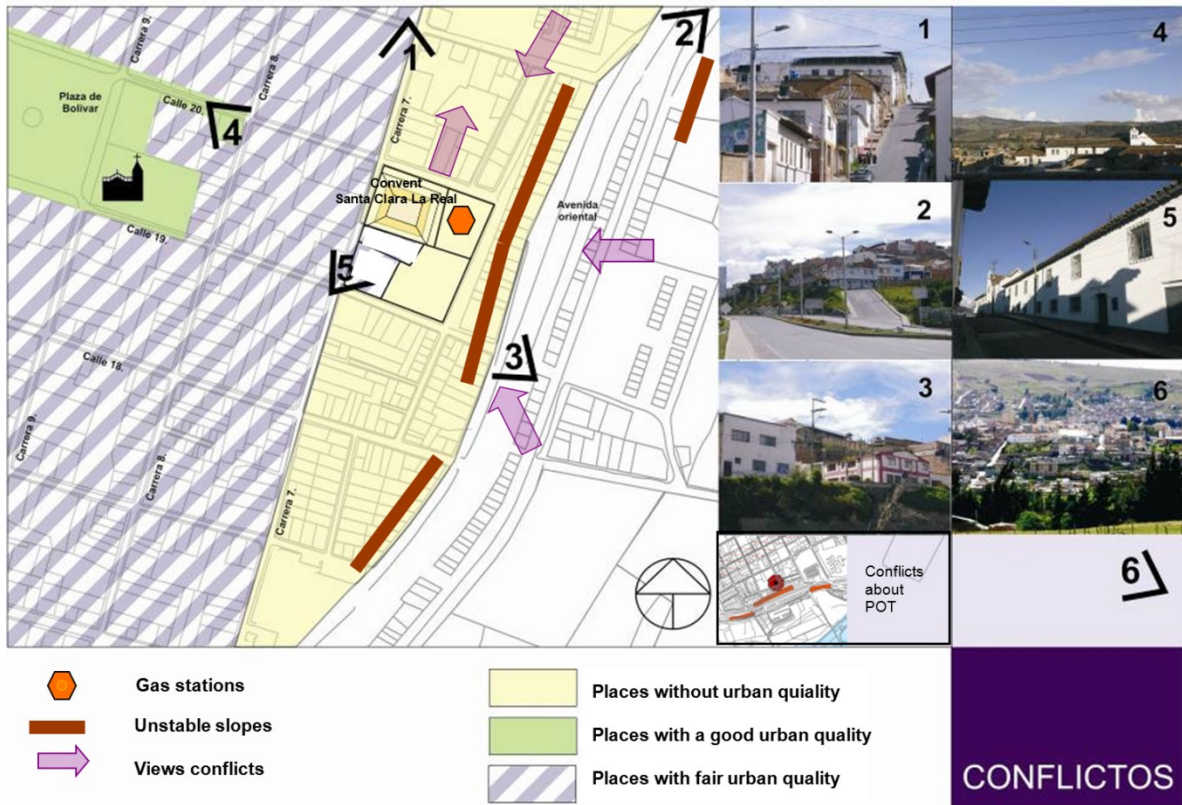
Image 8. Conflicts in terms of urban uses

In the conflict Plane, image 8, is shown how the “solar” or back yard house is functioning now as a gas station because the current use of this space is for parking and mechanical workshops for official’s vehicles of the municipality. It is possible to see, in addition, the unstable line of slopes generating continuously a menace. In this order the local government has invested considerable money to avoid the collapse of the houses located there. The local planning office in Tunja classifies in a general way the zones in the city depending of the risk level and urban qualities themselves. These charts remark the necessity of intervene the immediate context of the Convent to ensure its conservation.

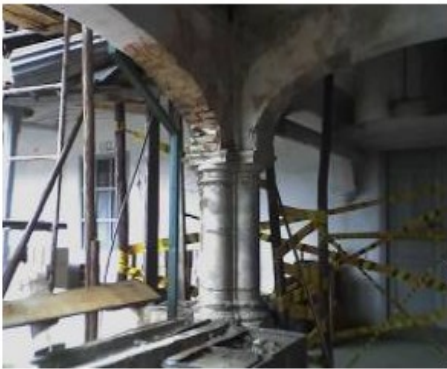
| VALUATION CHART 1 | | BUILDING <input type="checkbox"/> | MOVABLE GOOD <input type="checkbox"/> |
|--|--|---|---|
| <p>Para la cualificación de este inmueble se optó por una metodología que se desarrolla inicialmente con un levantamiento arquitectónico y poder dar la valoración y clasificación de la edificación teniendo como guía el Manual de Bienes Culturales del Ministerio de Cultura, Dirección de Patrimonio.</p> <p>Esta valoración se hizo bajo tres condiciones que corresponden a:</p> <p>Valor Histórico: El inmueble se relaciona frente a eventos socioeconómicos, políticos de la ciudad, región y país; como también las diferentes clases de sistema constructivos, las fotos muestran por los sistemas constructivos y materiales las diversas épocas de intervención.</p> <p>Fotos 7, 8, 9</p> <ul style="list-style-type: none"> * Pisos Republicanos (adaptados) * Pies derechos época diferente al Siglo XVI * La unión de columnas talladas que dan origen a la dirección de las crujías iniciales (Siglo XVI) | <p>Photo No. 7</p> <p>Photo No. 8</p> <p>Photo No. 9</p> | | |

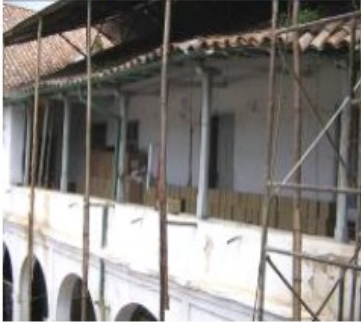
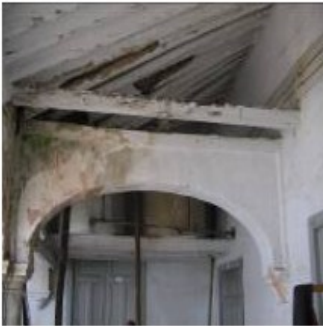
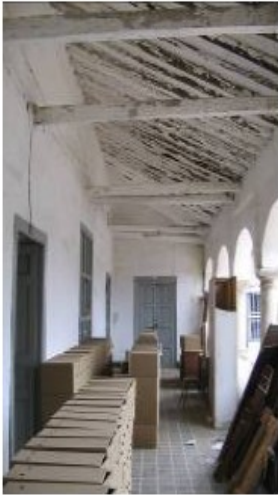
| VALUATION CHART 2 | | BUILDING | MOVABLE GOOD |
|--|--|---|---|
| <p>La Foto No. 10 muestra una época diferente a la inicial Siglo XVI en su galería occidental. Segundo piso donde su arcada es sustituida por un sistema estructural de pies derechos</p> <p>Su correspondencia en lo relacionado al remate de la cubierta por medio de canes sobre solera.</p> <p>La Foto No. 12 muestra el contraste del sistema de la cubierta con los pisos republicanos y una carpintería de madera diferente a la inicial.</p> | | <p>Photo No. 10</p> <p>Photo No. 11</p> <p>Photo No. 12</p> | |

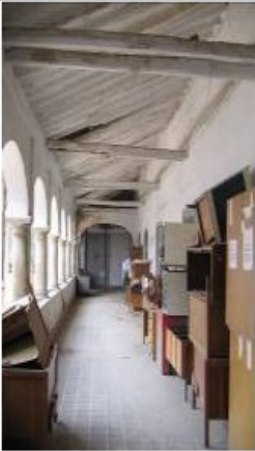
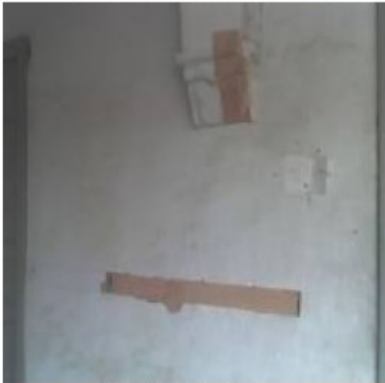
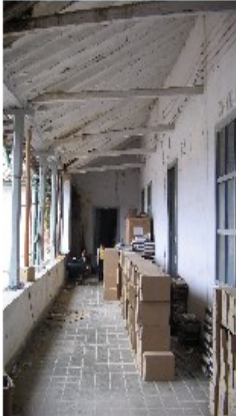
| VALUATION CHART 3 | | BUILDING | MOVABLE GOOD |
|--|--|--|---|
| <p>AESTHETIC VALUE:</p> <p>Foto No. 13: contempla a la proyección de la cubierta para formar la galería oriental; se destaca su proporción y la correspondencia entre espacios construidos y espacios libres como el Patio Central.</p> <p>Foto No. 14: Corrobora la existencia de pintura mural (proceso de calas) que como expresión pictórica ayuda al concepto del valor estético del inmueble.</p> | | <p>Photo No. 13</p> | |

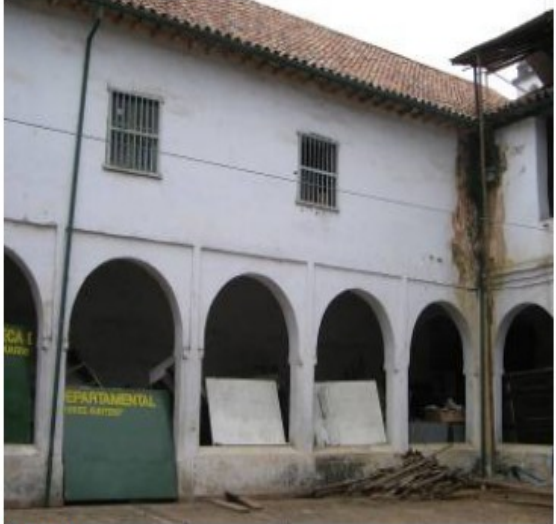
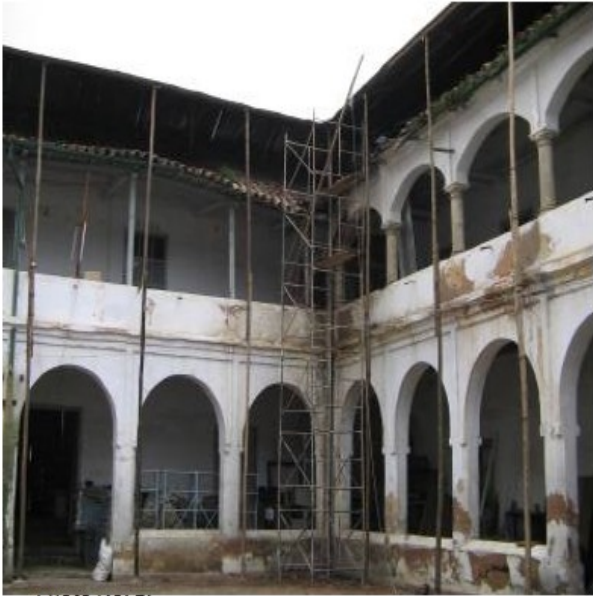
| VALUATION CHART 3 | | BUILDING | MOVABLE GOOD |
|--|--|---|---|
| VALUATION CRITERIA | | <p>Photo No. 16</p> | |
| <p>SYMBOLIC VALUE: Se tiene en cuenta el valor histórico, valor estético y la aceptación por parte de la comunidad respecto al inmueble. Esta aceptación se puede sintetizar en:S</p> | | | |
| <p>INSTITUTIONAL VALUE: El edificio se adaptó a espacios característicos institucionales como Colegios y Hospitales, los cuales fueron aceptados por la comunidad</p> | | | |

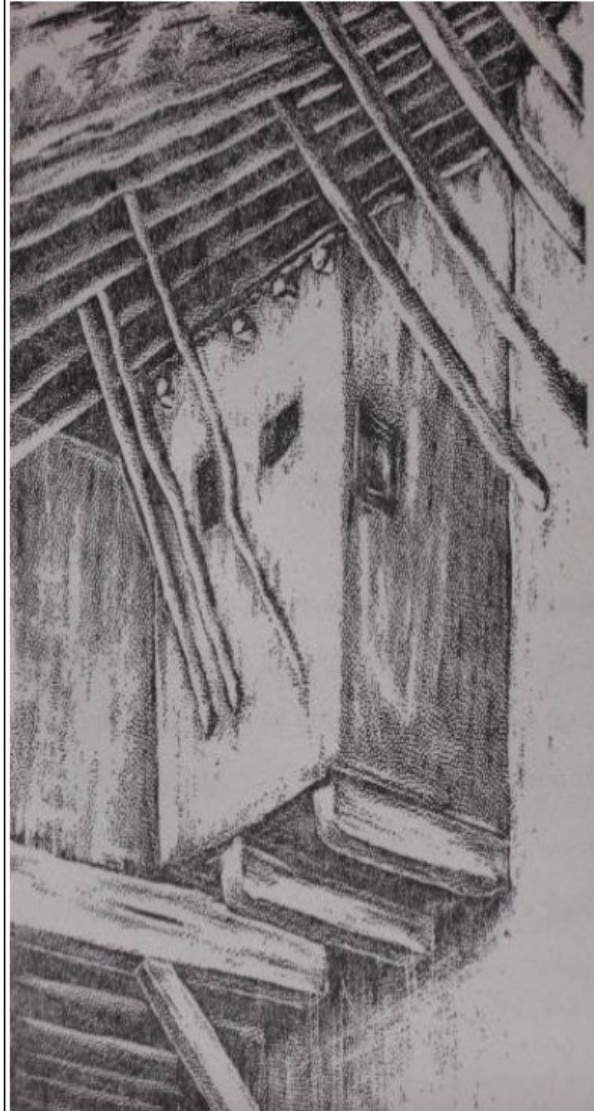
The Photo No. 18 shows the jail perspective of Sor Josefa del Castillo y Guevara; this space is not related with the convent but reflect the symbol of one of the rooms belong to him, the same who influence the Colombian literature and commonly related for the people as symbol of the colombian literature.
