***PROJECT: RESTORATION, UPGARADING &
MAITANANCE PLAN FOR LAMU MUSEUM***

FINAL REPORT – march 2010

*Compiled & Presented by; Alex K. Jimbi – Conservation Officer &
Architect, Lamu World Heritage & Conservation Department-Kenya*

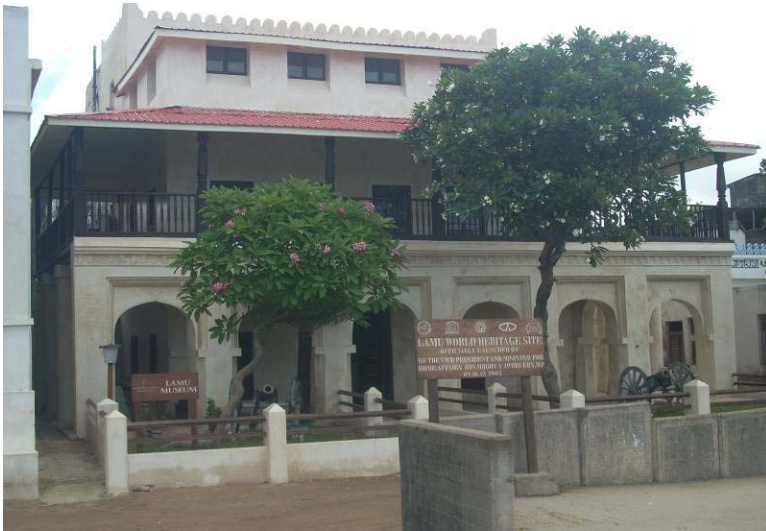
has coral wall approximate 500mm thick bonded in lime Mortar mix.

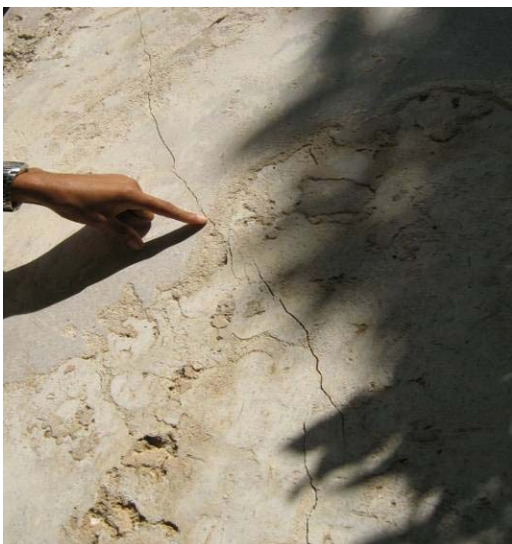
Despite the massive thickness of the walls some traces of water infiltration and environmental factors such as weather has posed serious threats to both the interior and exterior finish of the structure.

It is also notable that wind and rain splashing against the walls erode plaster surfaces.

Cracks on wall surface.

Minor cracks on the wall surface were stitched and replastered with a mix of lime and white cement.

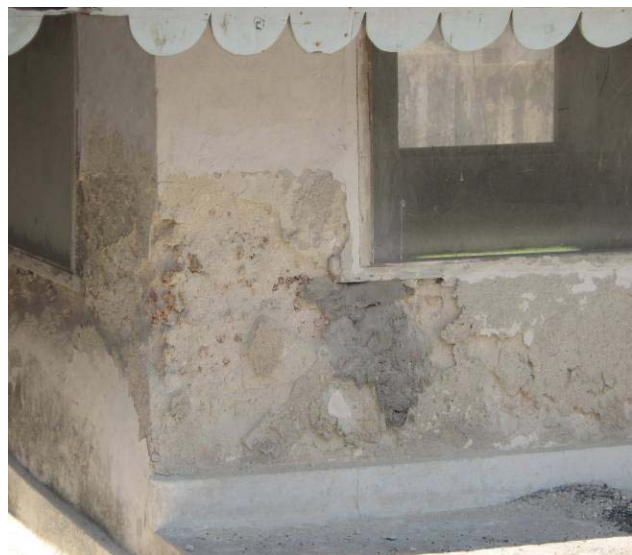
Improper applied plaster hastened the deterioration and eventual plaster has crumbled off leaving masonry core walls exposed.

Deteriorated plaster work

The construction materials of the museum (coral, lime) plaster which had deteriorated over time was hacked off and comprehensive work done by replacing new plaster and finished smooth with white cement.

The interior plaster was peeling off as a result of poor workmanship and use of inappropriate plaster ratio was completely removed and new plaster of lime and white cement replaced.

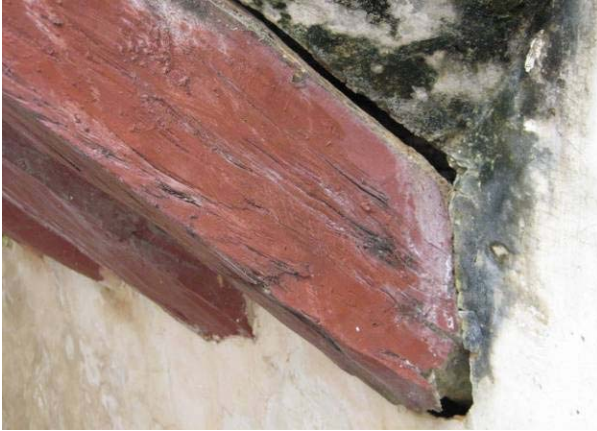
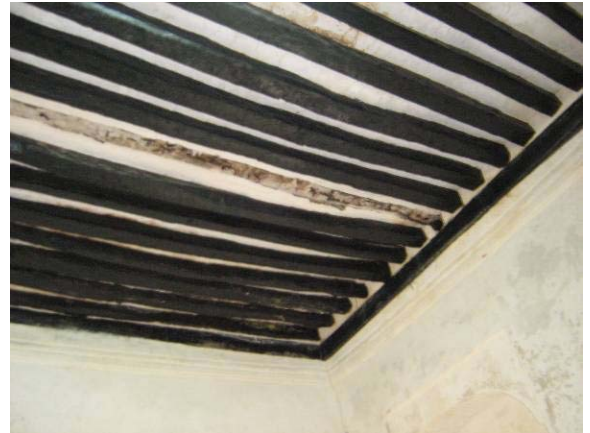
Most of the hardwood beams are still intact on the first floor however at the second floor most of the beams are affected and decayed as a result of inadequate slope and cracked plaster finish of the roof where water permeate and seeps into the masonry creating damp conditions at the end of wooden joists.

Moisture surfaces under stairs.
Rotten wooden ceiling joists.

All affected and decayed ceiling joists had to be replaced with sawn and treated wooden joists.

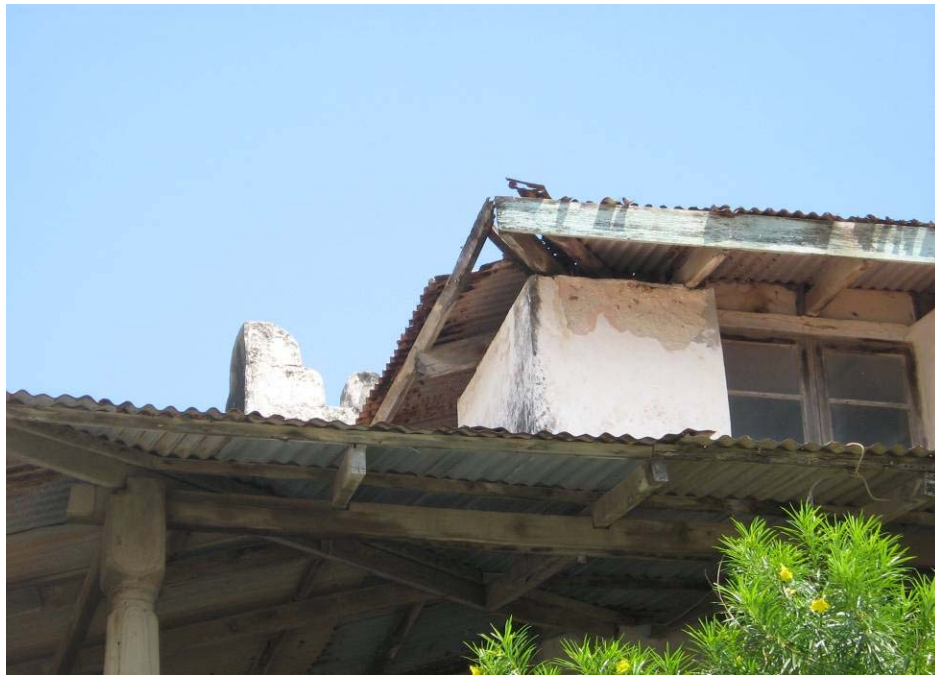
Roofing sheets covering the wooden balcony at first and second floor were rusted due to the harsh climate from the sea.

Corroded iron sheets and rafters attacked by termites and humid.

The entire roof covering balcony at first floor was leaking and also the timber supports had been affected by termites and suffered effects of dry rot due to alternate periods of wet and dryness.

All roofing sheets and wooden rafters were replaced and treated with wood preservatives.

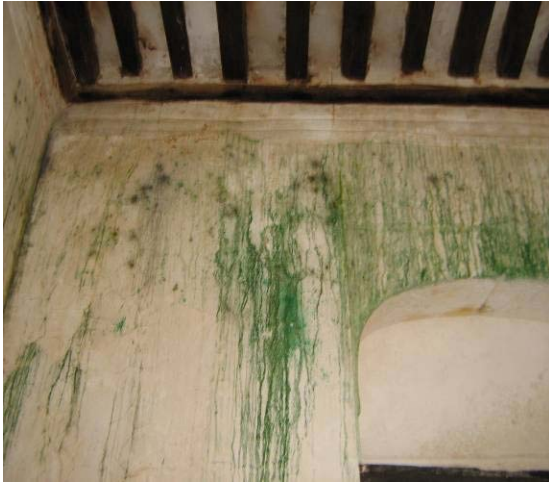
Poor drainage had also affected the floors and stained the walls due to dampness infiltrating into the building at floor slab level. Also rainwater pipes and spouts were missing in some places.

Stained walls due to infiltration.

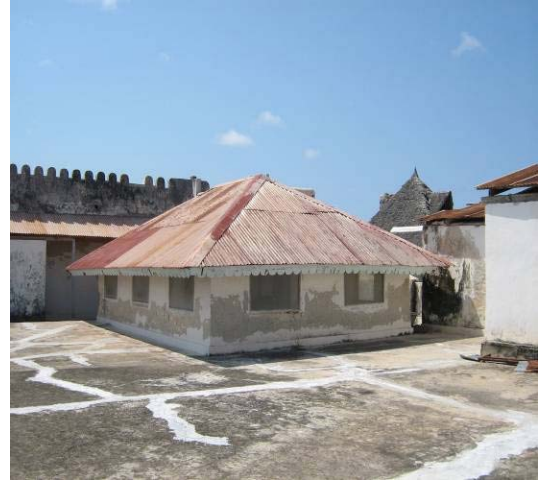
Cracks on the second floor slab.

The floor cracks was scraped off completely and replaced with new cement sand screed.

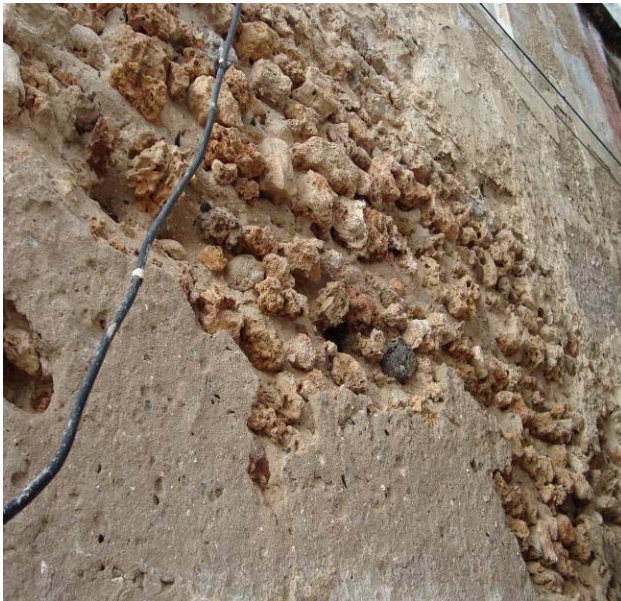
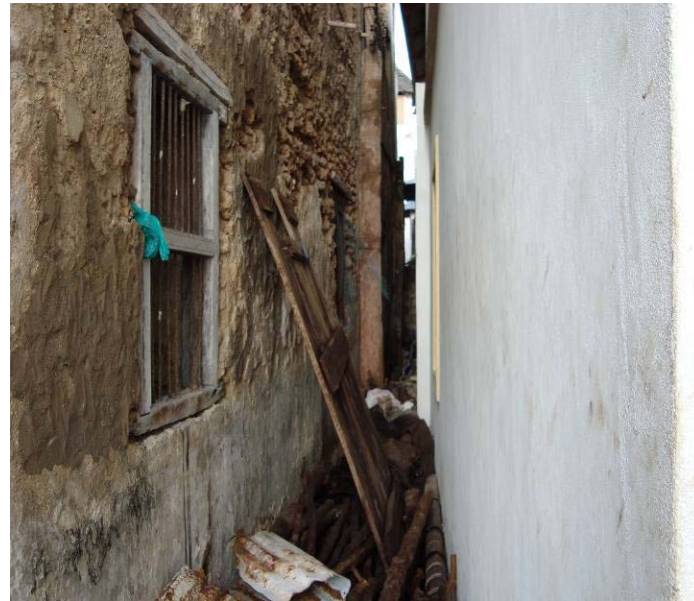
In general the structural components of the entire building are not badly damaged; however both the interior and exterior plaster work has deteriorated due to age and also environmental conditions leaving the core walls exposed.

Deteriorated plaster work on the exterior walls

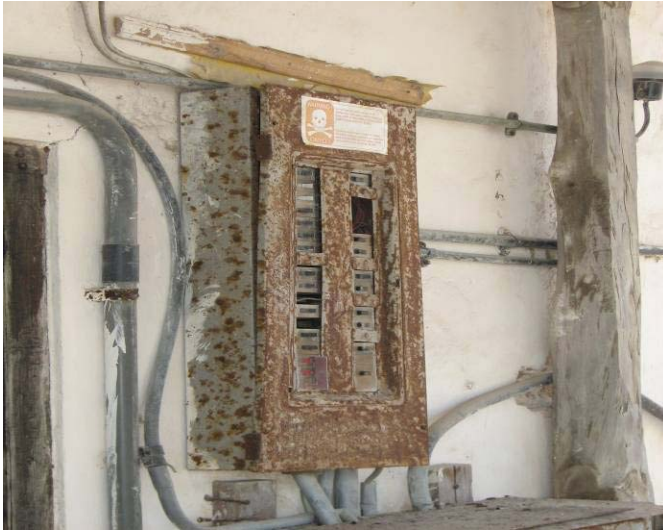
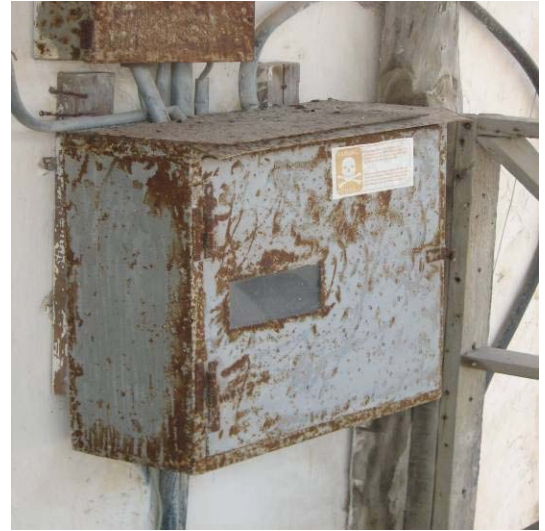
The electricity facilities and ducts are exposed in a disordered manner. Some of the cables are hanging loose on the wall surfaces.

There is no sufficient lighting system in the entire building, making some of the unventilated exhibition spaces humid and dark even during the day.

Control load unit centre

Most of the electrical works had not been properly done initial. It was decided to redo the entire electrical conduit and all overhanging cables embedded inside the walls.

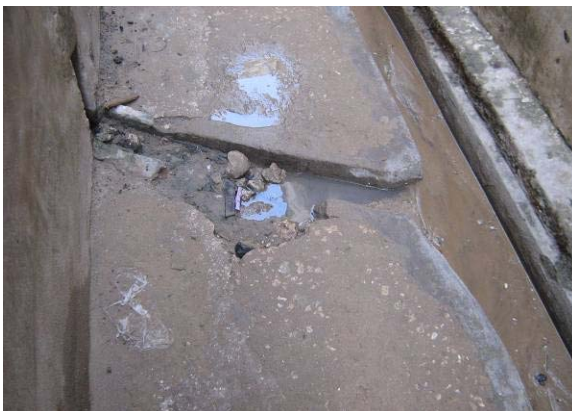
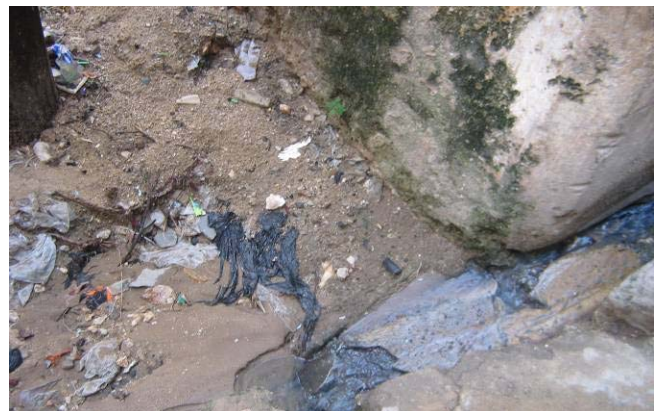
The surrounding site is unkempt with offensive dirty materials and also on one side there is a blocked open drain which has poor slope thus causing unnecessary blockage and stagnation of grey water on the pavement.

The front garden requires some leveling and landscaping has to be upgraded, also the main entrance to the museum building has to be raised and paved with cabro blocks.

The drain was cleaned and reconstructed; also its slope was adjusted for easy flow of grey water and rain water collected by rain gutters from the roof.

Initial the entire surrounding was unkempt with the garden also not properly landscaped. The overgrown trees and grass was dressed and new lights installed. the pavements were also cleaned and repaved .
