Revival of the Swahili Built Heritage Along The Kenyan Coast

Case Study of The Dheulle Mosque

Mohammed Ali Mwenje

National Museums of Kenya –Lamu World Heritage Site
and Conservation Office .

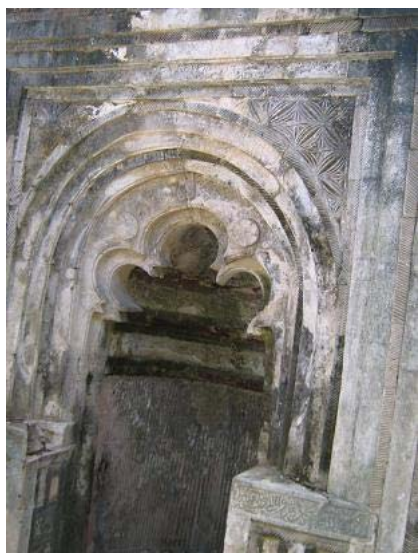
Plate 5. mihrab of the dheulle mosque

The Mihrab is in a seriously dilapidated condition. In 1975 the Lamu Museum cleared the mosque of vegetation and restored the broken mihrab(NMK Records) .A number of clinical restoration exercises have since been undertaken but have not been sufficient as to prevent the accelerated rate of decay of the mihrab.

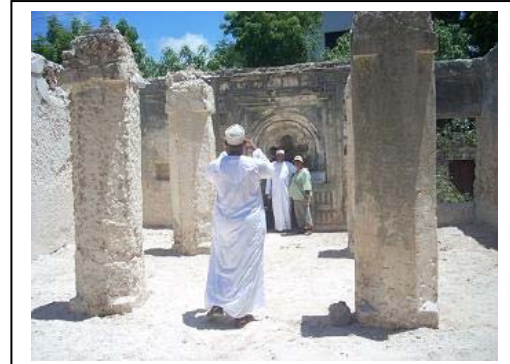
PLATE 7:The mosques traditional roof was seriously dilapidated and had to be reconstructed anew using the traditional techniques and materials

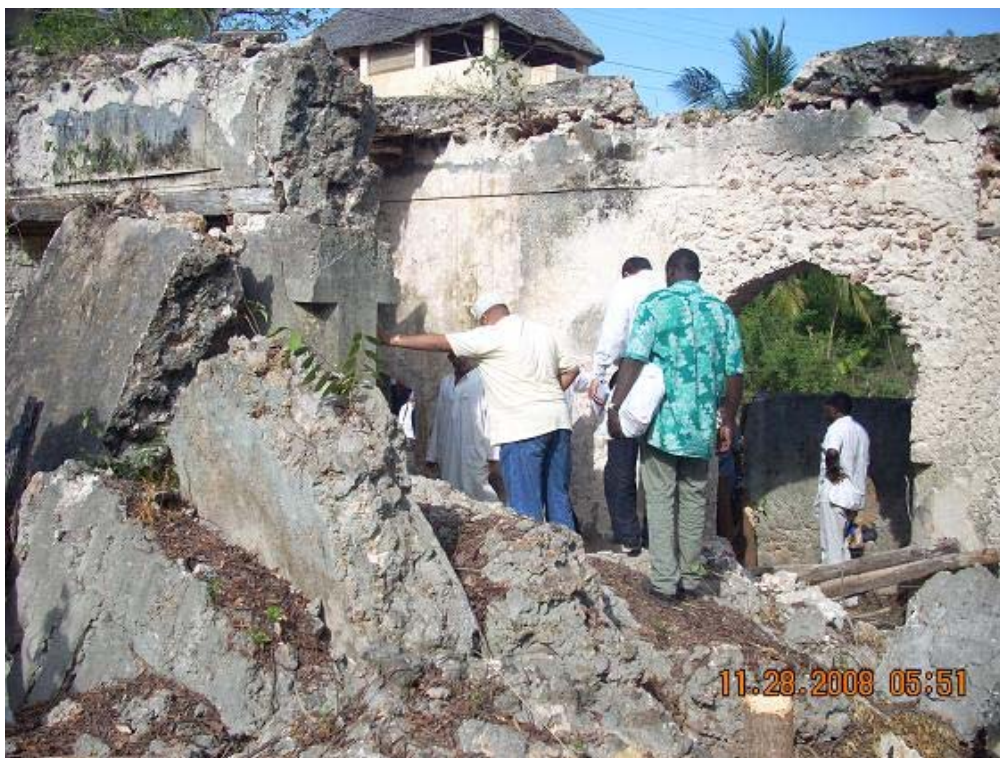
Plate 10 The roof of the mosque had completed collapse and was earmarked for complete reconstruction

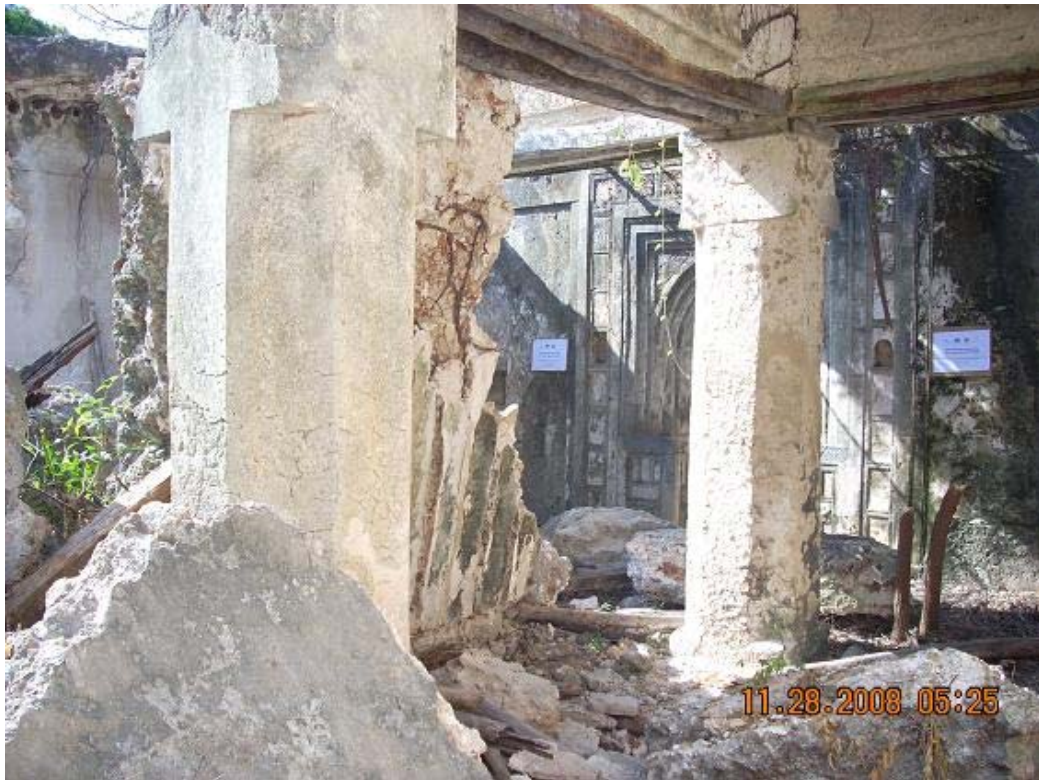
Plate 11.Interior of the mosque before rubble from the collapsed roof was removed

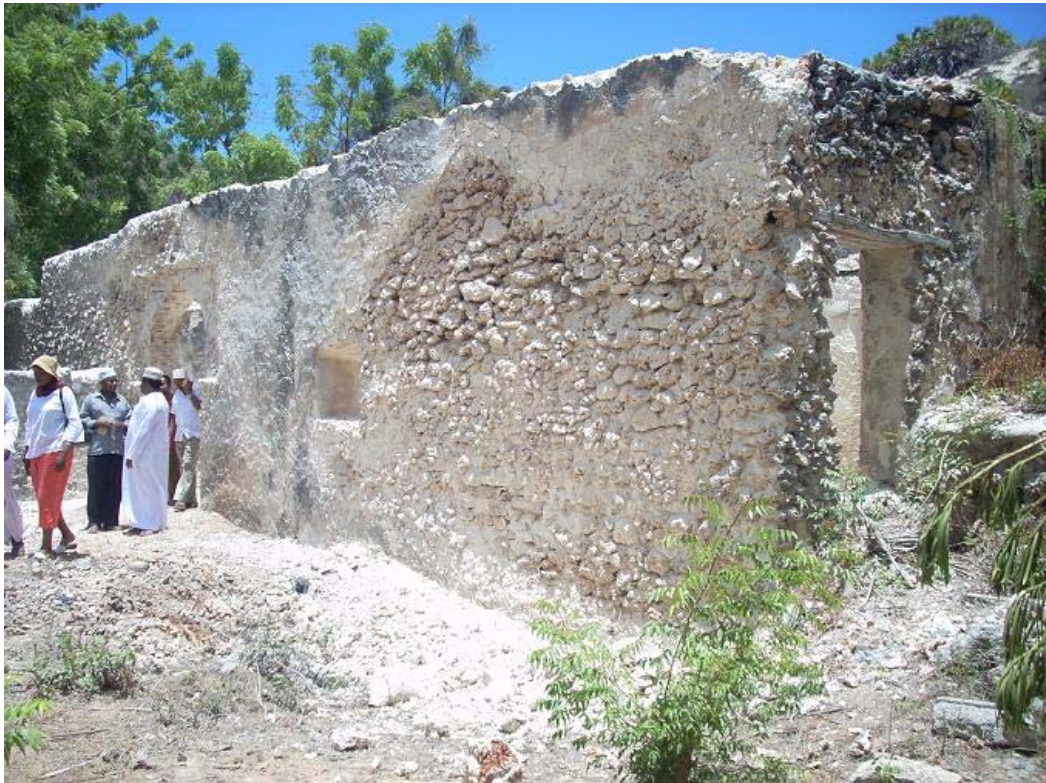
Plate 13. Eastern façade of the mosque as work commenced

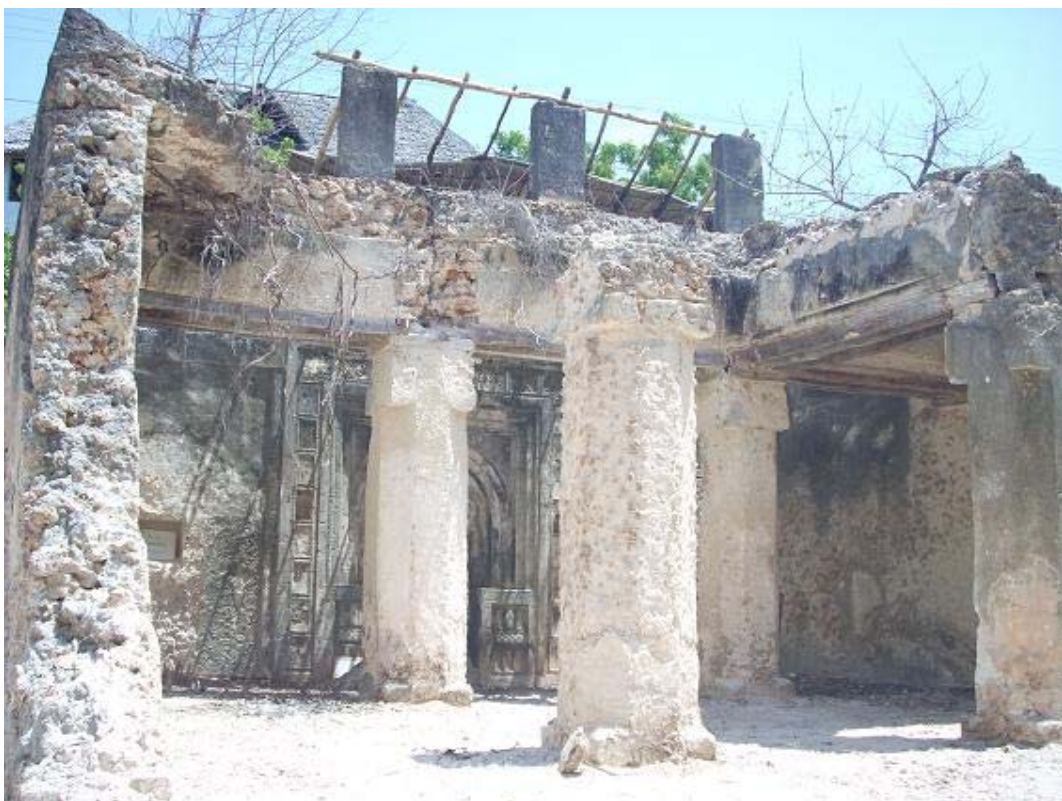
Plate 14. Interior of the mosque .many components of the roof structure had been extensively damaged and needed to be replaced

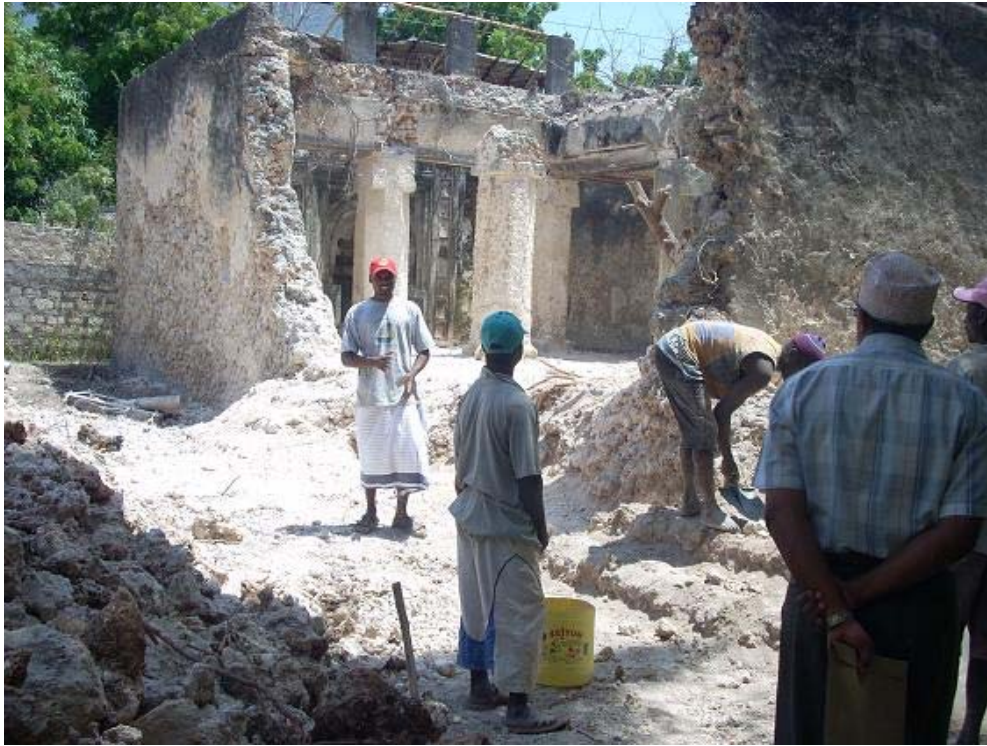
Plate 15. Western façade before reconstruction

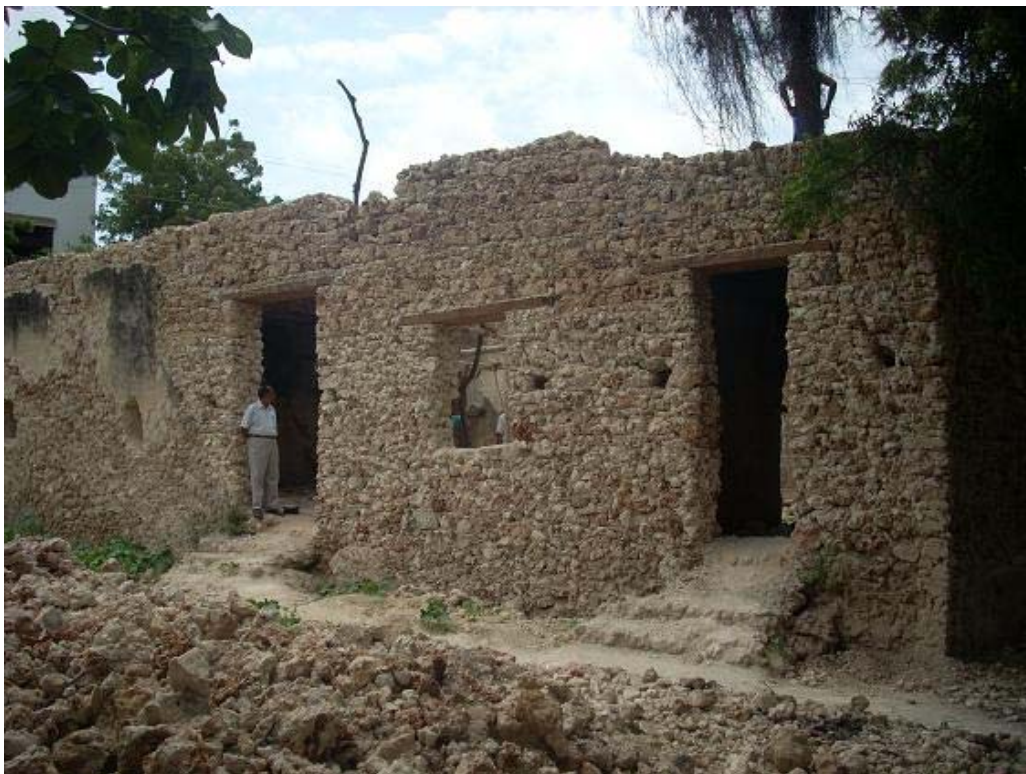
Plate 16. Western façade after reconstruction

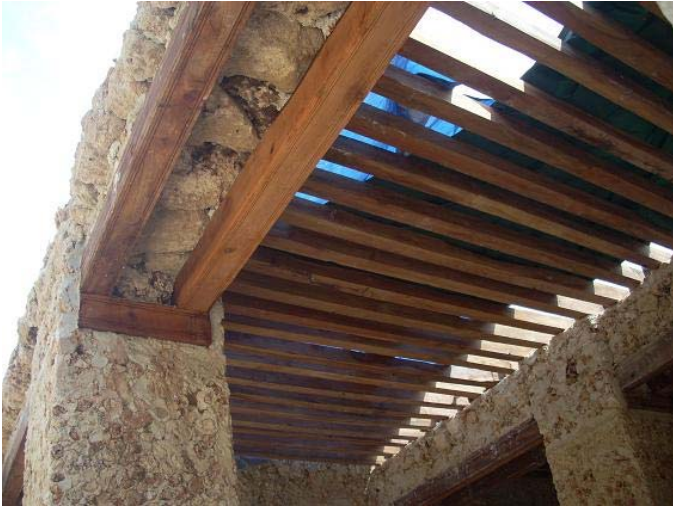
Plate 17. shows the laying of timber ceiling joists of the same material and shape as the original. the joists are supported by intermediate composite beams of coral rag pices bonded in lamu mortar and set on timber members . the timber members will be painted with linseed oil

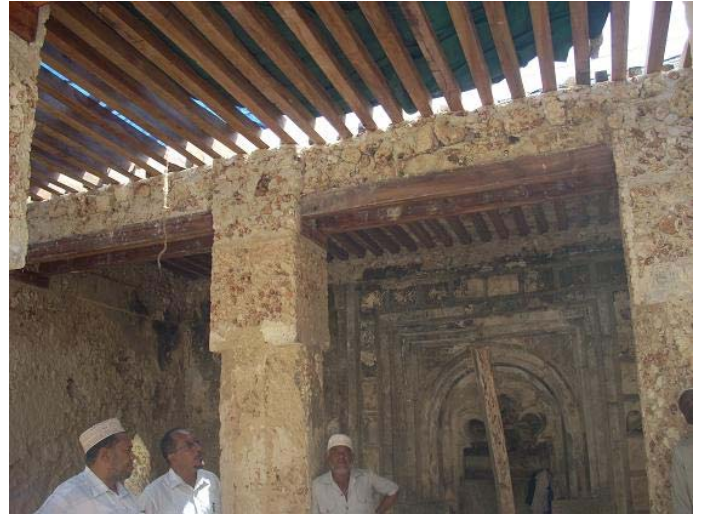
Plate 18. the timer members forming the roof structure can last for decades and can be replaced at will using tradional techniques. the restoration project provided the community with an arena in which traditional skills were exchanged from the master craftsmen to the younger generation

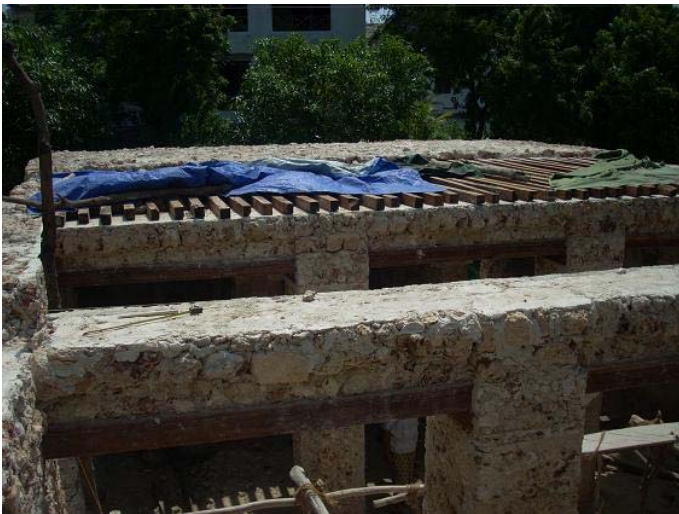
Plate 19. showsthe reconstruction of the roof structure from the top . coral rag pieces will then be laid on top of the timber members and then covered with a layer of lean concrete to form the topping slab. if well maintained this kind of construction can last for generations as evidenced in the stone town of lamu.

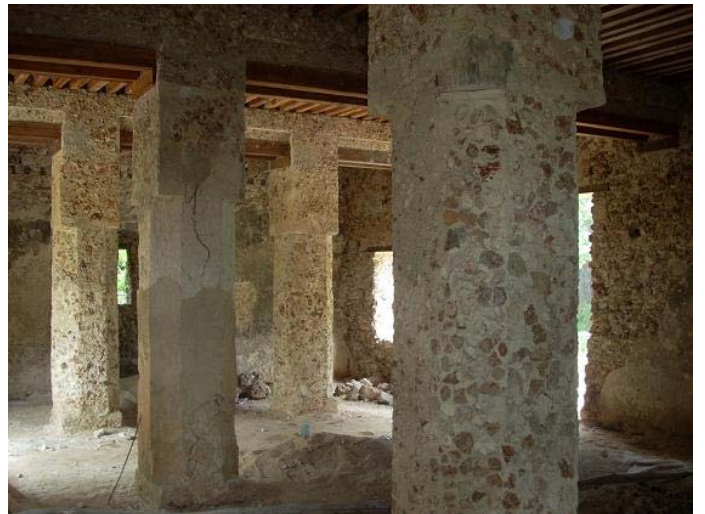
Plate 20. shows the interior of the mosque after the entire ceiling/roof slab has been reconstructed. the octagonal shaped columns were also repired using pebble dash to restore their original shape.

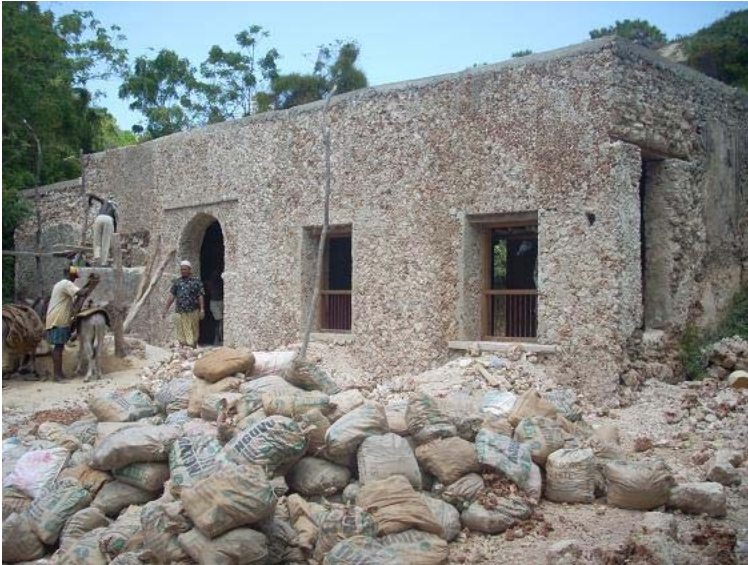
Plate 21: shows the rehabilitated eastern façade .new window openings had to be introduced to improve the air circulation and lighting inside the mosque.

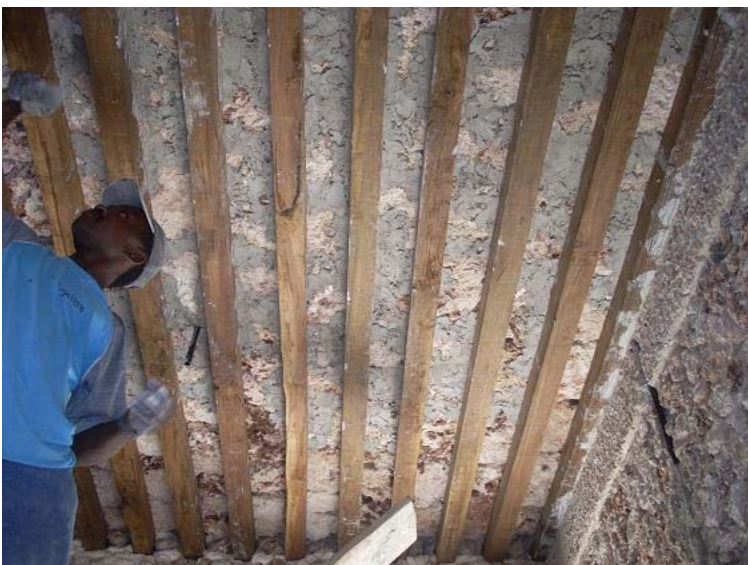
Plate 23. filling the joints of the coral rag bed laid over the timber ceiling joists. this is the traditional technique used in constructing suspended floors in Swahili buildings.

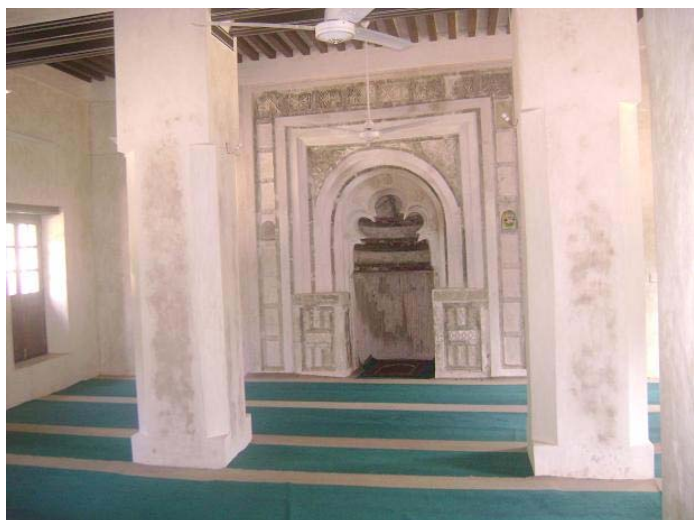
Plate 24.shows the restored interior of the mosque.

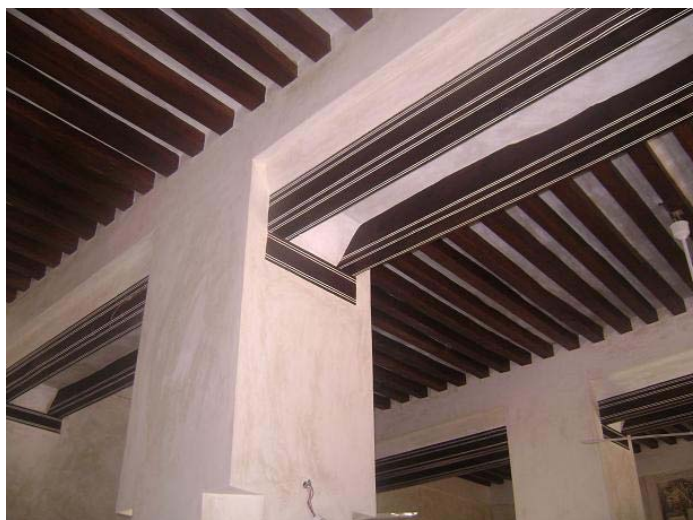
Plate 25.reconstructed roof slab of the mosque.this was the only component to be fully rebuilt.

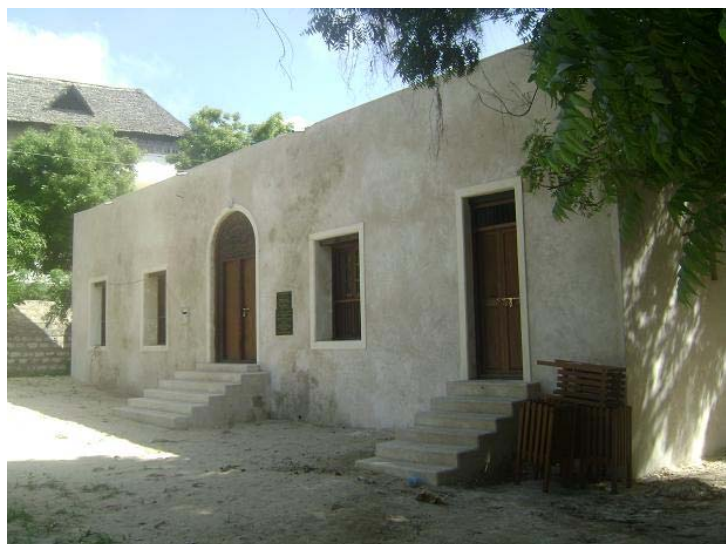
Plate 26.the rehabilitated western facade

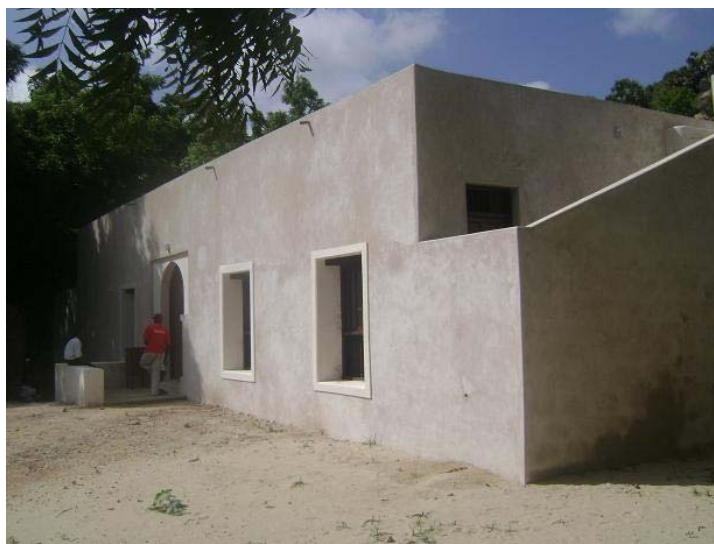
Plate 27.the rehabilitated eastern façade
