*Deepak Pant*

Conservation and Management of Historic Buildings  
Advanced International Programme  
Lund University 2009/10.

# Restoration of 17<sup>th</sup> century Royal Residence in Patan, Nepal– some issues and challenges.

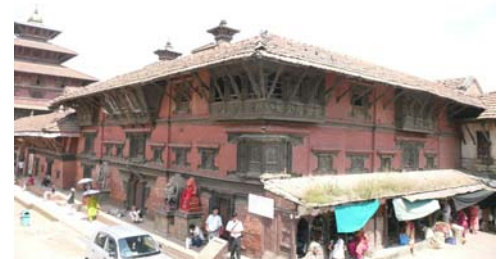
Fig-3

View of Sundarichowk

The Sundari Chowk, which means literally the “beautiful courtyard” is situated strategically at the public square forming a southern edge of the Palace complex. The palace complex of Patan or the Patan Durbar is formed by three principle courtyards Manikeshav Narayan Chowk, Mul Chowk and the Sundari Chowk which was built over a period of about 100 years. The Sundari Chowk was constructed by the king Siddhinarasimha as an extension of the palace complex for the purpose of his residence. But the king who is so responsible for the arts and architecture of the country had quite an unusual but very interesting life style of his own. He had a long life of 104 years, which is perhaps the longest in the history of kings in Nepal. In his long life he had three distinct phases; the king, the sage and the *sanyashi*. Since his third stage i.e. *sanyashi* was the stage in which he had completely relinquished his worldly affairs and went away from the society, nothing had been known so far except his death. He served the nation as a king for 41 years (1619-1660 AD). Then he placed his son Srinivas Malla into the thorn and stayed in the palace for a period over 20 years leading a life of a sage. He was a man of religious disposition. He is known for the favorite of the Lord Krishna, the master of yoga, the chief of poets, the relinquisher of the world and ultimately the jivan- mukta (having obtained salvation while still on earth). It is the building where an extraordinary king had spent most of his time both as a king and the sage. So, any effort for the restoration of this building demands the study of the life history of the king and his process of revitalizing the city square.

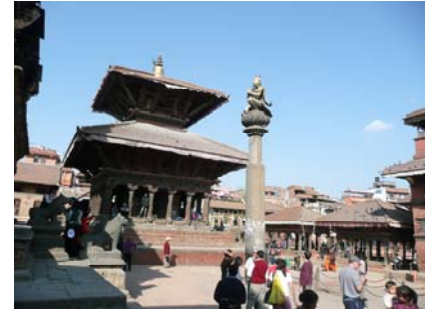
Fig-4, source:author

The temple of *Visvesvara* is an earliest surviving structure that *King Siddhinarasimha Malla* has built in 1627 AD when he was at the age 21 (fig.-4).

View of temple of *Visvesvara*

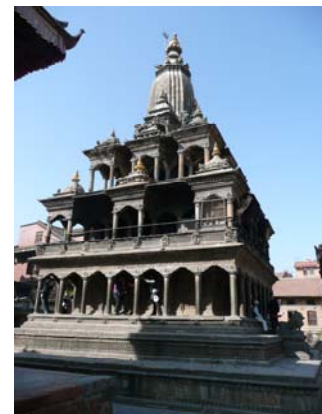
Fig-5, source:author

In 1637 AD, ten years after the construction of the temple of *Visvesvara* the king constructed another temple dedicating to the lord *Krishna* (fig.-5). By then the king must have been an age of 31 years. The temple can also be taken as an expression of fully grown up person as well as the king. As a person he was well known for the devotee of lord *Krishna*. But in the same time he had not lost the faith on the *Lord Shiva*. That dualism of him has found to be ingeniously addressed with the concept of multi shrined temple. Which means it is

View of *Krishna* temple

the shrine where we can find the image of Lord Krishna in one level and that of Shiva in another level.

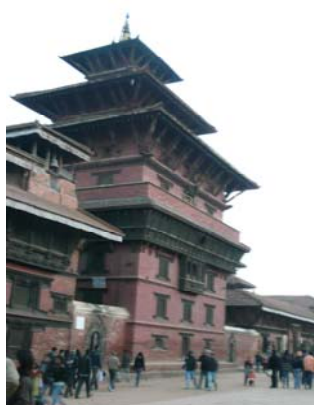
Fig-6, source:author  
View of Degutale temple

In NS 761 (1641 AD), the king builds the temple of Degutale to please his clan goddess Parvati (fig.-6). According to the inscription, it was grand a temple of five tiered roof and pinnacle of the jilted gold. The temple was destroyed by fire in his son's reign. The present temple is the structure of the post earthquake restoration after 1934.

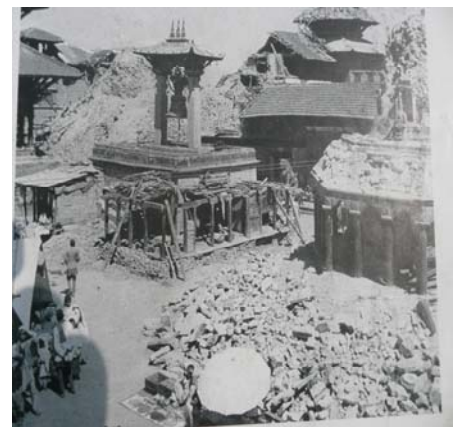
*Fig-8, source: book, Patan Durbar Square after 1934 earthquake.*

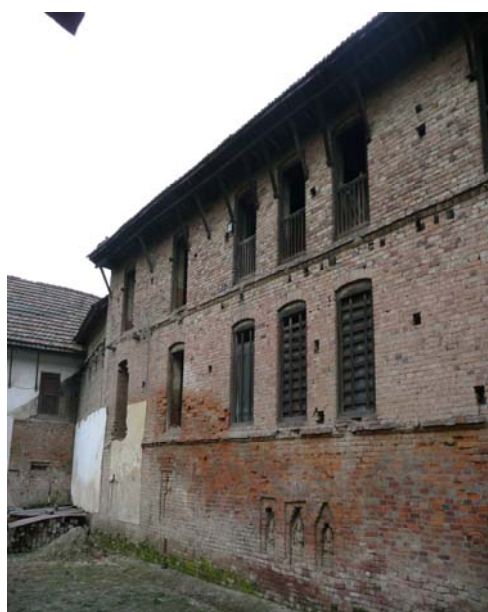
*Fig-11 source:author.  
Photo East Façade after restoration  
of 1934 earthquakeside the  
courtyard*

There is a great deal of works to be done but my current proposal is focussed on the eastern wing of the quadrangle. As mentioned earlier it was rebuilt after the earthquake of 1934. There are number of things which could be noted in this part. First of all, the east elevation which is facing the garden is contrasting sharply with the rest of the building in term of the use of materials and details, the facade composition, roof slope and overhangs. Its thick walls in south east corner which breaks the symmetry is also my particular interest to investigate them further. Although it is comparatively newer part but physically it is quite vulnerable. The ground level at this façade is about 60 cm higher than the internal floor level. So, the ground floor wall is highly affected by damp. The roof is leaking and some of its parts is at the verge of collapse. The windows are without the shutters.

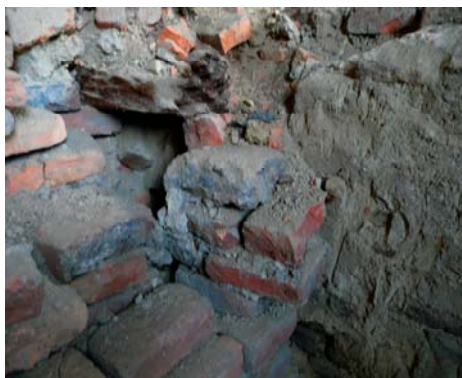
*Fig-14 source:author.*

On south east corner of the palace, a abandoned space filled with clay and debris in its investigation in the side there found to be two room surrounded by thick walls around and the north wall was blackened its bricks are over burnt (fig.-14). This space in Vastupurasa mandala falls under *Agni*, the god of fire. Those two rooms may be the most possible spaces where the used to meditate under intense heat created by fire during the summer time. Being filled with clay and abandoned for long it still retains originality in some parts.

*Photo showing remains of burnt brick in earth filled room*

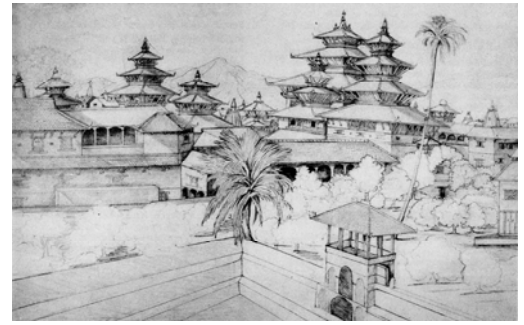
**Evidences- Pencil sketch of 18844 and oil painting 1854 AD;** Most of the paintings and photographs available of this building are facing towards the public square and nothing from the back . But interestingly there are two photographs of late 19<sup>th</sup> century sketch and painting from the collection of Hudgson collection of Royal Asiatic Society(fig.-15), and British library London are published by KVPT in their report. The pencil sketch made about 10 years earlier than the painting both of them do have a colonated bay at the centre of the second floor. Both of them provide the evidence of being a small open terrace facing toward the garden. The similar example of colonated bay can also be found in northern part of the same palace complex (fig.-14). So, the small terrace at the second floor may be the best conjectured space where the king must have sit whether that was the real event or dream or even the hallucination. They may be helpful for the conjecture of the elevation facing the garden. It will have a great mythic or a story telling value.

Fig-15, source:KVPT. Old Sketch(1844AD)Hodgson collection,Royal Asiatic Sociatic Society,UK

- iii. The second floor is the conjecture based on the 19<sup>th</sup> century painting and the pencil sketch (fig.-15) However certain adjustment has been made to maintain the symmetry as relationship with the rest of the floor(fig.-16,17). Its colonnaded bay will not only provide the best view of the garden but also be a great story telling space.
