**Conservation and Management of Historic
Advanced International Training Program 2009/2010**

Conservation & Maintenance plan of Tippu Tip House
in Stone Town of Zanzibar

Dr Muhammad Juma

March 2010

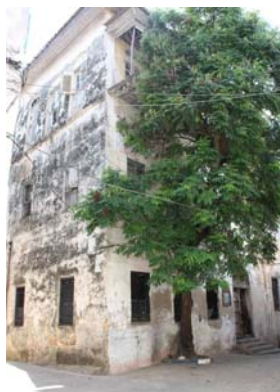
Figure 5 Tippu Tip House

Tippu Tip house is a typical 19th Swahili architecture composed of a mixture of architectural features of Arab, Indian and European influences. It is a four floors building with two entrances, a balcony, a terrace view facing east, and a tearoom on the top floor. It has been constructed with coralline lime stones, lime mortars and decorated with timber in ceilings and occasionally over openings. The building meets the definition of historic building.⁷

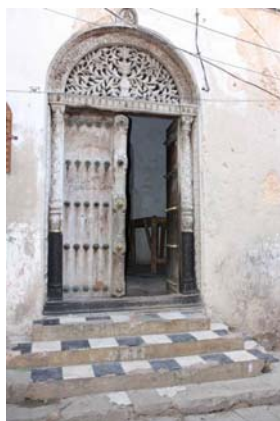
Figure 6 Door of Tippu Tip house

As per conservation and development Master plan of 1994, Tippu Tip house is one among the 26-gazetted monuments and Sites of Stone town. Therefore, it is protected by conservation Act and regulations of 1994⁸. The building demonstrates very well the 19th and 20th century Europe's influence in Swahili architecture. For example, its second floor of the building is an additional storey with big metal windows to let more light and ventilation. It has also a teahouse and a balcony that became popular in the late 19th century. The door of Tippu Tip house is among the most beautiful pieces of art of craft in Zanzibar (fig.6).

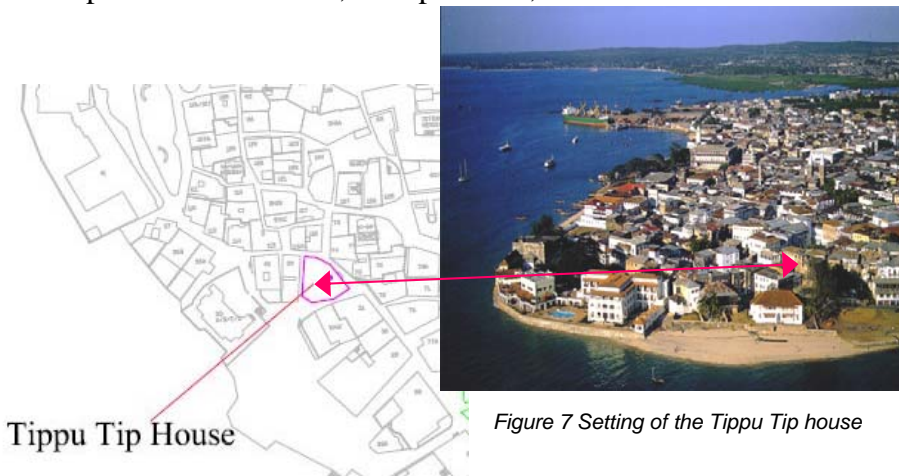
Figure 7 Setting of the Tippu Tip house

Located in the most touristic areas of the town, this historic building has also acquired an economic value. This is because important hotels, touristic shops, and touristic areas are located in Shangani zone. For its setting (fig 7), spatial configuration, and context the building has economic opportunities, as well as challenges and pressure of development from visitors, entrepreneurs, and vandalism.

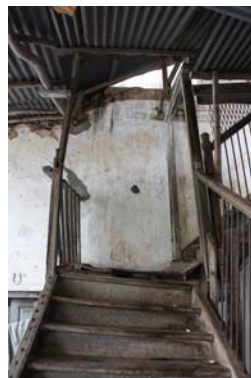
Figure 8 Stair in very poor condition

The change of uses from the single-family resident to multi-families apartment house has affected considerably the building. It is so because the building was not prepared for such changes of uses. Services areas used by one family are now serving more than 10 families; consequently, the building takes extra pressure. The poor condition of stair (fig. 8), toilets, and cooking areas prove this situation. They are the most deteriorate and damaged parts of the building because of the over uses.

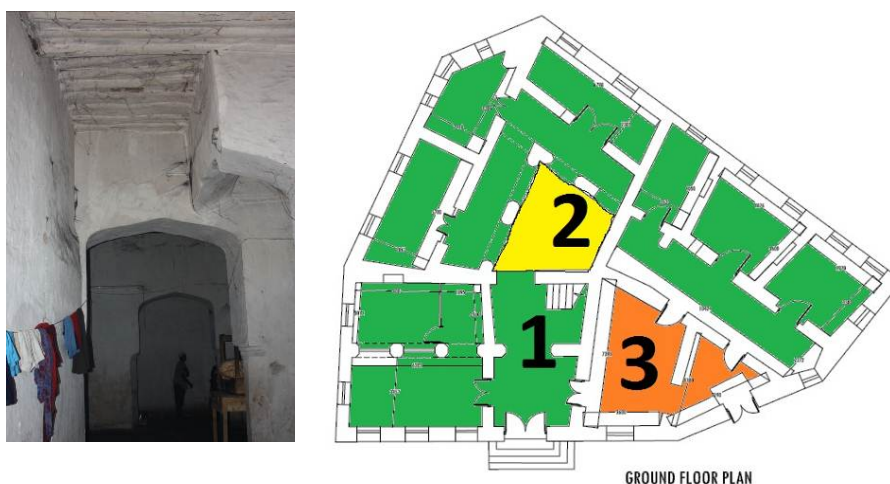
Figure 9a The remaining of the trimmed arch. Fig 9b Two new spaces: numbers 2 and 3

The inspection on ground floor reveals the extent of first intervention. Arches on this floor were trimmed to remove the original stair (fig.9a) and to abandon the courtyard, consequently new spaces 2 and 3 (fig. 9b) were created:

1. Original design areas and its structures
2. Court yard which has abandon to create large hall on the second floor
3. A new space, which has been created to accommodate the only stair of the house.

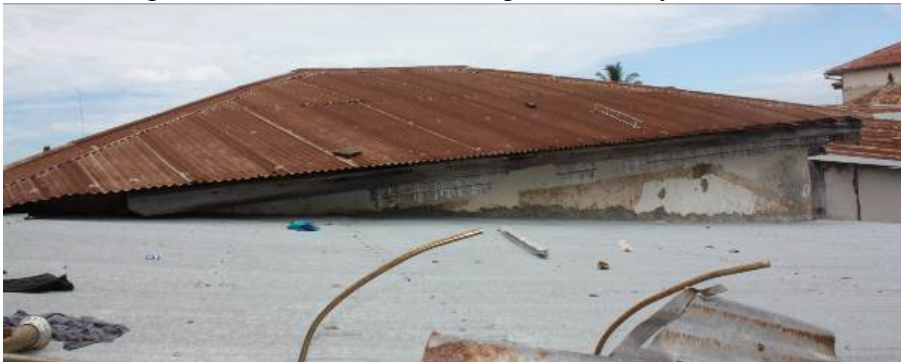
Figure 11 Changes on the original roof structure

The roof (fig. 11) shows also sign intervention where two roofs were combined to make one. The intervention enhanced the monumentality of the building, but deprived its two important elements, namely courtyard and original stair. For such kind of building, the courtyard is very important for air circulation and light. Today, the building is very dark in the ground floor and the existing stair is very small for its uses.

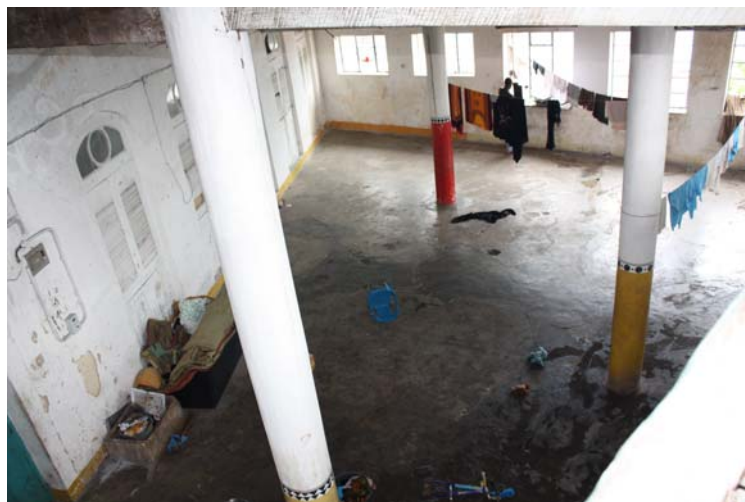
Figure 12
Living space
obtained
following the
intervention.

Definitely, the owner had had special reasons for such intervention that lead to abandon of the original stair and the courtyard. By analysing the spatial configuration of the building and its facilities, one can guess that Tippu Tip was found of the modernisation. It seems that the possibility of having modern house with spacious living area was very important. Physical inspection suggests that the owner changed the building to accommodate the then modern ideas of spacious living spaces (fig.12).

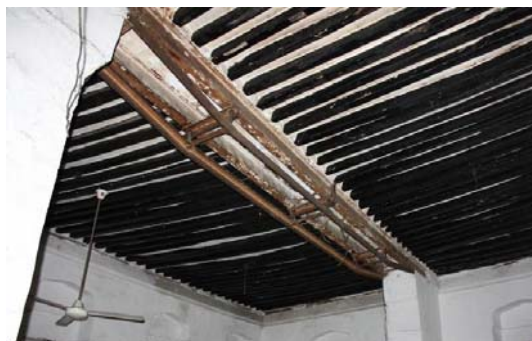
Figure 13 Metal structure to expand span

In fact, technical observation shows that the first intervention did not damage the building, but modified its form and aesthetic values. The changes were part of influence of the late 19th century on aesthetic, materials, and techniques of construction in Zanzibar, especially, steel material from Europe, and wooden technics from India. This is good example of the production of cultural artefact¹². In this building metal structures were used to expand the span of some rooms (fig. 13), and wooden balcony were added (Fig 14).

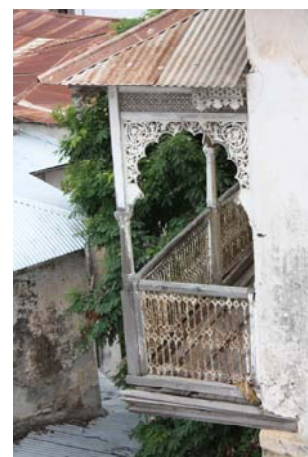
Figure 14 Balcony in bad condition

The interventions were huge but motivated by new functionalities, well accommodate by the users of the house. In fact, it is only through critical observation of the drawings and structure of the building that one can realise some of them. Even the cutting of the arches and the abandonment of the courtyard are not experienced openly. Furthermore, the intervention added new values, such as spacious spaces, teahouse, and balcony. The most important of all was that the building was well maintained.

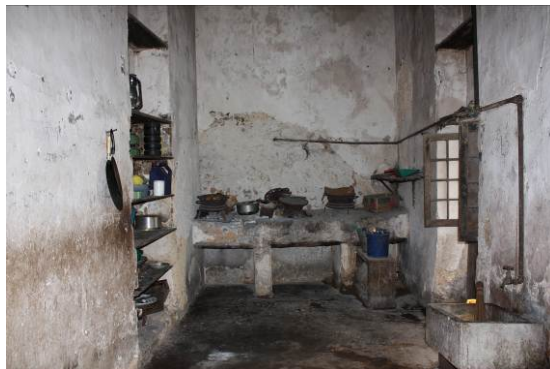
Figure 15 Cooking area introduce with new tenants

Following the revolution of 1964, and to accommodate new tenants, the building had new interventions. New services areas and many partitions were added to allow more families to leave together. The interventions were not properly designed. Services areas like wet and cooking areas (fig.15), were introduced inappropriately. With the time, they caused damages to the building. Lack of maintenance and of proper care have also affected the building seriously. In reality, the Tippu Tip house has become dangerous to its own tenants. However, the poverty and the lack accommodation in Stone town, force poor people to continuous use it every day.

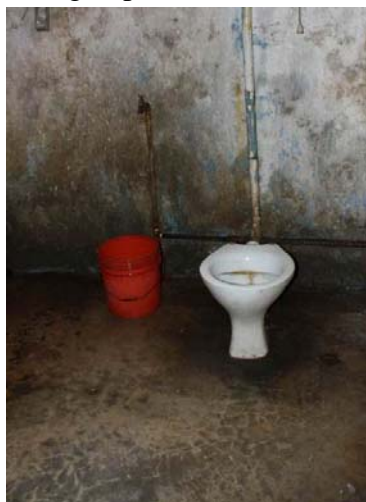
Figure 16 Typical situation of toilet

all services areas such as toilets (fig.16) is very bad. Technically, there is also a need to restore all services areas to function properly. The existing stair can no longer be used in such condition. The existing toilets need a complete renovation, quickly. Aesthetically, the lack of maintenance and care has finally damaged most important architectural features of the building. The actual situation of the balcony and teahouse is dangerous even to the pedestrians.

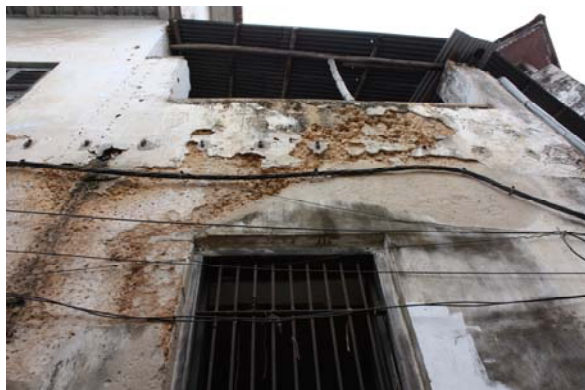
Figure 17 Condition of the wall inside the building

In Stone town, buildings are constructed with load bearing walls. Usually, the walls of first floor are larger compared to that of upper floors to allow the possibility of having extra floors. In average wall are of 70 cm. The technical situation of the walls of the building is not good. They may be structural stable but need a major repair (fig. 17).

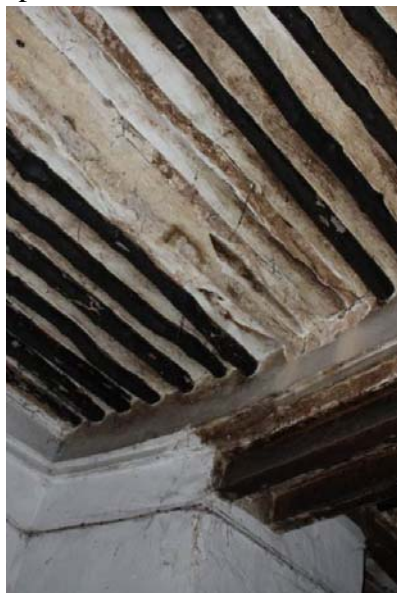
Figure 18 Slab with missing mangrove poles

One of the most important technique of the construction in Stone town is the uses of “mangrove pole” to hold stones slab. Before the availability of iron materials, all buildings were constructed with mangrove poles slab. This construction material has two weaknesses: its span capacity and its life span. Normally, mangrove pole cannot span a room of wider than 2.5 metre. The life span of this organic

material is also limited from 5 to 10 years, before replacement. Furthermore, under its regular life span, it needs regular monitoring to inspect its condition against insects and decaying. In Tippu Tip house, two types of slab materials have been used: mangrove poles and T-section cast-iron material (fig. 18). The iron materials have been used to increase the wideness of the room (fig. 13) but most of time, mangrove poles are the main materials.

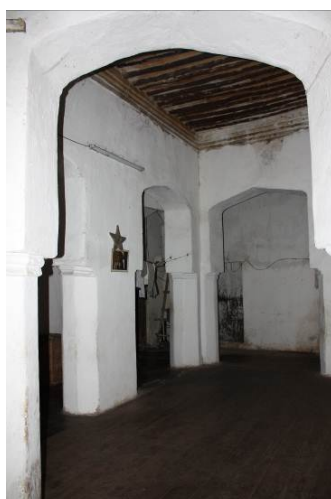
Figure 19 Arches opening, the photo shows also the courtyard, which has been abandoned to create a leaving space.

There are also two type of opening in the building. The normal opening for doors and windows and opening for arches. Door's and window's opening have not been affected. The arches are of good condition as well (fig 19).

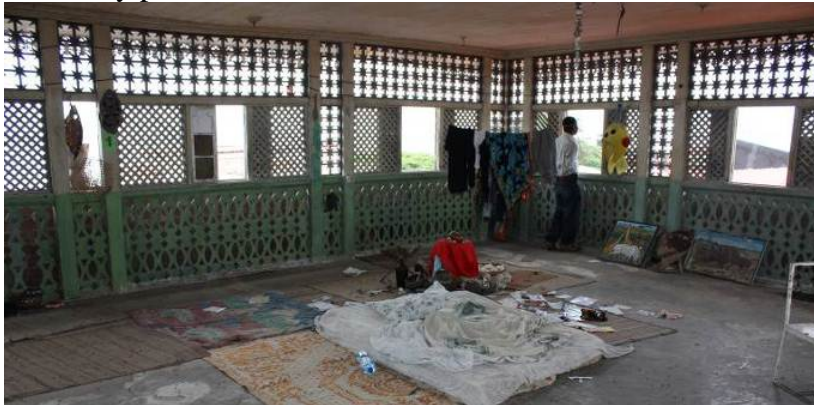
Figure 20 Teahouse used as a squatter

The most affected materials in the building are the timber elements. Door, windows, mangrove poles, stair, and balcony are all in very poor condition. These are also important features of the building for its aesthetic and artistic values, their poor condition affects the state of conservation of the building. The teahouse, which is also the important element of the building on top floor, is in timber. Yet the situation of the teahouse (fig 20), the front balcony, and the stair is of extremely poor condition.

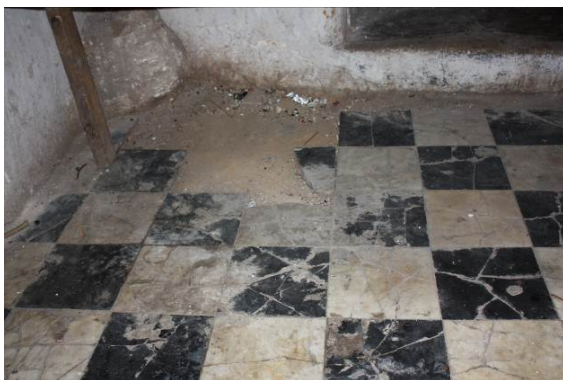
Figure 21 Original marbles in poor condition

Floor is of three types: marble, wooden floor, and lime floor. In the ground floor, the owner used black and white marble (fig 21), which used to be prestigious material of construction in his lifetime. The ground floor is in very bad condition. In the upper floors, there are also two kinds of materials: wood and lime. Wooden floor have been used in most important room, its condition is very bad. Today, lime floors are very rare in the building because they have been replaced with cement floor. They are also in bad condition.

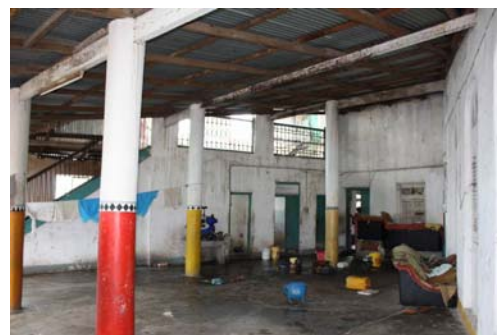
Figure 22 Leaving space uses as a kitchen

With the increase in number of the tenants, the number of kitchens has also increased. The absence of special areas located for cooking have pushed the tenants to uses other spaces such as corridors, for that purpose. This situation creates a danger and damage to the building (fig. 22)

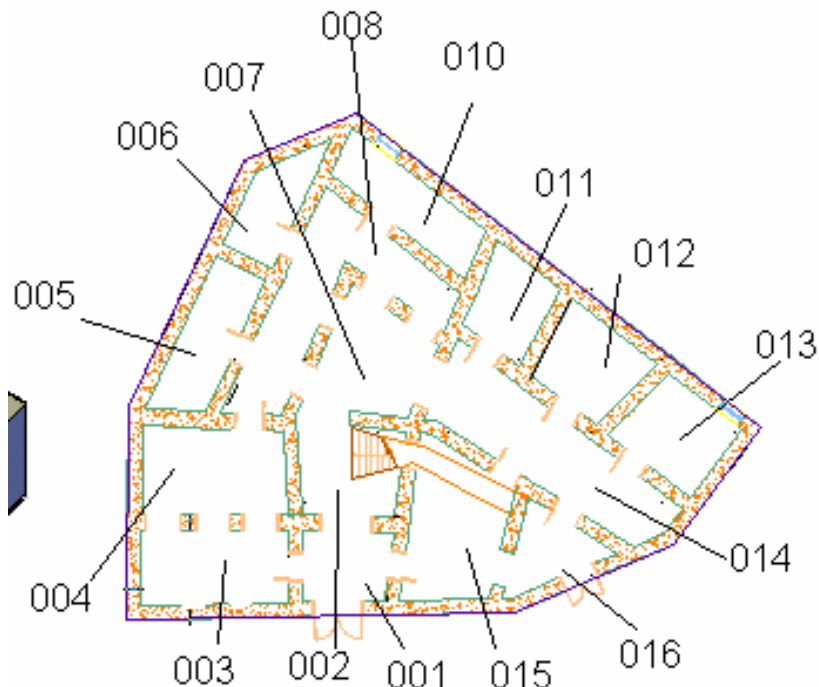
Figure 24. New proposal for the ground floor

Following public debate and discussion with different stakeholders, an idea of changing the uses of Tippu Tip house to a “Cultural Centre” was adapted. Although the new plan has sustainable strategies, it lacks financial resources for the conservation works needed. So far, the government is discussing on how to finance the proposed idea (fig. 24)

Space	Facilities in the ground floor (fig. 24)
001	Entrance of the building
002	Entrance hall
003-004	Part of the Museum for Slave history in Zanzibar
005	Office area
006	Court yard which has been changed by the owner will be reintroduced
007	Court yard area for circulation
008	Temporary exhibition spaces
010-013	Part of the Museum
014	Part of the Museum
015	Shop
016	Exit

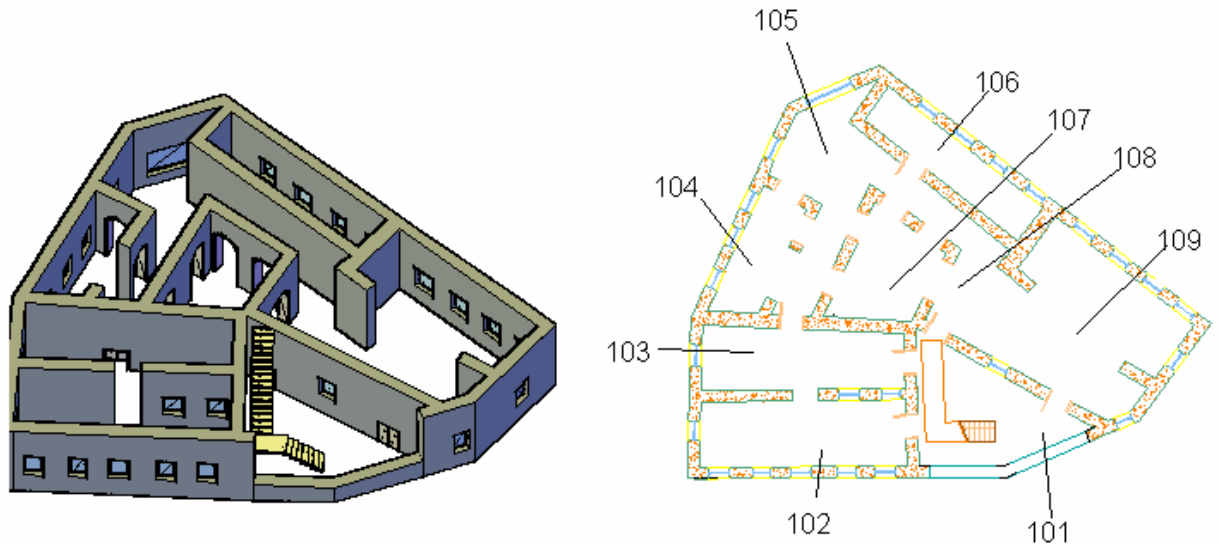
Figure 25 New proposal for the first floor

The first floor of building has been located mainly for the social activities. As the plan below shows, the idea is to have a minimum intervention so as not to disturb the structure and the authenticity of the monument.

Space	Facilities in the first floor (fig. 25)
101	Area for stair that will be also used as garden area.
102-103	Workshop area
104-105	Part of the Library
106	Service area
107	Courtyard
108	Exhibition area
109	Part of the Library

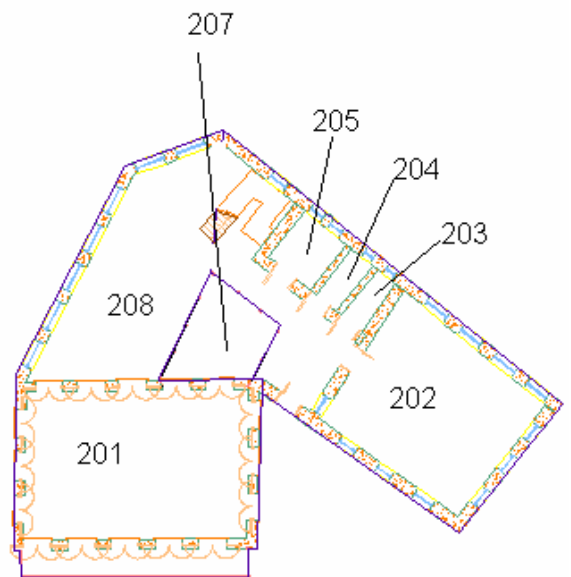
Figure 26 New proposal of the second floor

The second floor was also allocated for cultural uses. In reality, only two important rooms are available in this floor, connected together by very huge living space with important vista to the sea. This space has the potential to be a multipurpose hall for activities that require huge number of participants. The second floor gave also the possibilities to allocate services area.

Space	Facilities in the second floor (fig. 26)
210	Social Space
202	Multi-purpose hall
203-205	Service areas
207	Courtyard
208	Social area

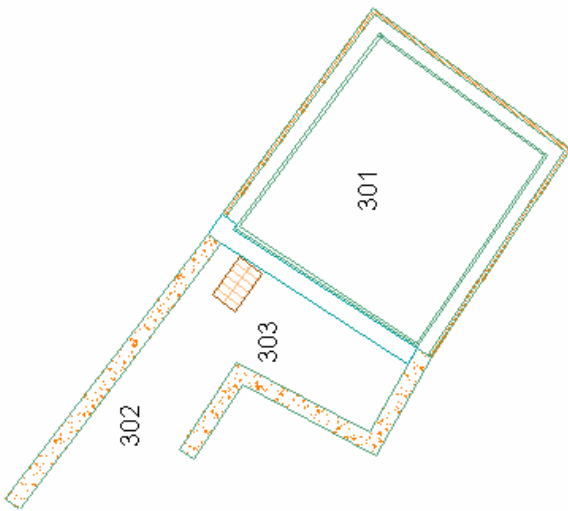
Figure 27 New proposal of the Teahouse

These facilities, together with the shop and museum, will offer substantial fund for the management of the building to sustain future maintenance works. As the plan shows (fig. 27), the third floor has only one activities and its service area.

As the plan shows, the main issue is conservation and maintenance. Therefore, with the exception of the few opening proposed to increase lighting in the building, no new addition is proposed. This is because the building itself does not allow major intervention as per conservation regulations. It also because the facilities provided are well accommodated in its existing spatial configuration.
