THE ROYAL HOUSE OF MINT POTOSÍ, BOLIVIA

Conservation project and maintenance plan.

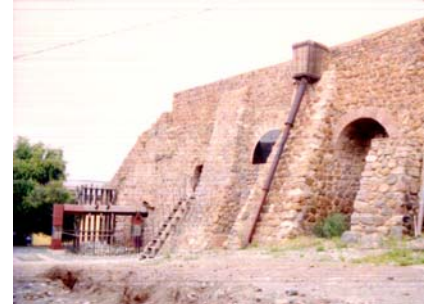
Figure 3. Molino del Rey
(King’s Mill) in “La ribera”
Picture: A. Balderrama 2005

Regarding the production of silver, the amalgamation using mercury demanded the circulation of water through an artificial river called “ribera” which divided the “Spanish city” from the “indigenous city” and fed 132 “mills” (figure 3) that were used to process the mineral in order to turn it into high sterling silver.

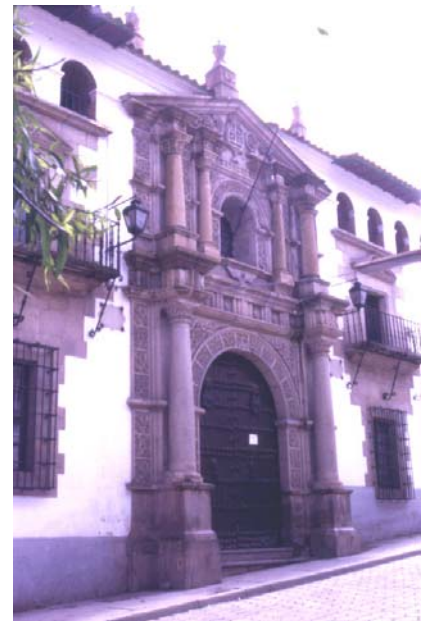
Figure 4. Royal House of Mint
Picture: A. Balderrama 1998

The original was replaced by the current building on the land occupied by the old “Plaza del Katu” (market square). It has three floors with more than 12.000 sq.m. and it is considered the biggest civil building of the Viceroyalty of Peru.

A part of all this silver was shipped to the Royal House of Mint (Casa Real de Moneda) - Figure 4- for the minting of coins of different values, which later on would circulate throughout the continent.

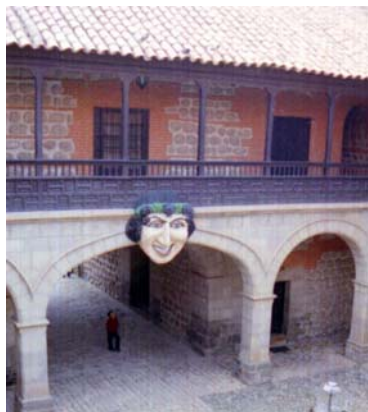
Figure 6: The first courtyard
Picture: A. Balderrama 1999

The basket-handle arches are to be highlighted and their image is well spread by the famous grotesque head found between the two first floors (Figure 6). A stone fountain completes the sector around which we can find the gallery, the XIX century art room, and the administrative areas of the Museum, which is in charge of the Cultural Foundation of the Central Bank of Bolivia.

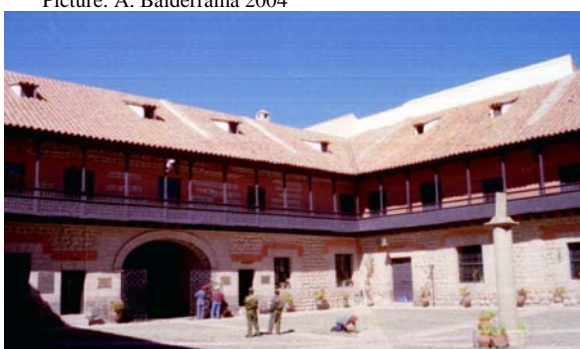
Figure 7: Second courtyard
Picture: A. Balderrama 2004

The second courtyard has great dimensions and a continuous projecting balcony made of wood that substituted the old iron balcony (Figure 7). The walls are made of solid stone with a thickness average of 1 meter, alternating with brick arches. A sundial supported by a stone column stands out in the centre. Besides providing access to the minting rooms, the space is surrounded by the Historical Archives and exhibition areas such as the “Sala Mariana” where one can see the famous painting “La Virgen del Cerro” (Virgin of the Hill), the “Sala Pérez Holguín”, the silver minting and numismatics rooms.

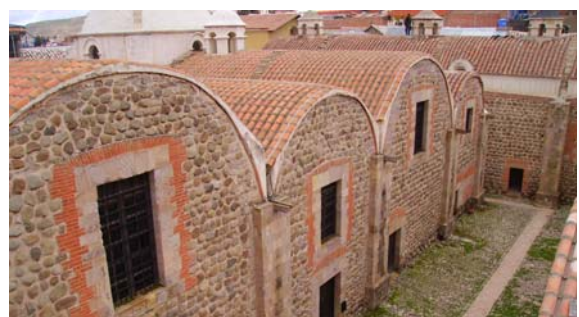
Figure 8: Third courtyard
Picture: A. Balderrama 2006

The third courtyard organizes the old storage rooms, which have been adapted by the Museum for the exhibition of weapons, mineralogy and other. In addition, with great architectonic value, we find the vaults and the elliptic cupola of the ventilation cone that covers the biggest of them, which was used as a chimney in the silver foundry room.

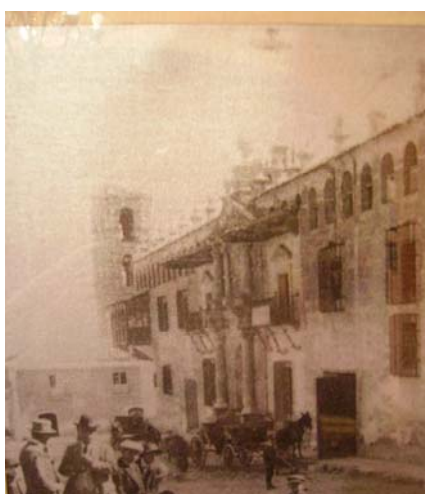
Figure 9: The building ca. 1910
(Historical Archive of Potosí)
Picture: Homenaje a Potosí, GMP 1998

- Towards 1910, the façade showed serious damage (see Figure 9), this is probably the reason why the building had a solid plinth made of lime (30%), sand (40%), pozzolana earth (15%), and animal blood (15%). All along the XX century, this mixture gave it a certain consistency, but it constantly presented cracks and detachments or slides, which forced the administrators to face annual maintenance works with high costs, if we consider a total area of 530 sq.m. of plinth (Figure 10). When performing these works, they even used car filler (putty) in order to fix and avoid the constant cracks.

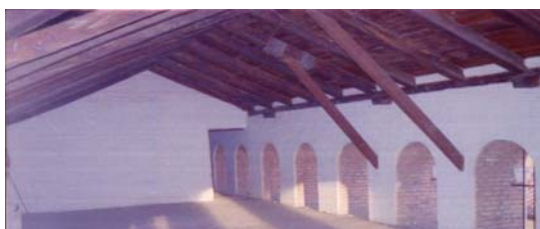
Figure 12: Attics or “duenderas”
Picture: A. Balderrama 2005

More space needs: Collection and cultural activities of the Museum are increasing every year, so it is necessary to increase new spaces inside the building. Two first floors have big windows facing the street, and the highest floor known as “duenderas” (goblins, spirits), have never been used, those served as precarious living spaces and were considered just as simple “attics” (Figures 11-12).

4. **RIDGED ROOF GABLES:** Similar work will be done on these roofs, to avoid leaking and keeping the shape of the building.
5. **THIRD FLOOR FITTING OUT (DUENDERAS):** the “duende” (goblin) is a mythical character related to darkness, this is how the third level received that name; it never had any windows and had no usage, except when used as an improvised home for slaves in the colony, as referred by some chroniclers. Due to the need of having bigger spaces in the Museum, these “duenderas” are currently being fitted out to be used as restoration workshops, storage for colonial paintings and restrooms. (Figure 20). The work includes new wooden windows, reposition of plastering and rendering, paint and other details. With this works a new 450 sq.m. useful sector will be set.

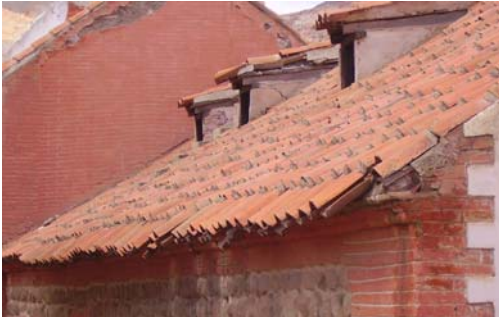
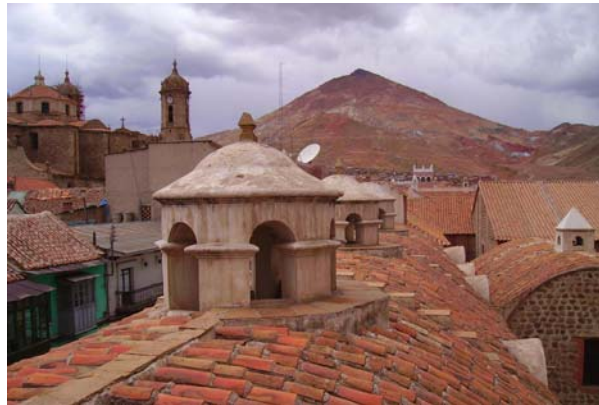
Figures 12-13: Damages can be seen on roofs, vaults and lanterns

- By effect of atmospheric agents and contamination, there are serious damages on ridged roof gables, barrel vaults, lanterns, skylights and cupolas, producing leaking inside the exhibition rooms (Figure 12-13). It is remarkable that all these are a part of the landscape in Potosí, with the Cerro Rico in the background.

the last intervention in the vault covers had been done 30 years ago in 1975, reason why there were frequent leaks of rainwater inside the building. Since January 2006, works are being performed (Figure 18) to restore the cover following these steps: removal of the roof tiles, placement of mortar, and rearrangement of the roof tiles with a waterproofing layer.

just as with the vaults, the mortar layer was removed, a waterproofing layer is placed and then another mortar layer with a waterproof additive, giving back to the lanterns their original image but protecting the ambiances inside.

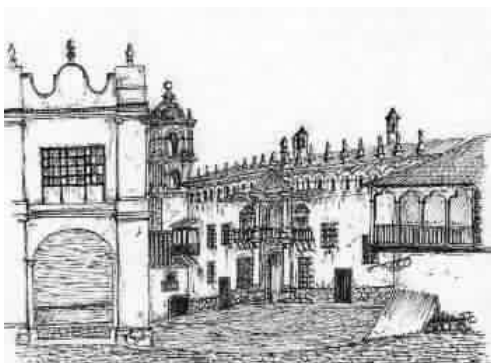
Figure 14: Drawing, 1860. See the building with stone plinth.

1. RECOVERY OF THE STONE PLINTH: As observed in this drawing dated 1860 (Figure 14), the building had an exposed plinth, just as the rest of the important buildings of the time (compare with “La Merced” or “Santa Teresa”). During the current intervention (Figures 15, 16, 17), all the mixture is being removed, the joints between the rocks have been made waterproof, and the entire plinth is in the process of being liberated, with which all maintenance works will be reduced in 80%.

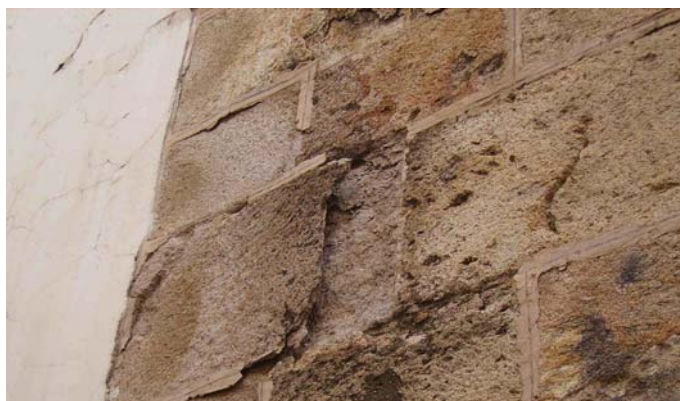
Figure 21: Damaged sand-stone on facades.

6. **REPOSITION OF FAÇADE ELEMENTS: STONE, AND RENDERING:** due to rain and winds, some sectors of the façades present wearing away, reason why some pieces made of cut stone are being substituted on the façade, and some rendering sectors are being replaced, specially those which showed a high degree of damage.
