Conservation and management of historic buildings. University of Lund

Rehabilitation of Severin Building in the historic center of Valparaiso

Conservation project and maintenance plan.

Paulina Kaplan Depolo

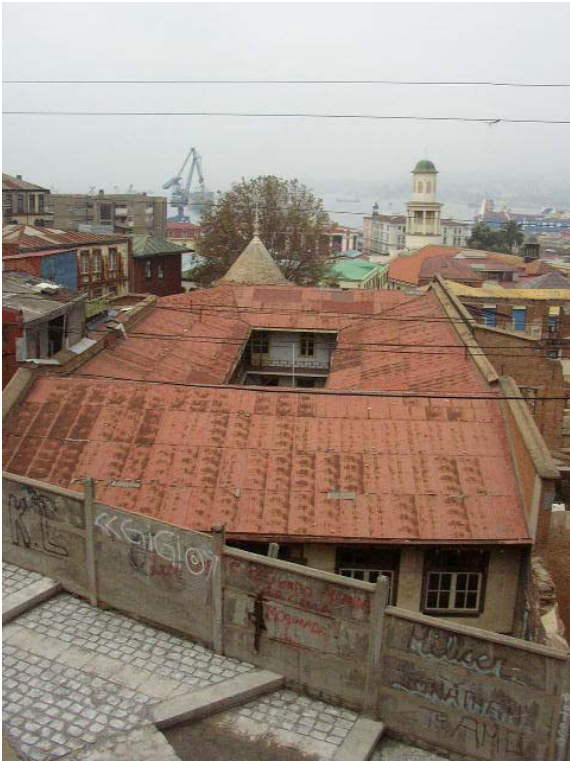
photo n°1 Roof of the building before the year 2003

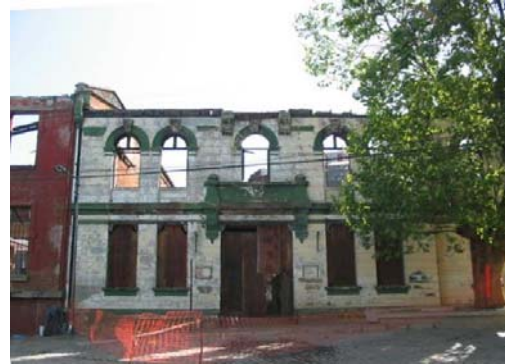
The Severin building was affected by a fire by the end of year 2004, the one that destroyed great part of its original structure, is by which the structural cadastre has been made, to determine the present state of the structure and the damages that affect it. The facade of the structure shows serious damage. Once to the interior of the building, it is appraised that the structure was destroyed almost in its totality by the action of the fire and the few elements that were still on, will be analyzed in the present cadastre.

photo n°2 Burnt Façade

The facade of the building is in good conditions, but it must be reinforced to maintain it in his place when the new work is constructed

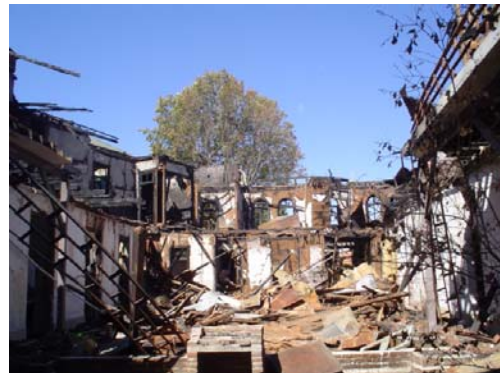
photo n°3 Interiors Building

Analysis of the internal structure. At the moment of the visit, no longer inner structure practically exists, only some partitions have left still on and very little structure. Of this it is possible to be appreciated that it was composed by a framework of wood and bricks, because the building underwent a fire the wood structure burned almost in its totality, therefore all the inner partitions are due to replace since no longer loads will resist because the supported structure is in good conditions

The internal structure, that is composed by half-framed of wood with brick masonry, is due to eliminate and to replace by a new structure because the resistant elements of the old structure were destroyed by effect of the fire that affection to the building. As it were said previously in the conclusions of the structural analysis, the only thing that will stay will be the facade and the fire walls, because the present facade is able to support the loads which it will be put under the building once it is reconstructed.

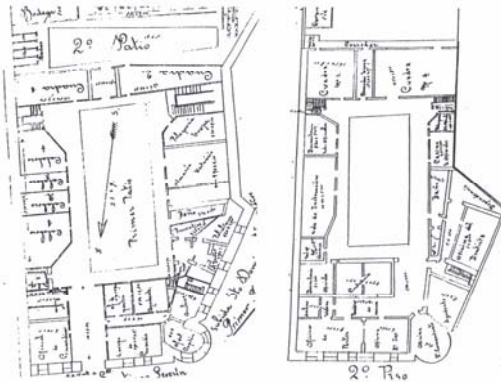
"Tiene de frente 15 m. (calle Santiago Severin), de fondo 65 m. (calle Santo Domingo) y de controfrente (cerro Santo Domingo) 25 m. Consta de dos pisos con 28 departamentos, en cada uno, ambos de cal y ladrillo, con un pretel al fondo de piedras y ladrillos, también de propiedad fiscal; dos murallas de ladrillos: una al este de 70 m. y otra al Oeste de 20 m. Esta destinado a Cuartel de la Segunda Comisaría "Valparaiso" de la Primera prefectura, de la Prefectura General "Aconcagua"."

Document N°4 ORIGINAL PLANS
Plans of the building when it was occupied by
Chileans Police

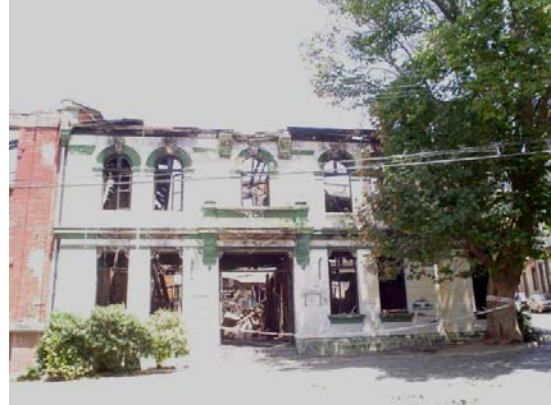
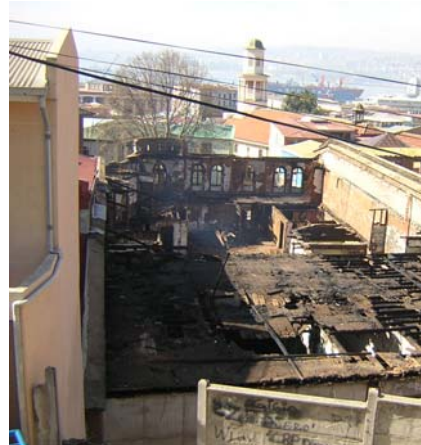
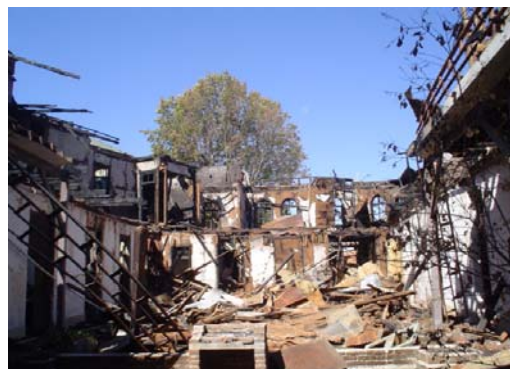
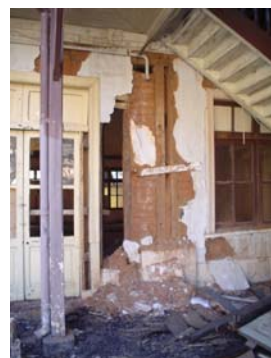
After the fire

In a series of photography's, it can be appraised as it is the present state of the building. Severín building has two fire walls; one leaned to a structure by street Santiago Severín, which also was destroyed in the fire and other that it gives towards Santo Domingo street where at the moment inhabited constructions exist. The fire walls are of masonry and they are in good condition as it is possible to be appreciated in the following photography's in the annex B
