# Investigation and Design for One Part of the Great Wall Named *JINSHANLING*

# Investigation and Design

**Report for Investigation**

# The Design for Conservation

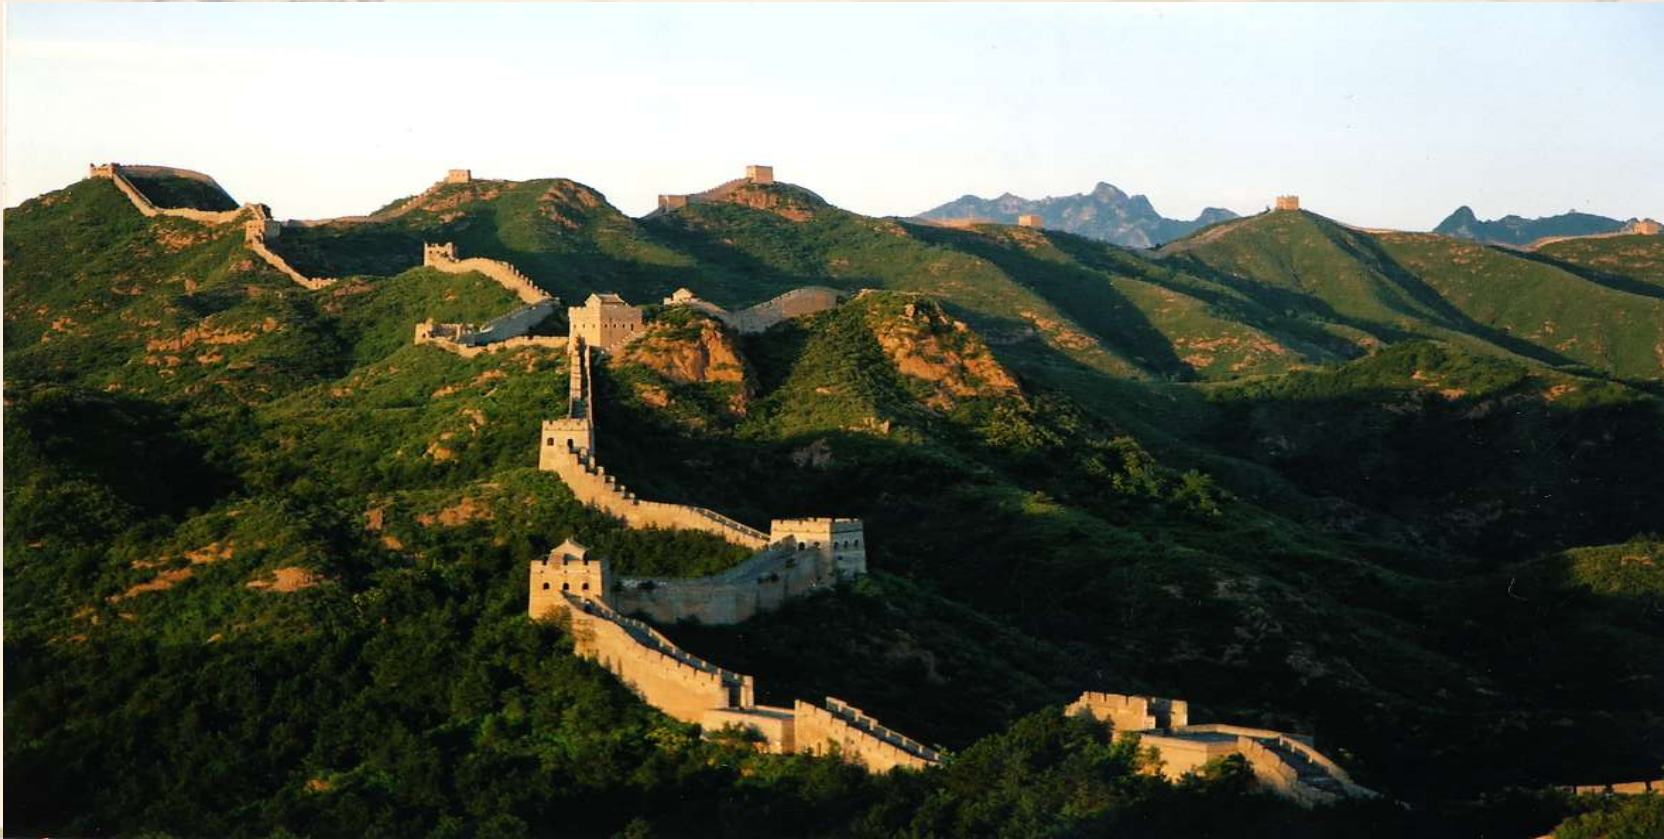
**Dense  
Dilou**

The wall has many dilou, about every 100 m along the ridge of the mountain, many more than on other sections of the wall. Where necessary, they are 50--60 m apart. The form of the dilou is square, oblong, or rhomboid. All dilou are hollow, sit in the middle and on top of the wall. They are about 10 m high.

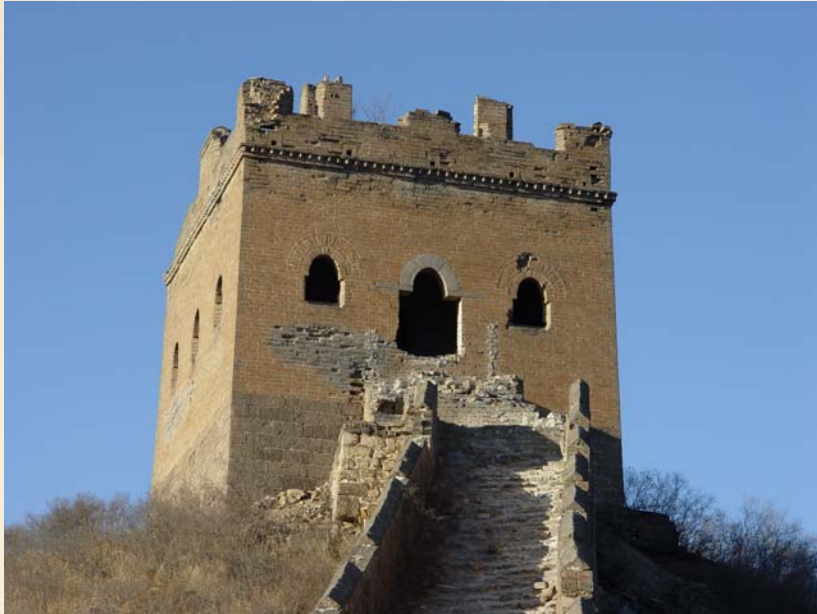
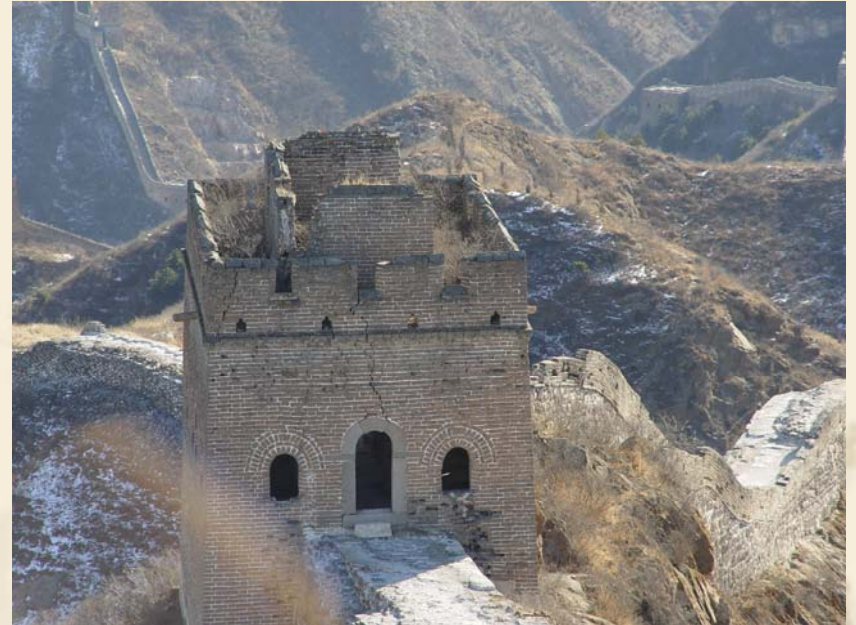
The foundation of the dilou is of bar shaped stones and the body of bricks and stones. Its wall was built with bricks with stone fill. All dilou have two floors: the ground floor is is brick and wood, or brick with arches. The soldiers lived, stored food and weapons on the ground floor, and used the second floor to fight or stand guard.

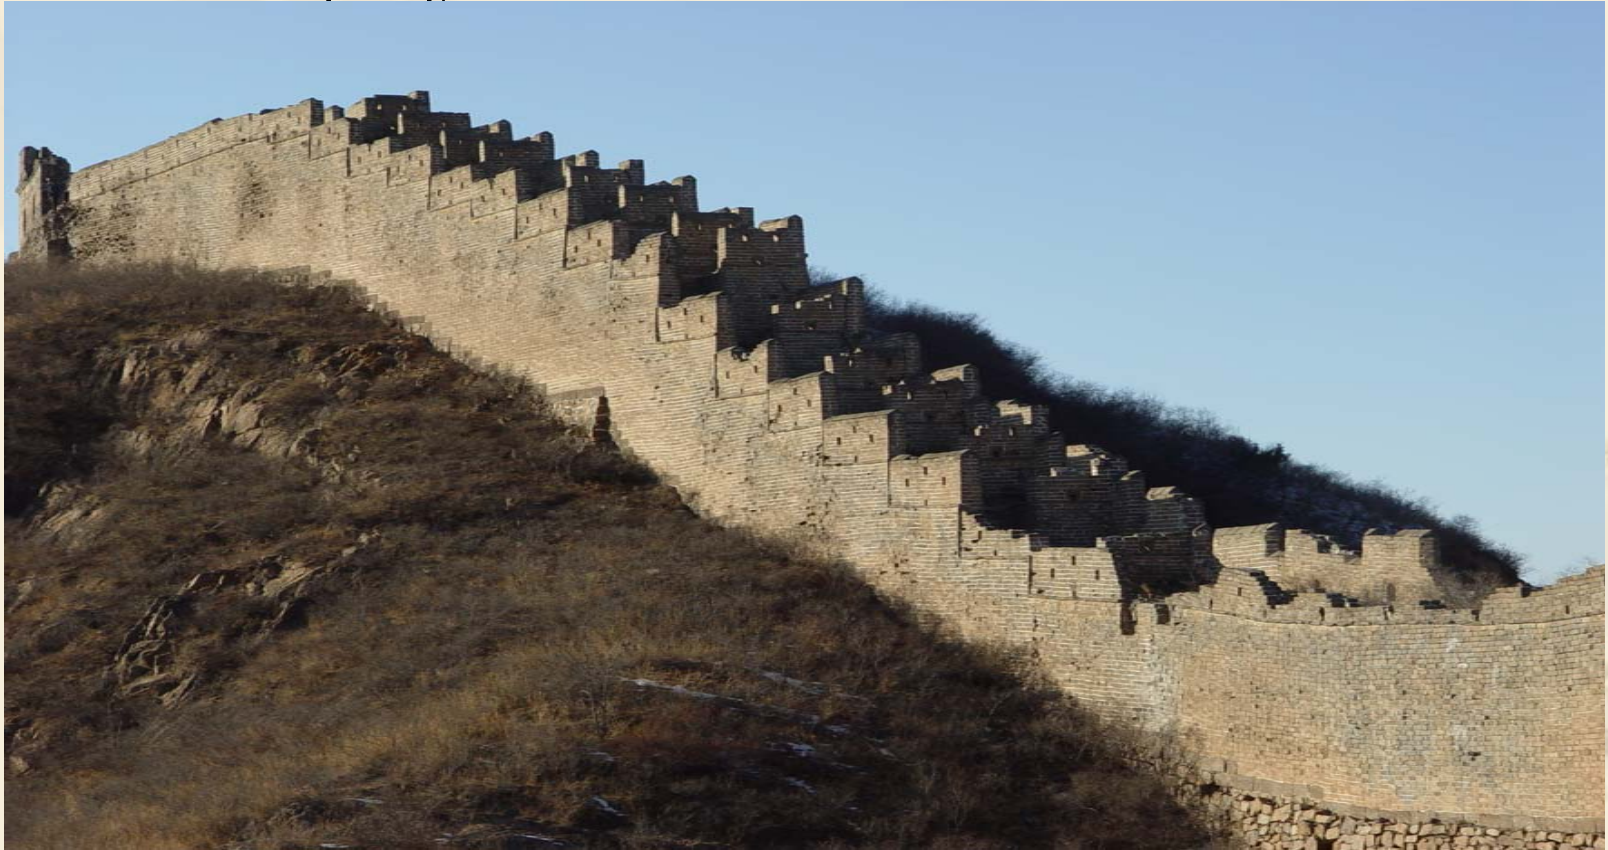
The wall is the main body for the whole system. It has a stone base. The wall itself is a brick shell filled with stone and earth. Where the landform is even, the wall is about 4.5--5 m high. The width at the bottom is about 5 m. The height of the wall is about 4.5 m. On the outside (right in the picture) the Duokouqiang (steps on the side of the wall) are 1.8 m. The inside of the wall has Yuqiang, which are about 1.5 m.

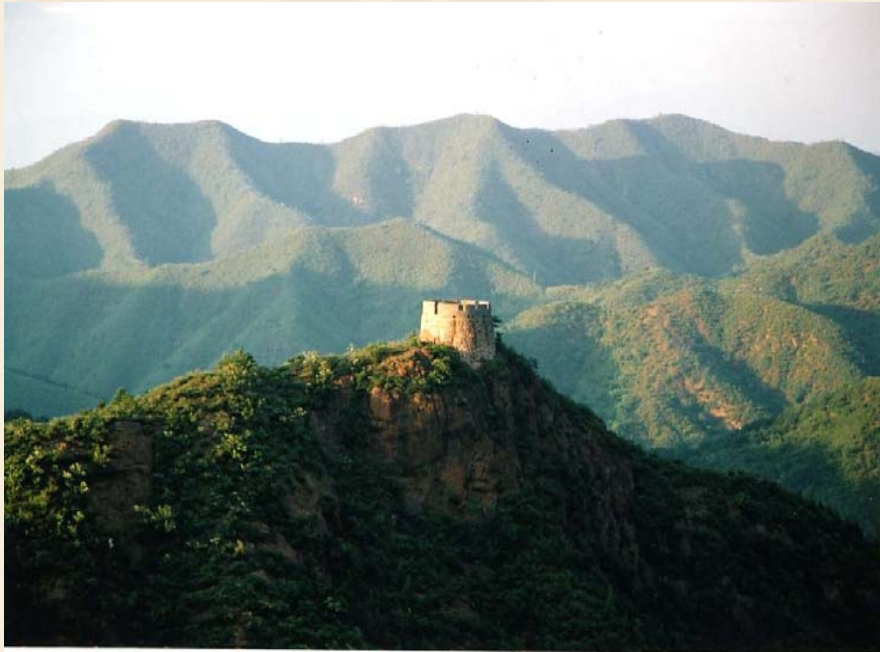
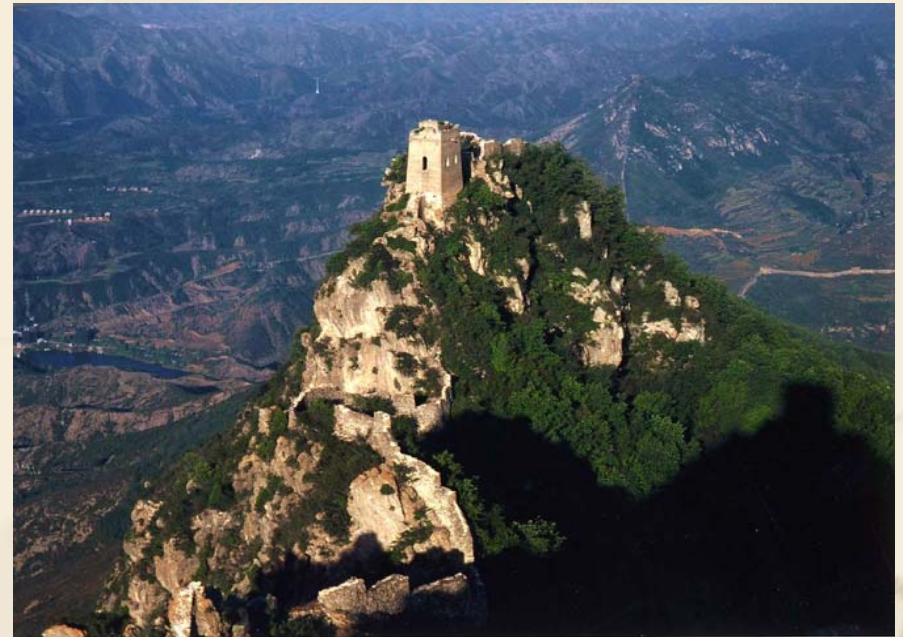
Feng Huo Tai (watch towers) were built on steep peaks inside or outside the wall. When the enemy came, soldiers would light fires to warn the others.

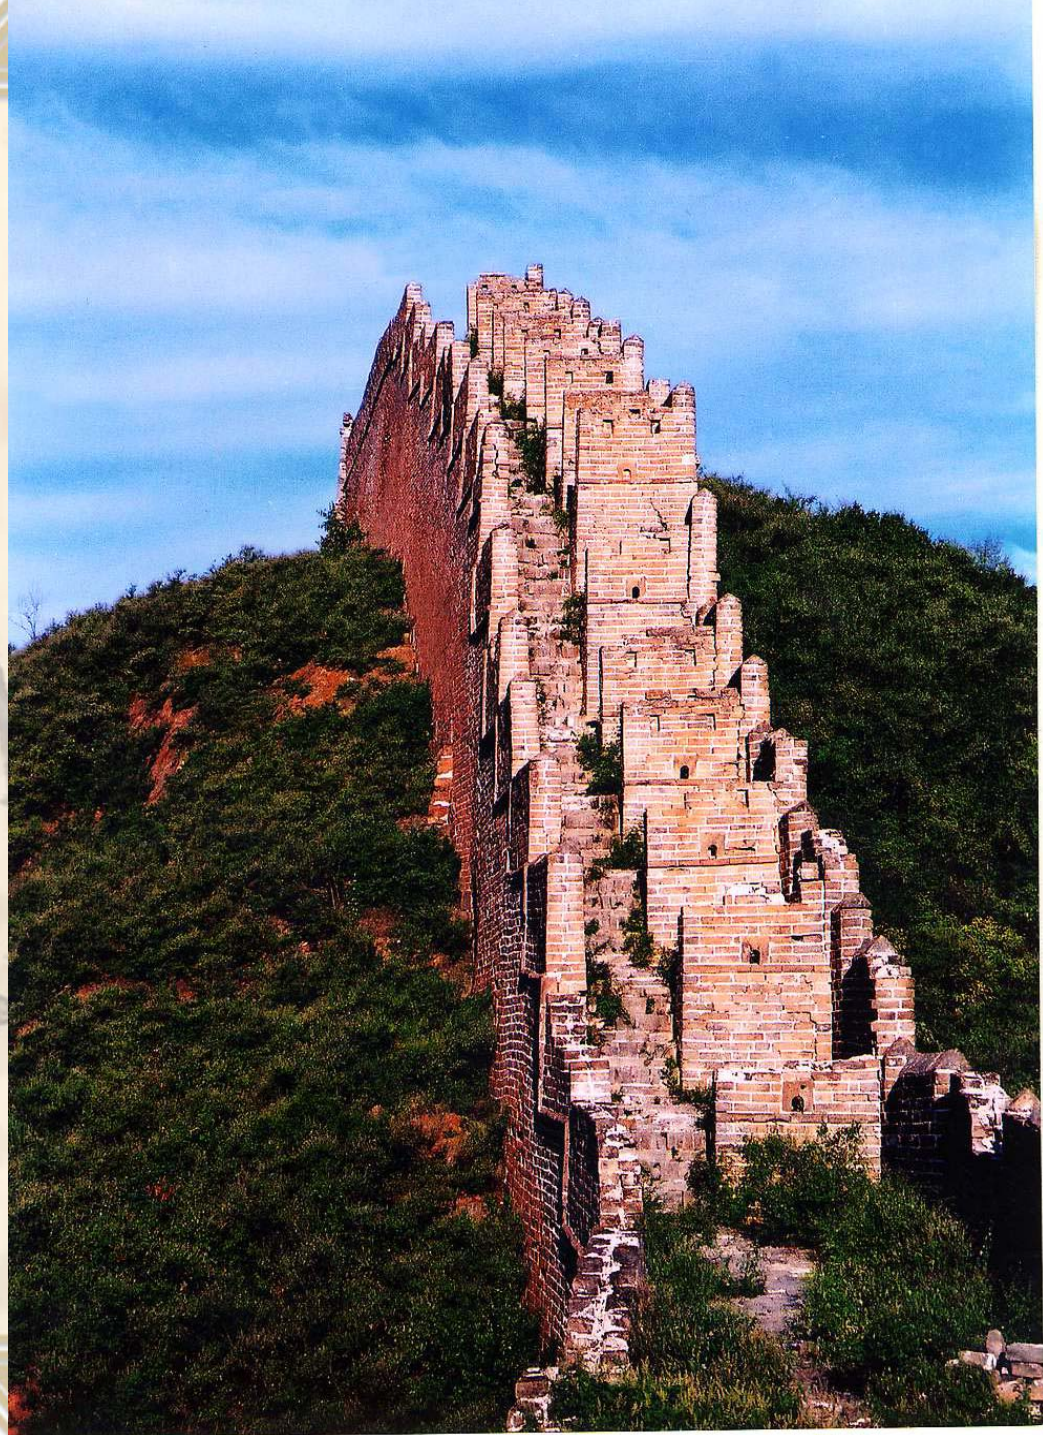
A barrier wall  
was built inside  
the wall to delay  
the enemy if they  
climbed the wall.

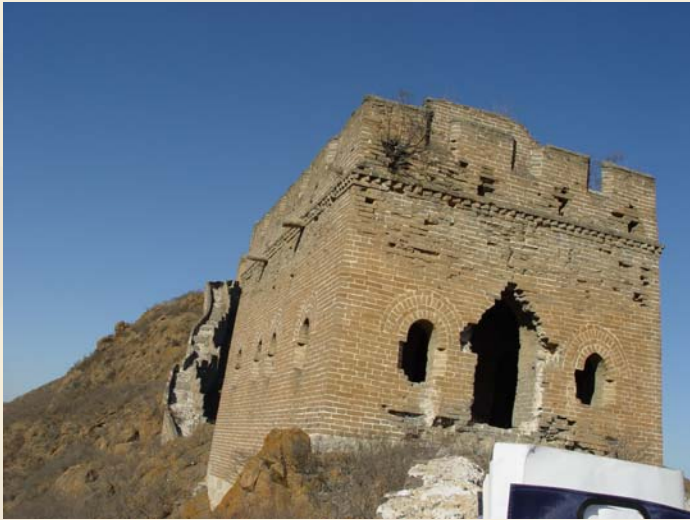
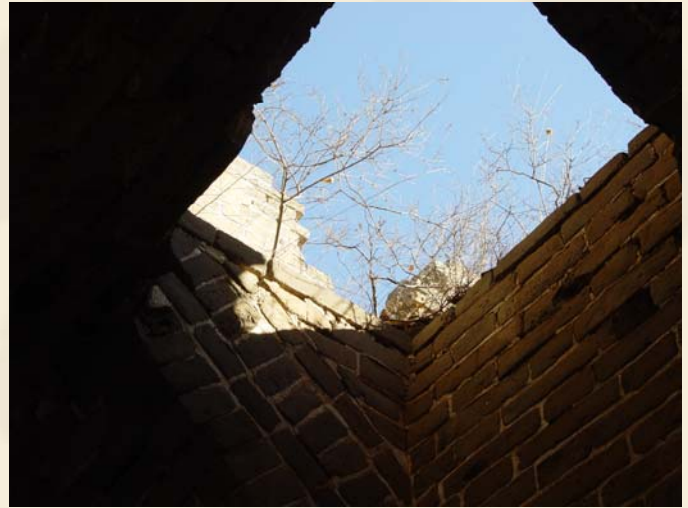
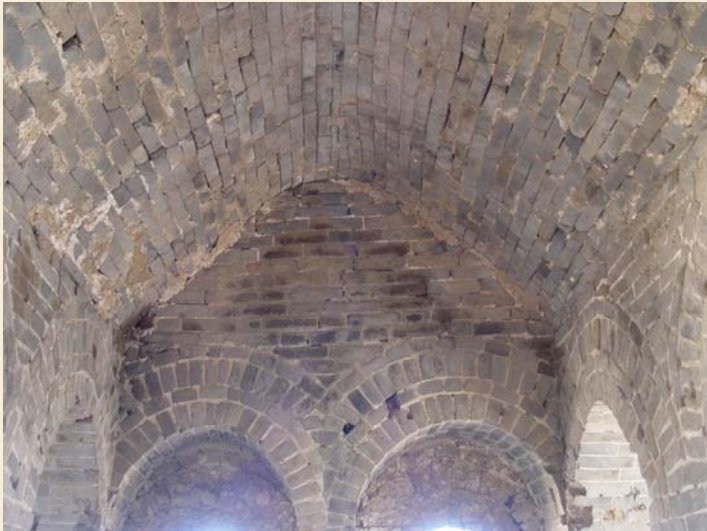
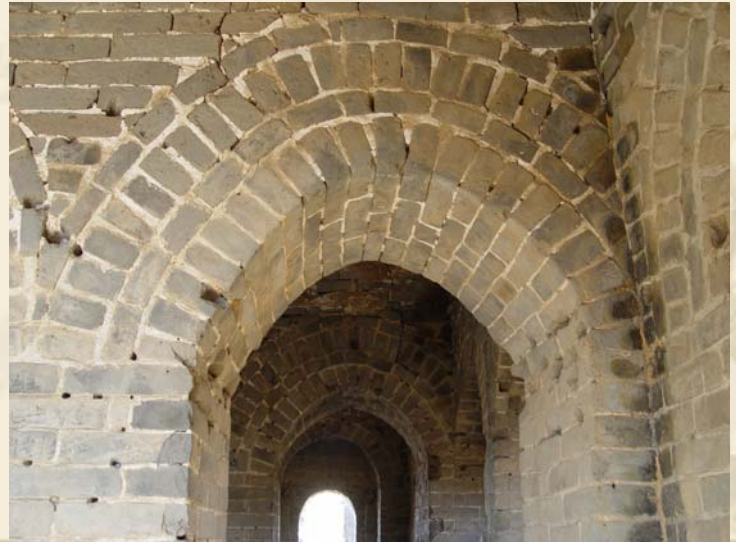
The east gate is damaged: the brick (or stone) around the gate is gone. The west gate has a crack and a lot of weeds and shrubbery on the roof. The arrow window is damaged. 2/5 of the floor bricks were broken.

Patch the east gate and arch with old brick around the wall

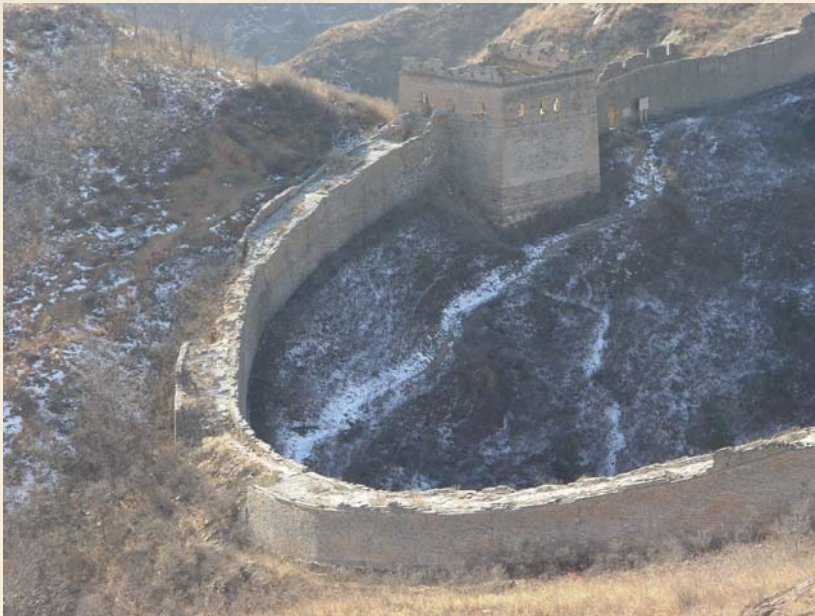
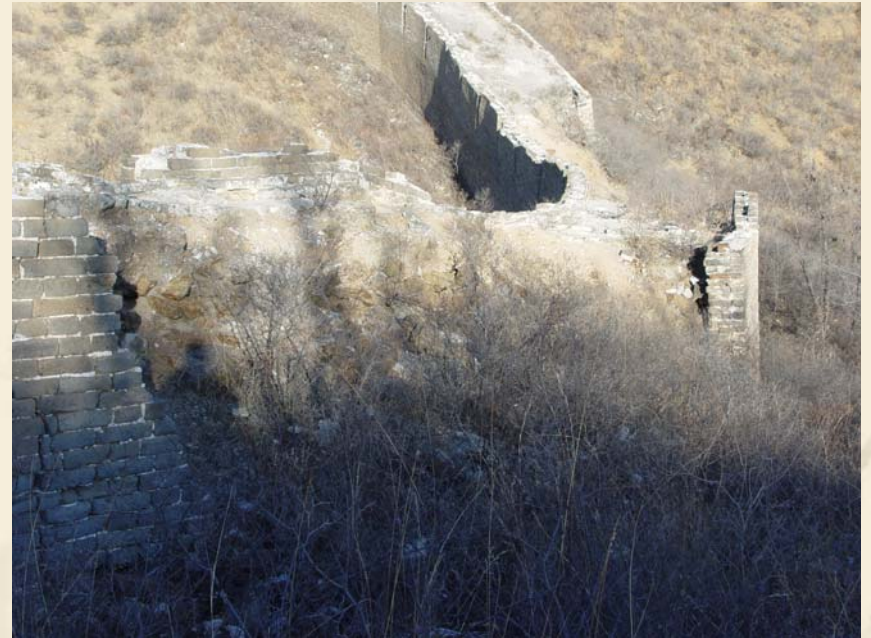
4.2 Some of the wall has fallen down. Many of the wall bricks are gone. Most of the earth filling has collapsed, and only the inner wall remains.

4.2.2 Remove the loose stone and earth, patch stone and earth, fill with the traditional slurry.

4.2.3 Replace the bricks which are old, fill with the traditional slurry.

4.2.4 Do not repair the Duokouqiang and Yuqiang entirely. Patch three layers of old bricks along the width. It should retain the origin shape.

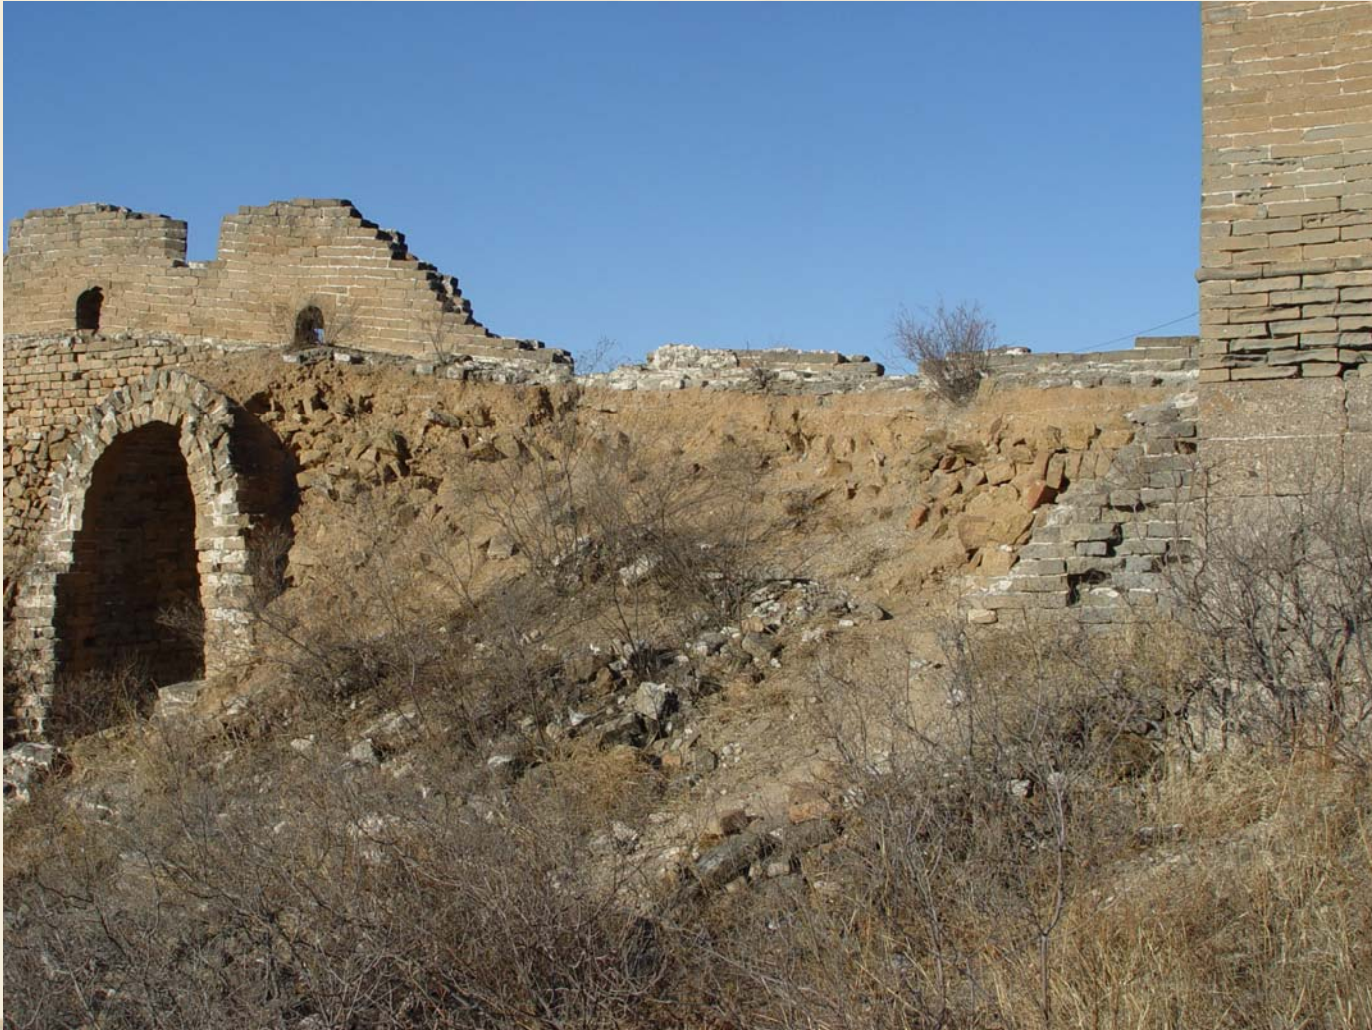
4.3

The col (two layers of the arch) has collapsed.

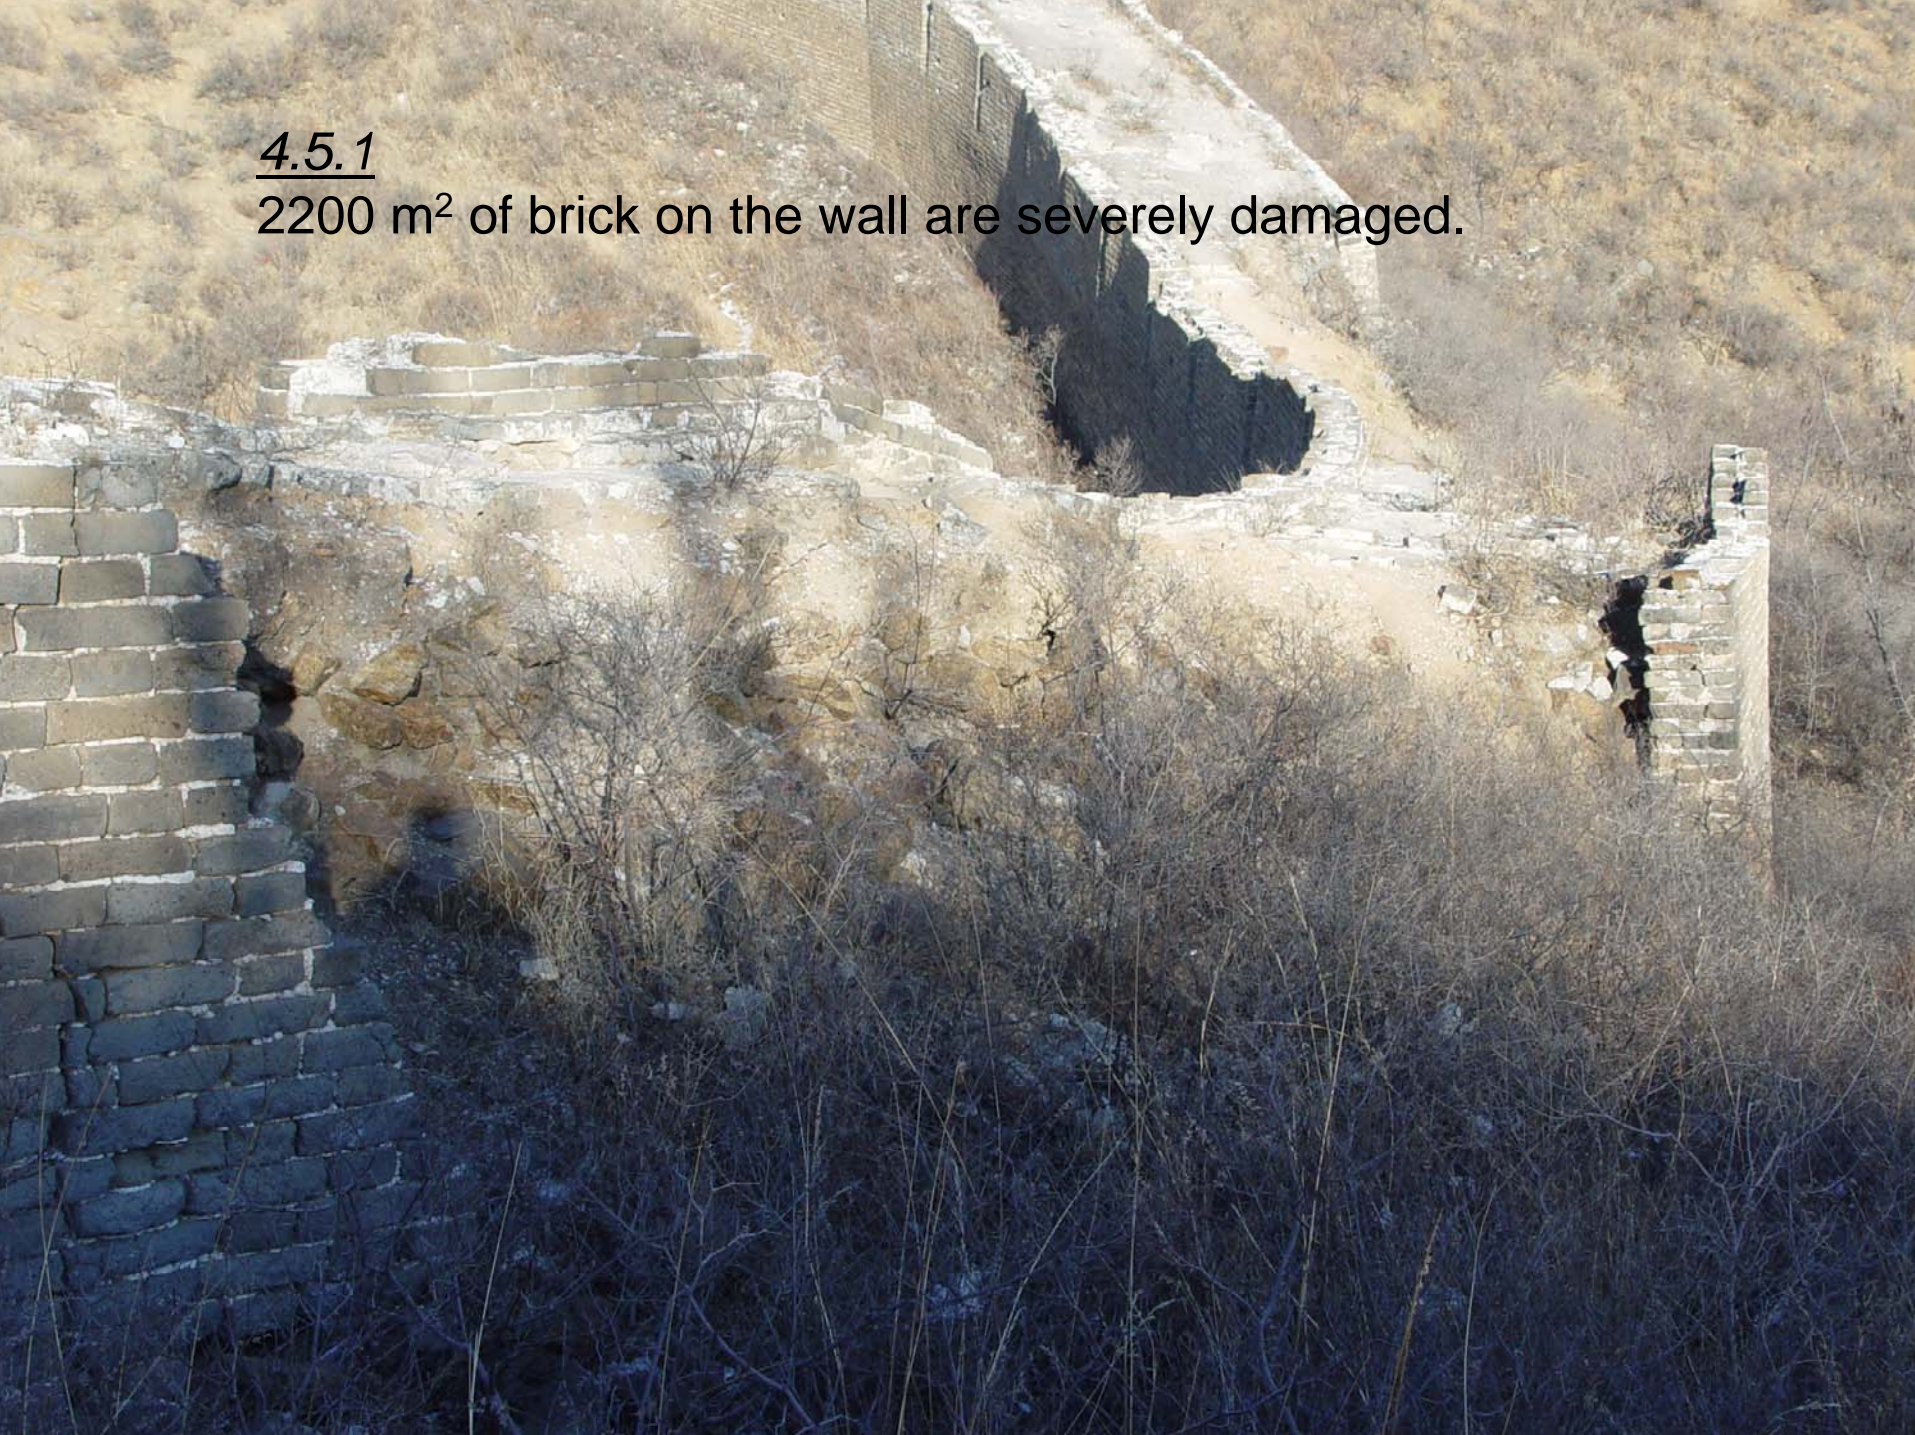
4.5.1

2200 m<sup>2</sup> of brick on the wall are severely damaged.

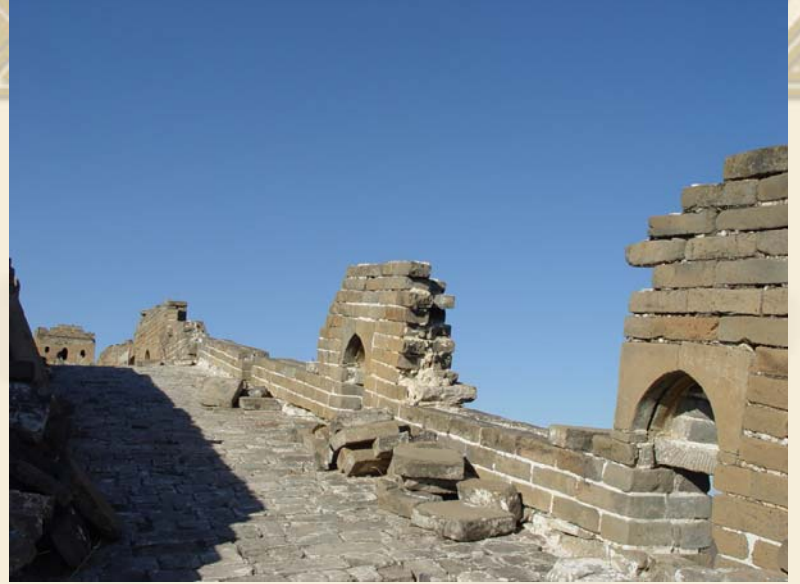
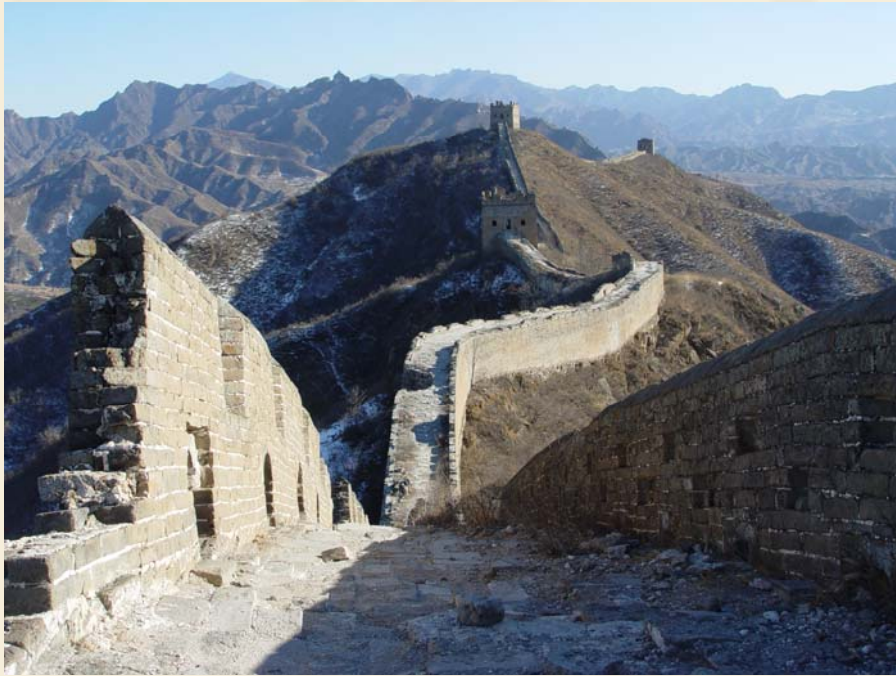
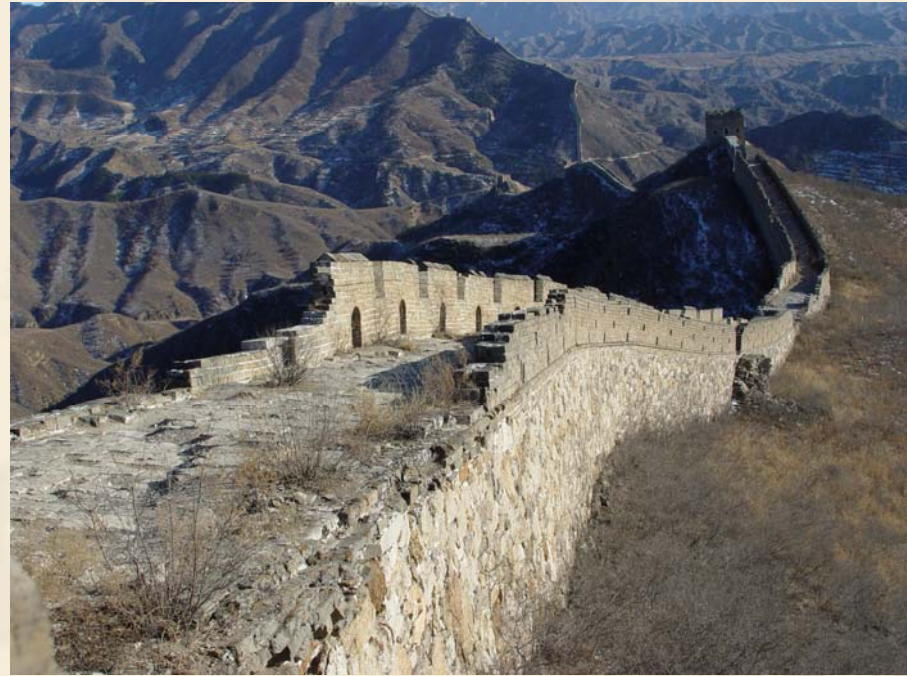
### 4.5.2

One section of 130 m of the wall's Duokouqiang and 140 m of Yuqiang are gone.

6.3.2 The small wall on the wall is damaged very seriously and for the safety of tourists, it should be repaired.

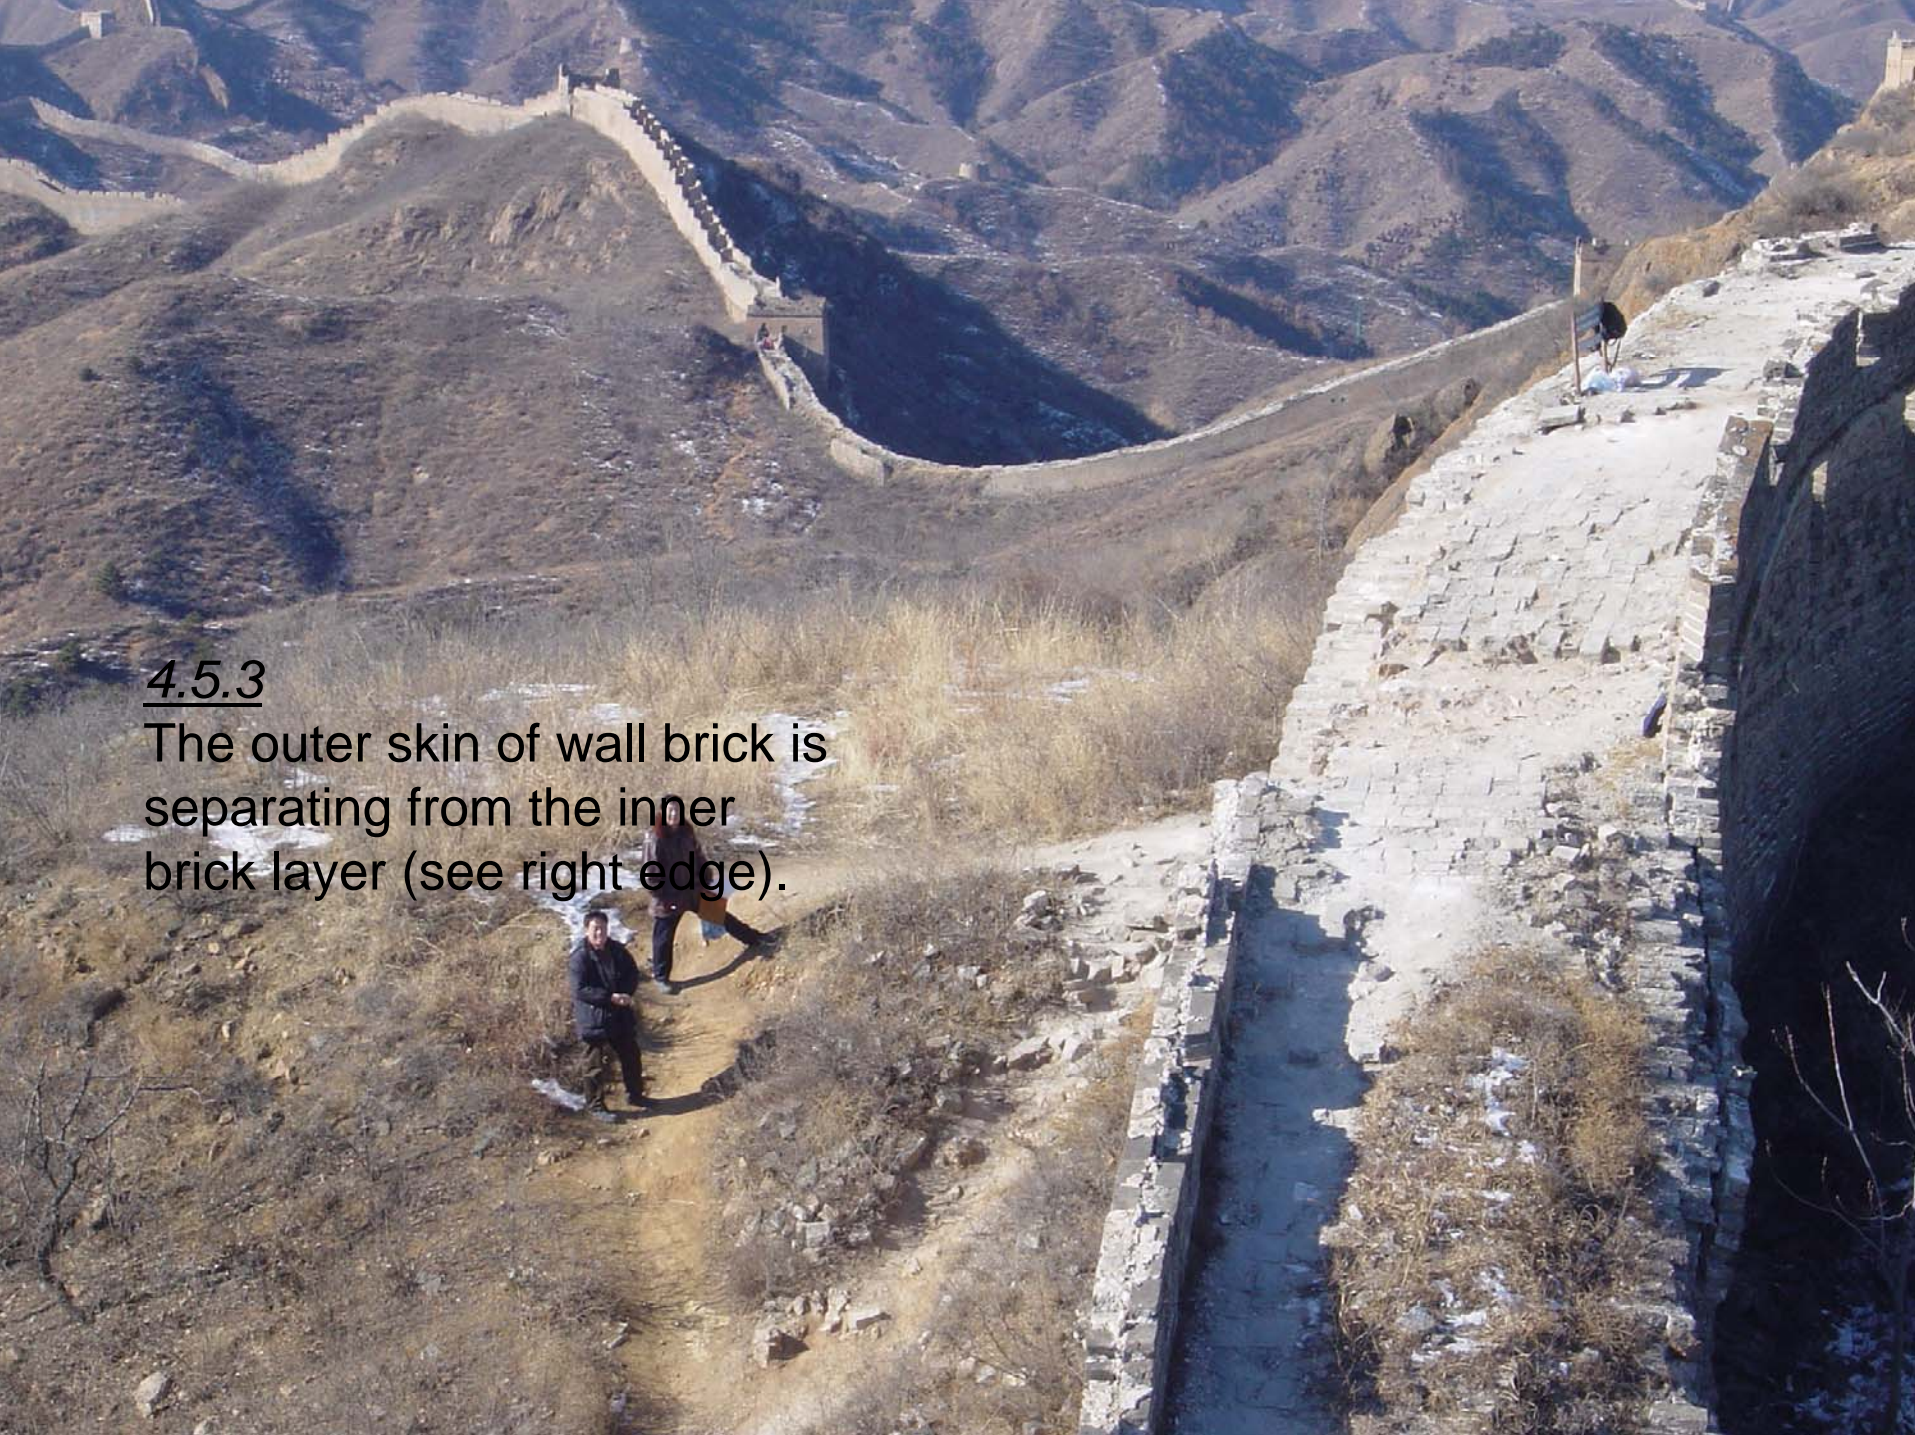
### 4.5.3

The outer skin of wall brick is separating from the inner brick layer (see right edge).

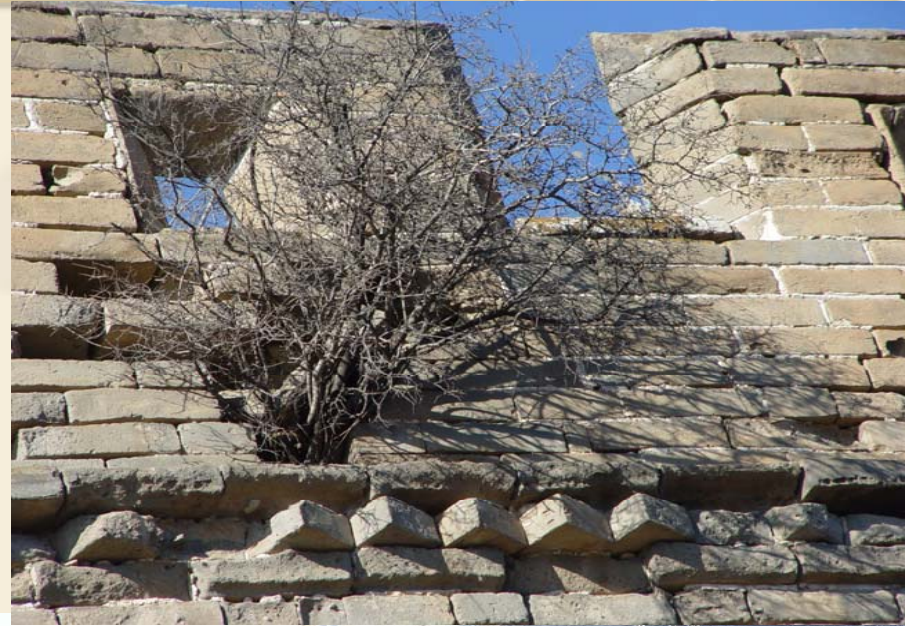
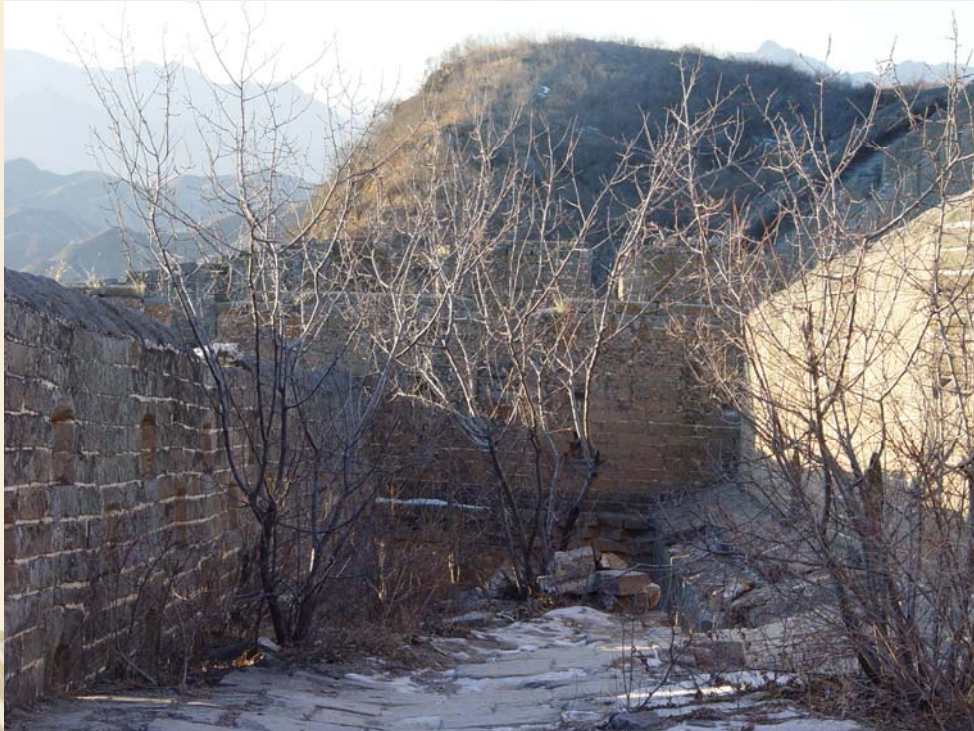
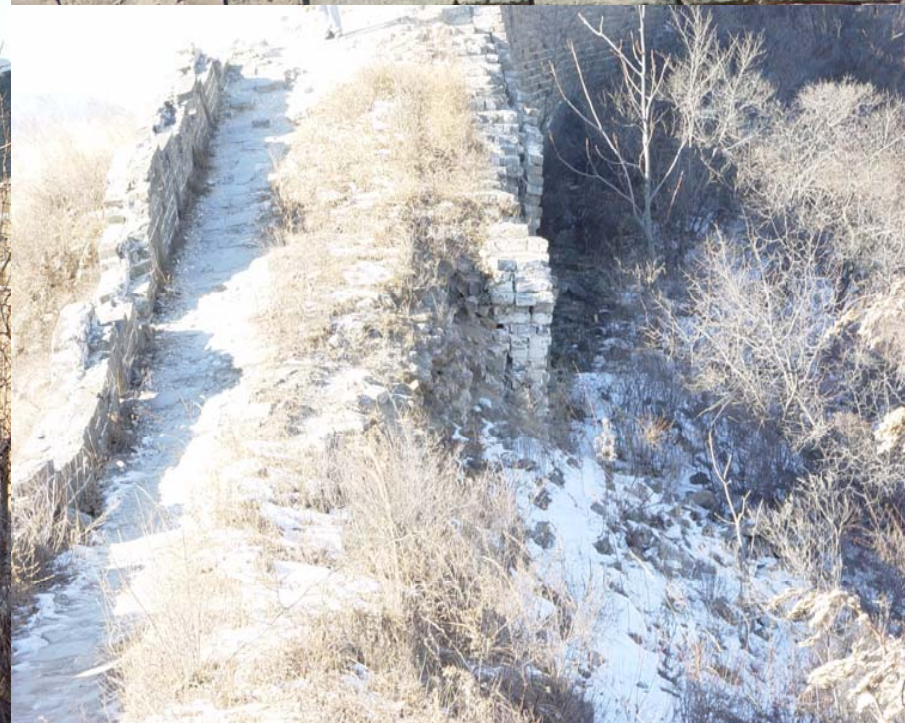
4.5.4

There are many weeds and shrubs on the wall.

6.3.3 The weeds and shrubs cause to the wall crack. Snow and rainwater inside the cracks expand when it freezes, and the brick shell falls off, so it should be cleared and water drainage system fixed.

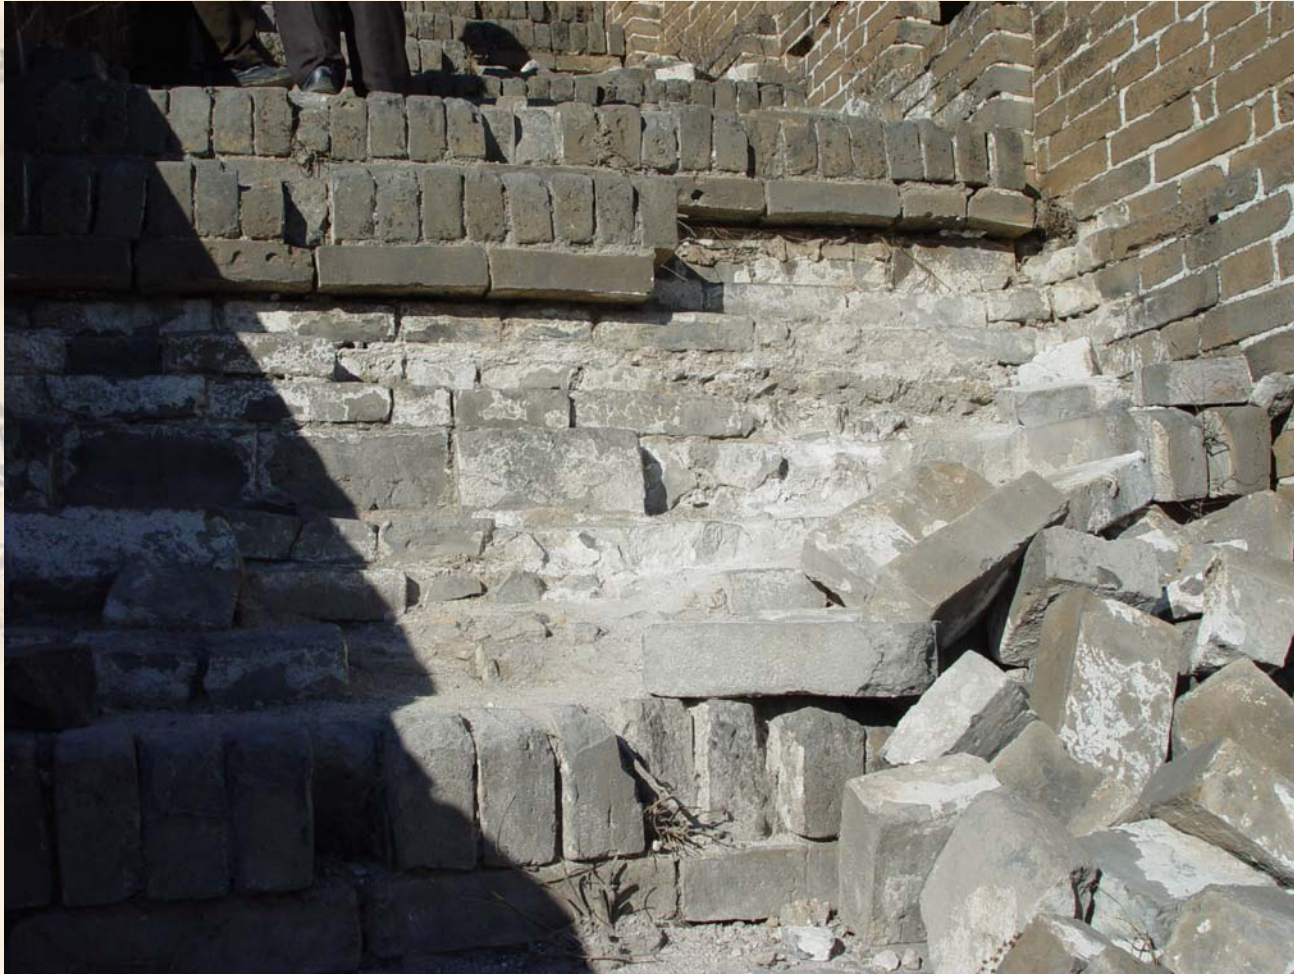
### 4.5.5

The collapsed brick deposits around the wall makes it is hard for water to drain.

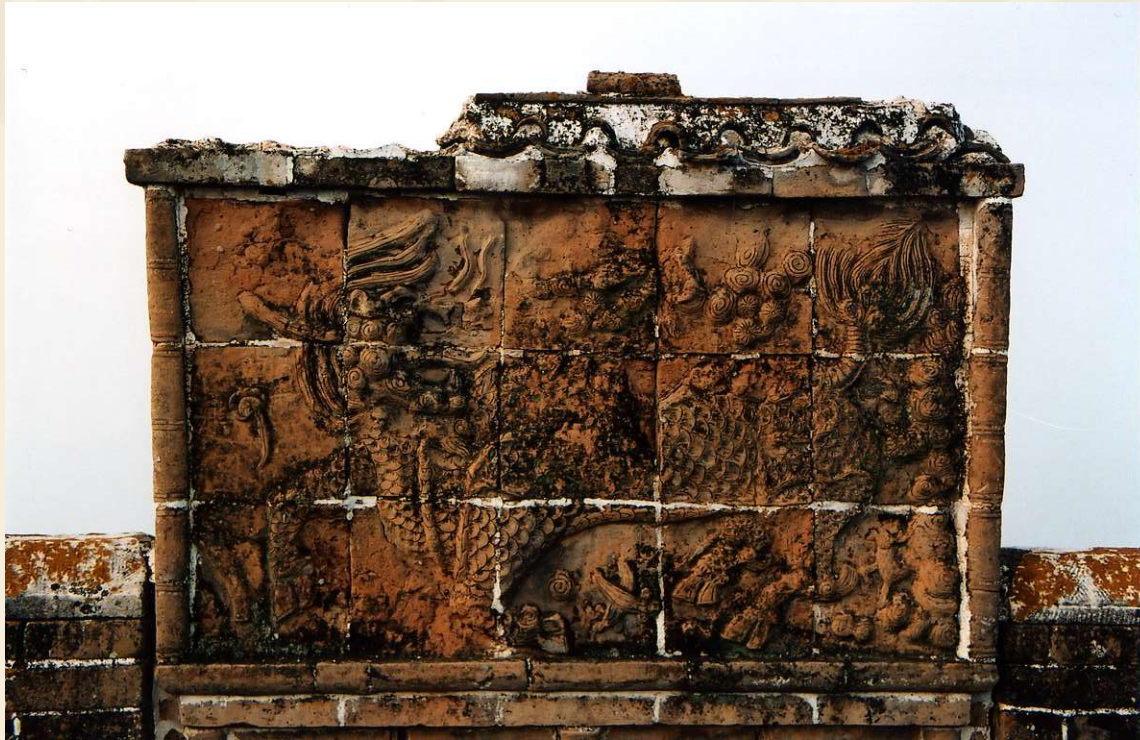
The wall has a nice and artistic framework and components, such as the QiLin wall (QiLin was an imaginary animal in ancient China). It was formed with beautiful carved bricks.

6.3.4 The qilin wall is sensitive to the weather. A special protection plan should be designed. (It should be done very carefully because we do not have good experience).

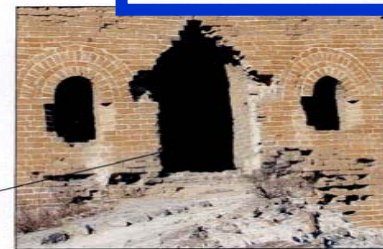
East surface 1:50

Fill the cracks with traditional slurry

Patch the flexible brick

Clear up the weed and shrubbery

Fill inside inner wall with stone and earth and mend the wall's surface with brick.

Why not use stone to patch the east gate, just as the west gate

- No sure evidence to prove the gate is made up of stone;
- Other dilou near the Siyanlou are made of brick;
- There are many old bricks around the gate and the wall. Although it can no be proven the gate is made of brick, we can use it;
- We can keep detailed records for this conservation, and the project is reversible. If we have definite evidence to show the gate was made of stone (such as old photos), we can correct it later.
