# Investigation and Design for One Part of the Great Wall Named *JINSHANLING*

# Investigation and Design

**Report for Investigation**

# The Design for Conservation

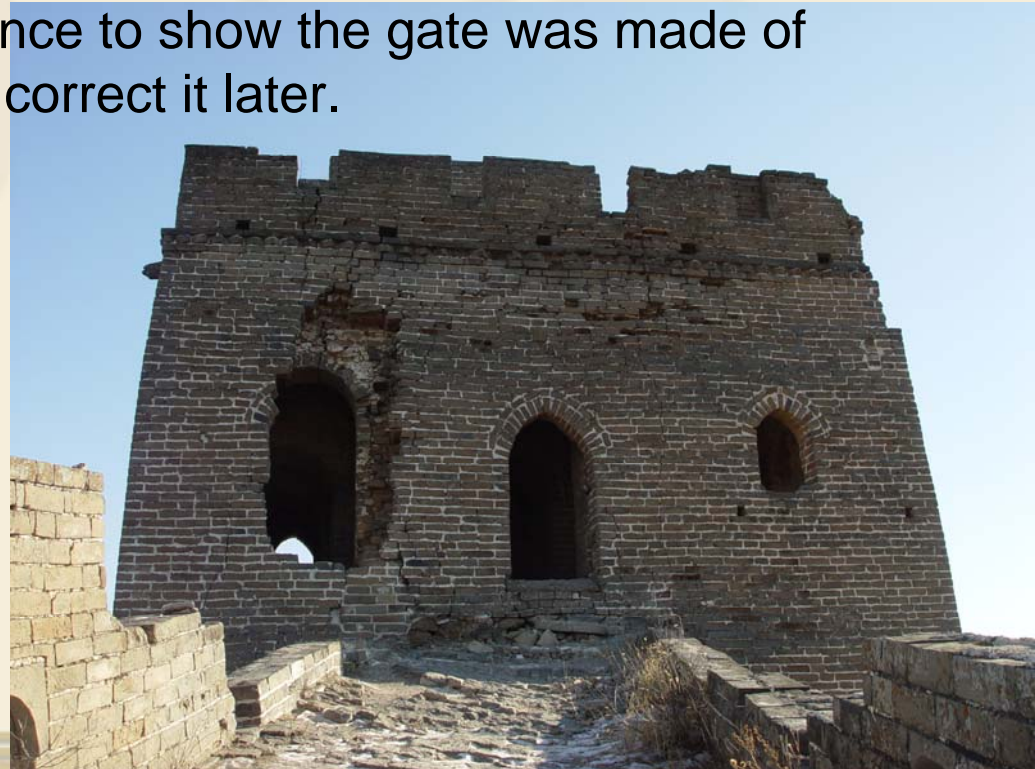
West surface  
1:50

整修残墙松动砖层

Patch the flexible brick

Clear up the weed and shrubbery

裂缝一道宽25-30  
白灰砂浆灌注

Fill cracks with traditional slurry

裂缝一道宽15-25  
白灰砂浆灌注

清除敌楼顶上的杂草树木

补砌坍塌墙体及垛口墙三层

方砖补砌残损地面 青条砖铺墁一层

青条砖砌筑墙体  
410X200X90  
毛石填充墙芯  
桃花浆灌注

Fill inside inner wall with stone and earth, and mend the wall's surface with brick.

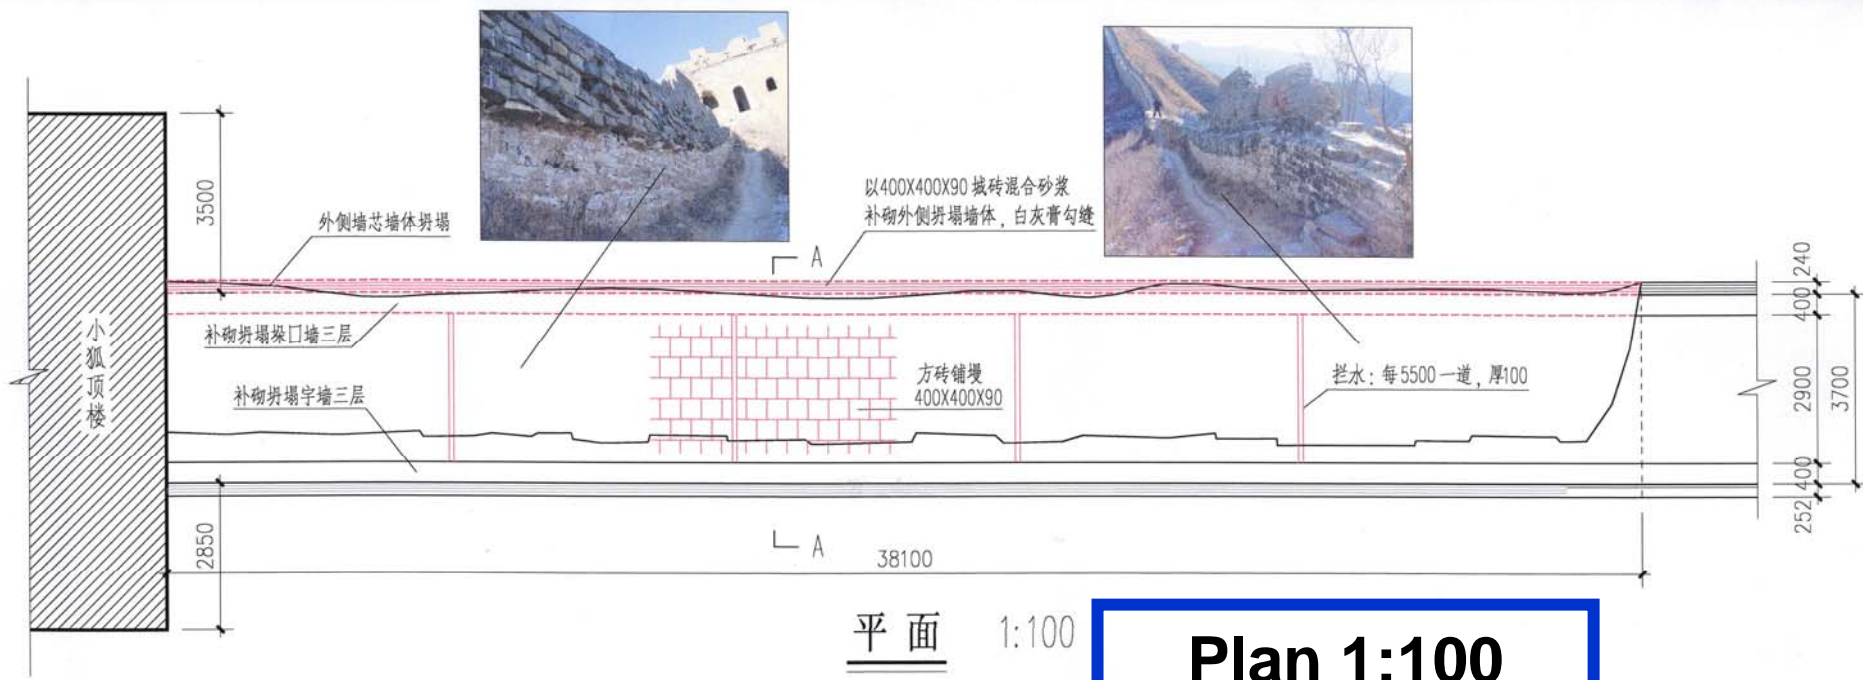
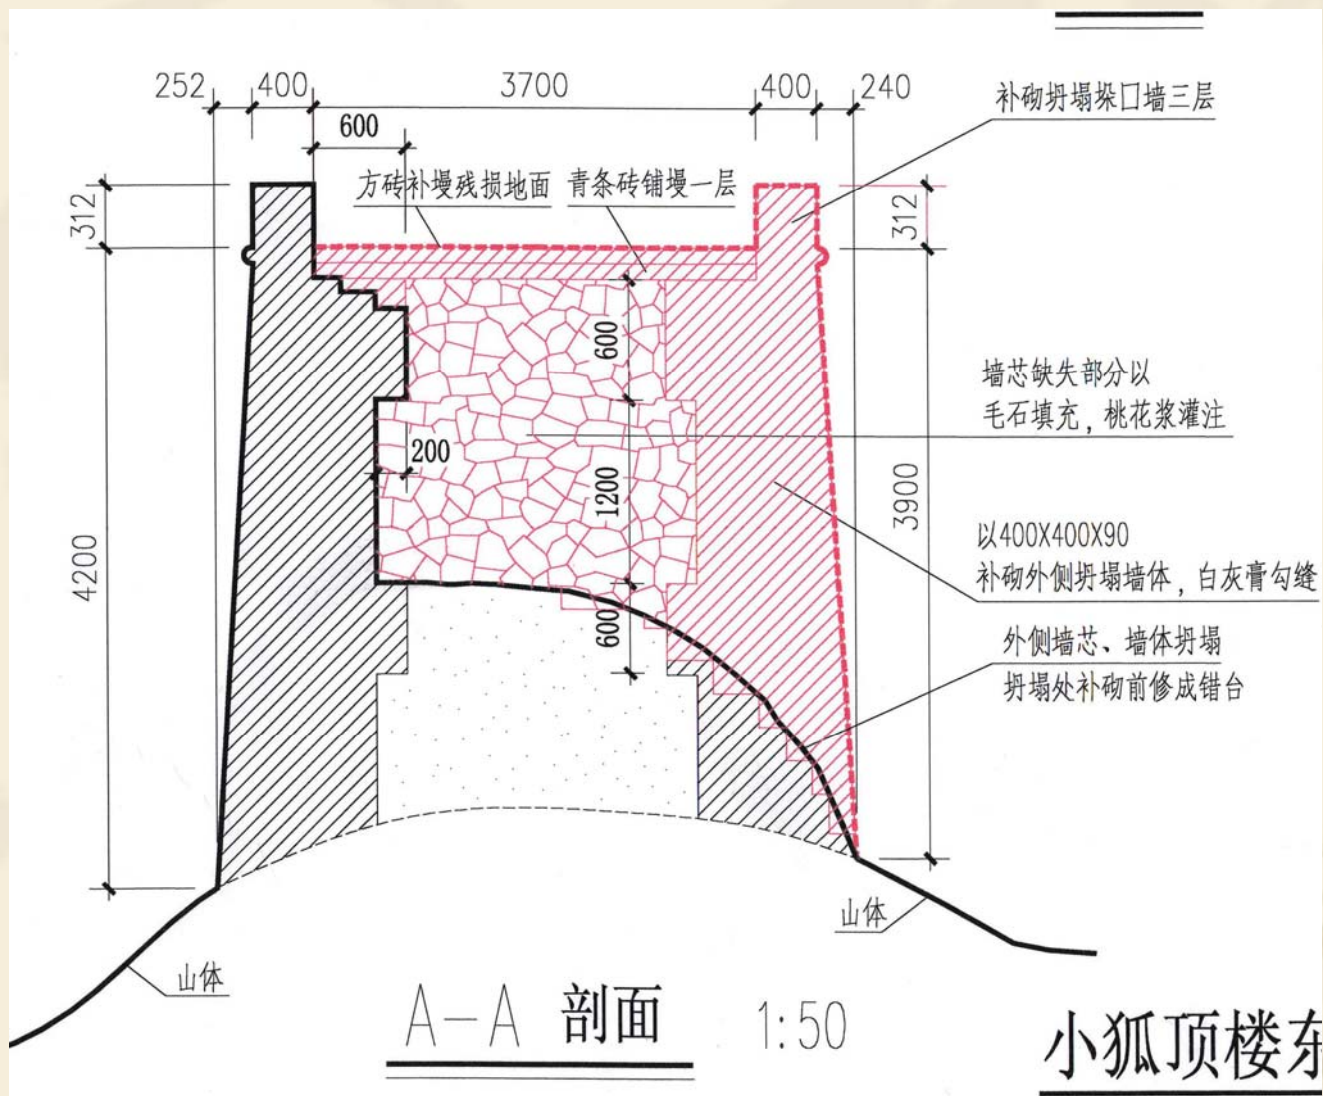
**Section 1:50**

4.2.1 Do archaeological excavations around the collapsed wall.

4.2.2 Remove the loose stone and earth, patch stone and earth, fill with the traditional slurry.

4.2.3 Replace the bricks which are old, fill with the traditional slurry.

4.2.4 Do not repair the Duokouqiang and Yuqiang entirely. Patch three layers of old bricks along the width. It should retain the origin shape.
