**MOST FREQUENT PROBLEMS IN WOODEN ROOF STRUCTURES OF THE ARCHITECTURAL HERITAGE  
PAMPLONA - COLOMBIA**

**Conservation & Management of Historic Buildings**

**Department HDM – Lund University and  
Swedish International Cooperation Agency**

**APPENDIX 1**

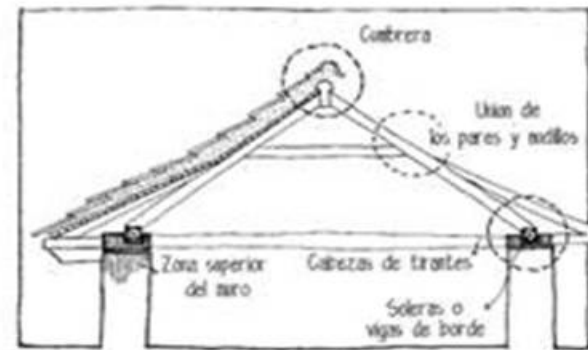
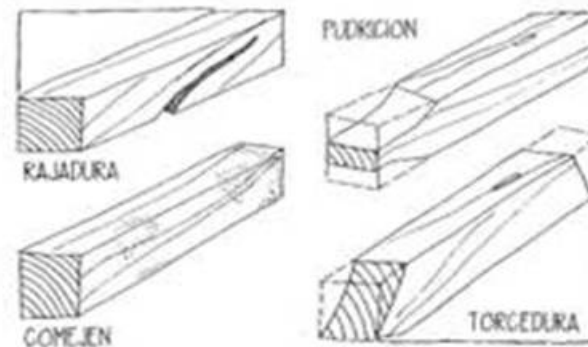
Water is the most frequent problem on wooden structures.

Leakage from the roof generates strong damages when water comes in contact with the wood. The damages on the wooden structure can be classified as:

- Cracks on the beams
- Wood rotting.
- Bend and deformation of structural elements
- Termites

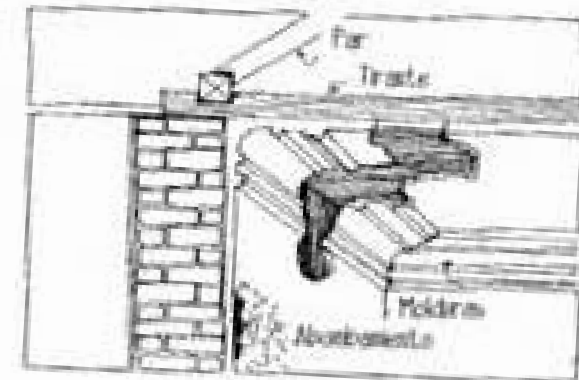
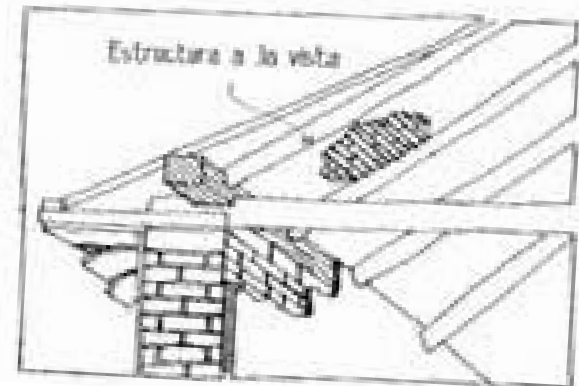
Once the water come in contact with the wooden structure it start to generates problems and degradation of several elements as ceilings and adornments of the building.

Another symptoms can be seen in the ruin and spoil of the walls due to the infiltration the rainy water.

Ruptures and disjunctions causing detachments specially of ornamental elements.

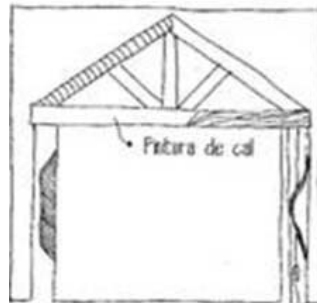
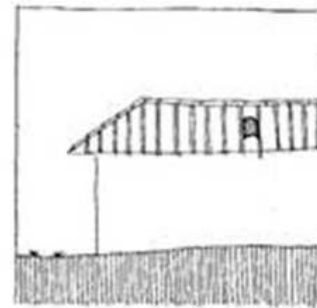
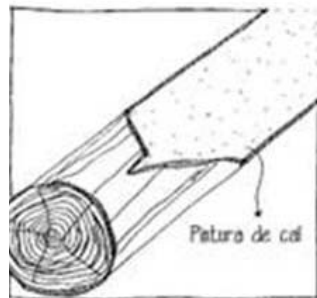
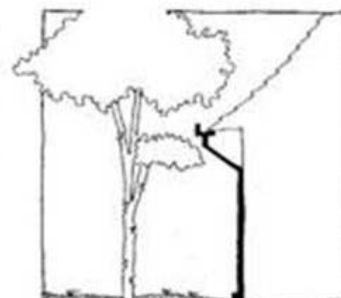
It is necessary immunize the wood structure in order to avoid humidity and biological attacks from termites and other insects.

It is advisable to protect the wood structure with slaked lime which will reinforce the protection and also will guarantee the duration of the wooden structure.

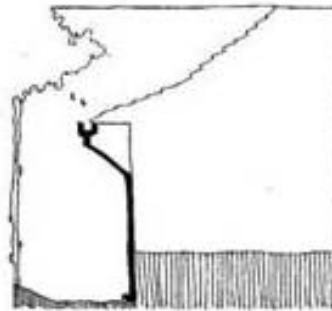
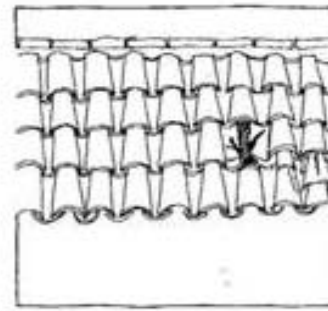
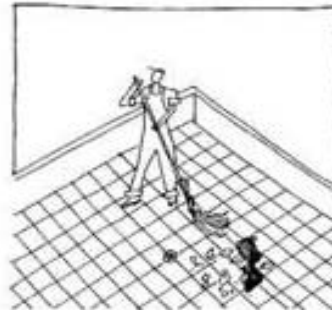
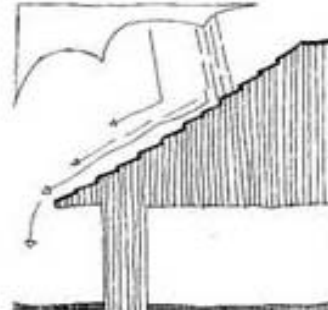
Its is advisable to clean at least once every six months the gutters and drain roof pipes in order to avoid obstructions of the drain system. The obstruction can generate overflow of the drain system and with the time rot of the wood structure.

It is necessary to check the waterproof of terraces at least one a year and replace it if gets broken or if is not working properly.

It is necessary to remove high trees and shrubs growing near to the building in order to avoid the block of gutters and the drain roof system. Also to protect the building from a falling of a tree branch. It is important to check and replace permanently roof tiles that gets broken or missing, taking care of changing its for tiles of the same size and dimensions. To keep the direction and the align of the roof tiles in order to facilitate the evacuation of the rainy water.
