LUND UNIVERSITY

COURSE “Conservation and management of historical buildings”

By: Archt. FRESIA CÉSPEDES CORDERO.

Guanacaste, Santa Cruz, Costa Rica

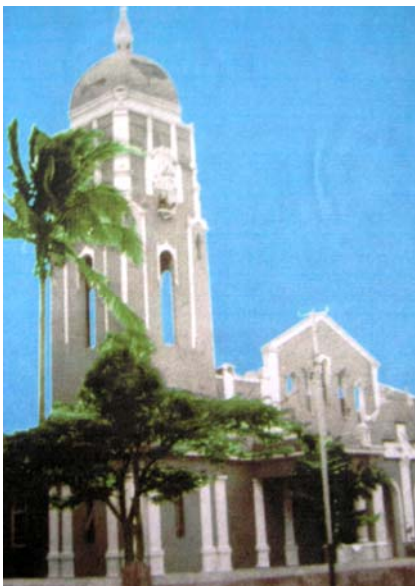
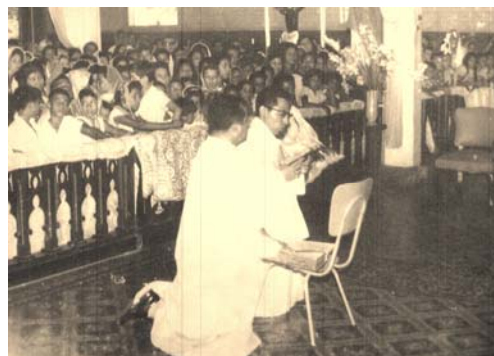
Fig 2 and Fig 3. "Internal and external views"

This pictures represent how the church looks in 1934 after the construction of the new and modern church, until now the only part of the church that remains is the bell tower. Photos courtesy of MCJD of C.R

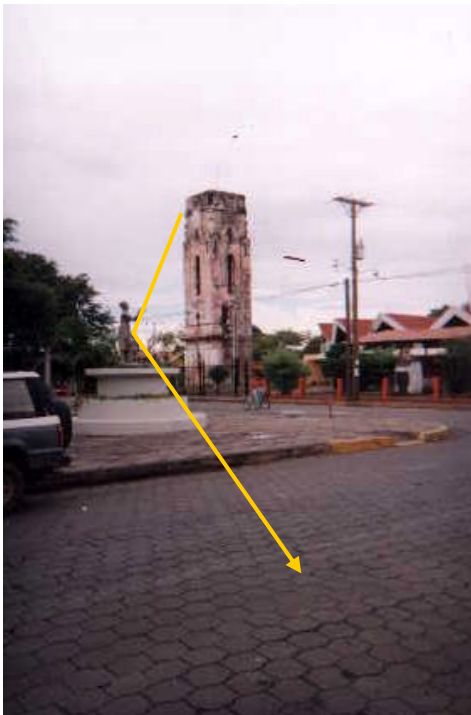
Fig. 9 “relationship between spaces”

An analyze of the tower height in relation with the street and the park in front of it, as well as the communication between symbols like the statue, the tower and the park, is relevant in this photograph, they represent the city center a mark in the landscape a sign for the pedestrian and inhabitants. This elements create the sense of please in the site.

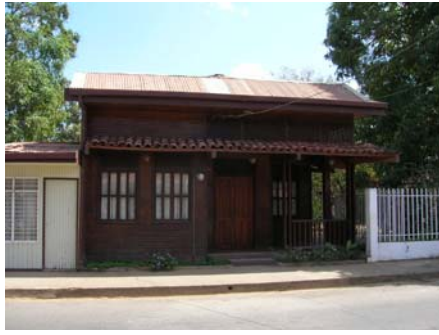
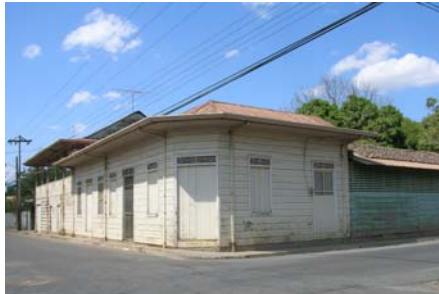
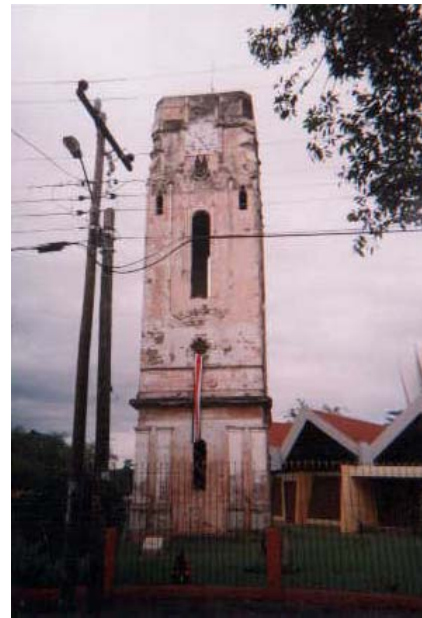
Fig. 10,11,12,13. “Santa Cruz’s urban profile”

Observe the different scales between the elements. A prominent element surrounded by one floor wooden houses.

Santa Cruz is a low density town, most of the construction is composed by one or two floor, made of wooden structure and zinc roofs. In a very simple way, very modest heigh-ceiling with one floor and long slanted that protect windows from the heavy sun (see fig. 8), It is easy to understand the architectural magnificence of the tower in this environment, if we compare the tower with other architectural pieces it probably is not very impressive, but it is important to analyse the study object in its context. Under these conditions the tower emerges as a prominent symbol, constructed with new materials in the midst of a little villa with a low urban profile. (see fig 10,11,12,13)

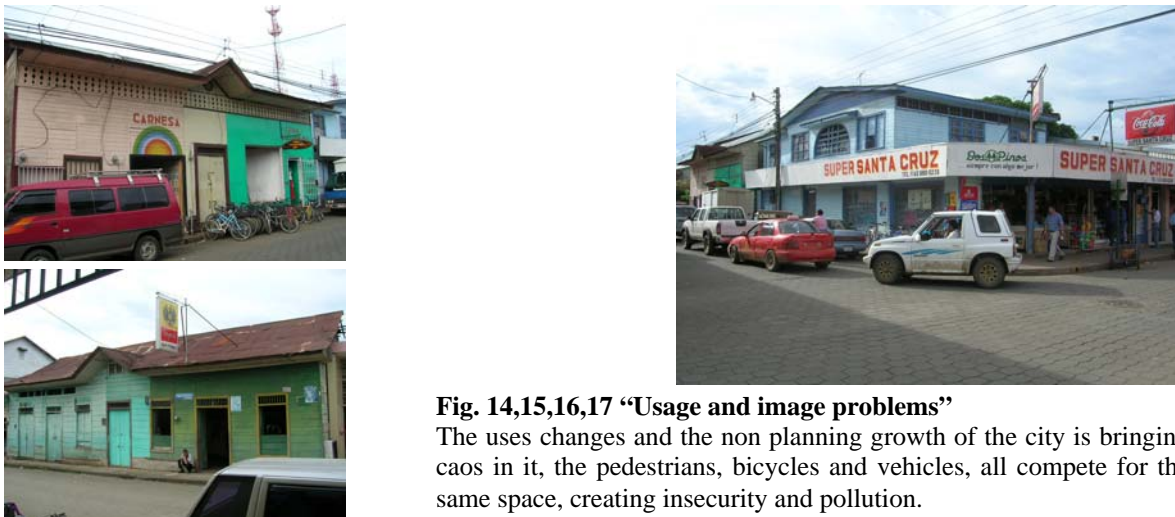
Fig. 14,15,16,17 “Usage and image problems”

The uses changes and the non planning growth of the city is bringing caos in it, the pedestrians, bicycles and vehicles, all compete for the same space, creating insecurity and pollution.

Santa Cruz as a border city presents many urban design problems, mostly refered to the change in use of its areas. The city is not prepare for the population growth and tries to supply economical needs. These issues along poverty, cultural identity loses and non planned growth, this little city tries to keep up with global flow, but in the matter of urban image, cultural values and folklore it is loosing the battle. (See fig 14,15,16,17)

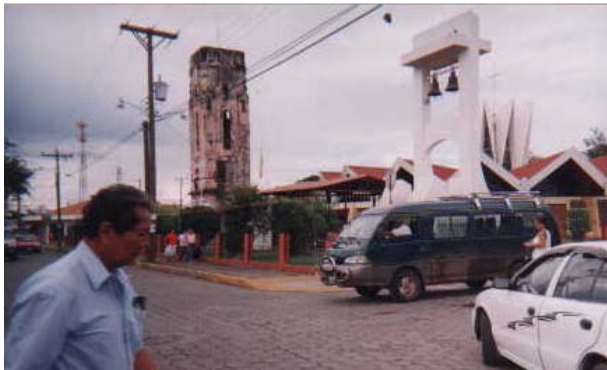
As most of the houses in the surroundings today work as shopping centers, the tower is used as storage building and its deterioration is easily to detect, the urban problems embrace it and cover it with pollution and isolation, (see fig 18): a fence has been built around the building, interrupting the integration with the public space.

Fig. 18. “Chaos in the urban environment”
The problems surrounding the tower: the car traffic and the pollution within, makes the tower look like an isolated element in the middle of all the urban confusion around it.

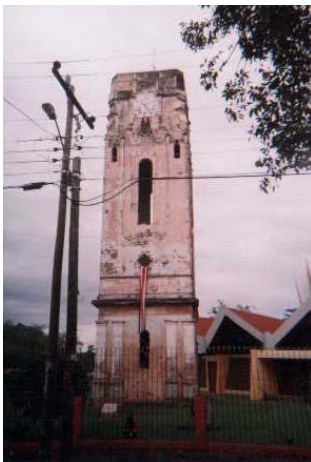
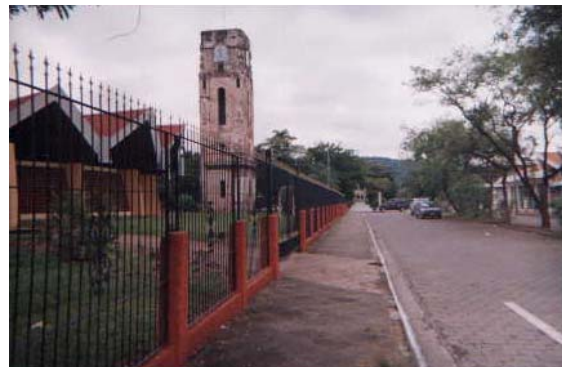
The door of the building are closed, and there is no access to it, the only way to approach it is walking through the church gardens destroying the grass (see fig 19, 20)

Fig 20,21. “communication between spaces”
The permeability of the fence is not enough to integrate the tower with the public space, instead of that, it creates the sense of isolation

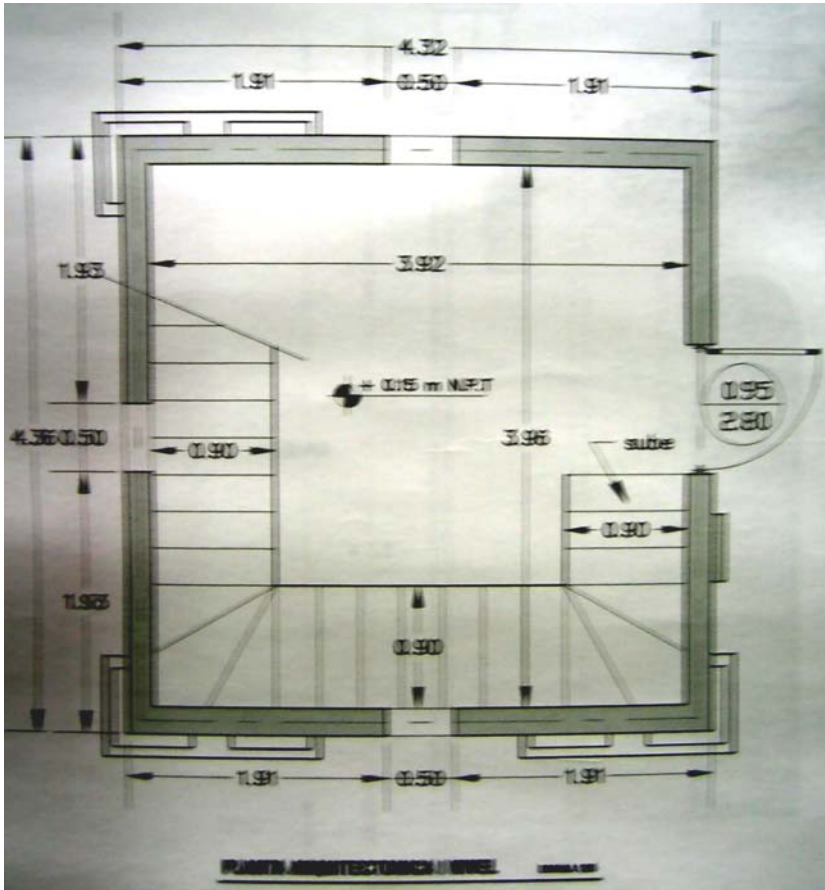
Drawing. 1. Plan of the bell tower's fist floor''

According with the plans, the solid concrete walls work as support structure, the columns in corner have an esthetic function, non structural. One door three windows about 0.50m each. The floor level from the ground is 0.15m.

According with the plans¹¹, Santa Cruz's bell tower is a 4.32*4.36 square building (see draw1). The stair only leads to the second level. To acces the third floor is necessary to use a ladder, which doesn't exist any more, it used to be in wooden structure it don't last until today. (see drawing 2)

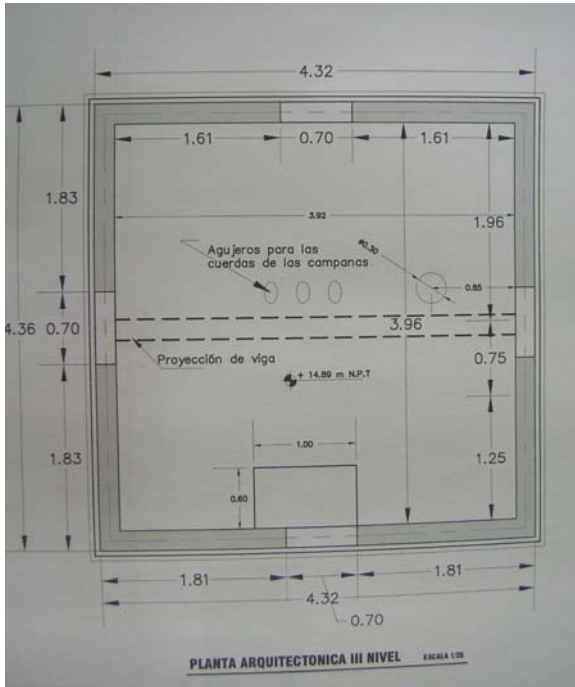
Dra.2. “Third floor”

This plan indicates the location of the stairs as well as the holes for the bell ropes.

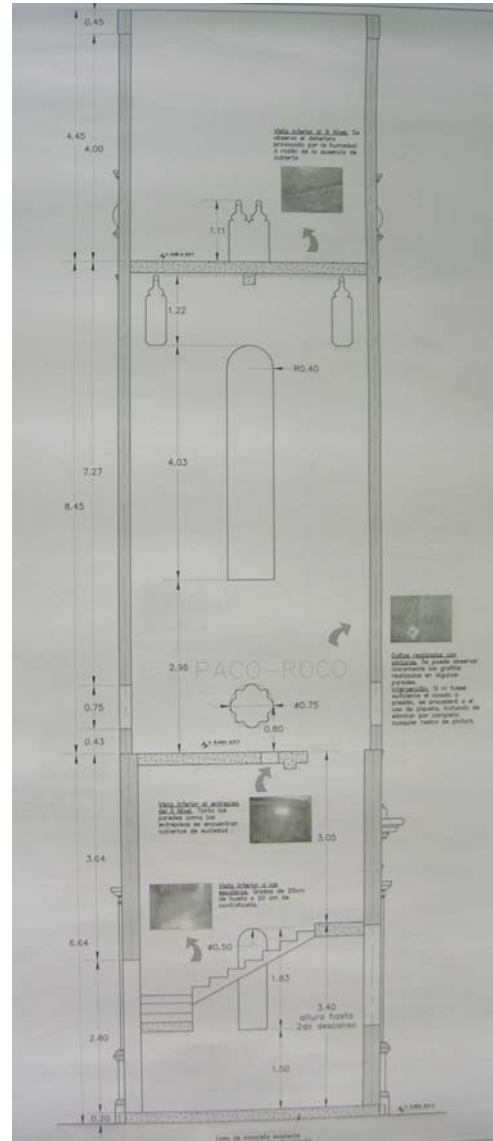
Dra.3. “Section view”

Three levels appear in the section, the cupola and the ladder are gone, the first one was removed in 1970 and the ladder before that time.

The tower is 19.70m height (see draw 3), and has three floors. It was built in concrete, with steel bars, the plaster is also concrete, and the paint is a mix of clay and natural pigments.

Inside the tower there is a concrete stair used to access the bell, that no longer exists, it also has two clocks in the façades, that don't work at the moment, (see draw 3).

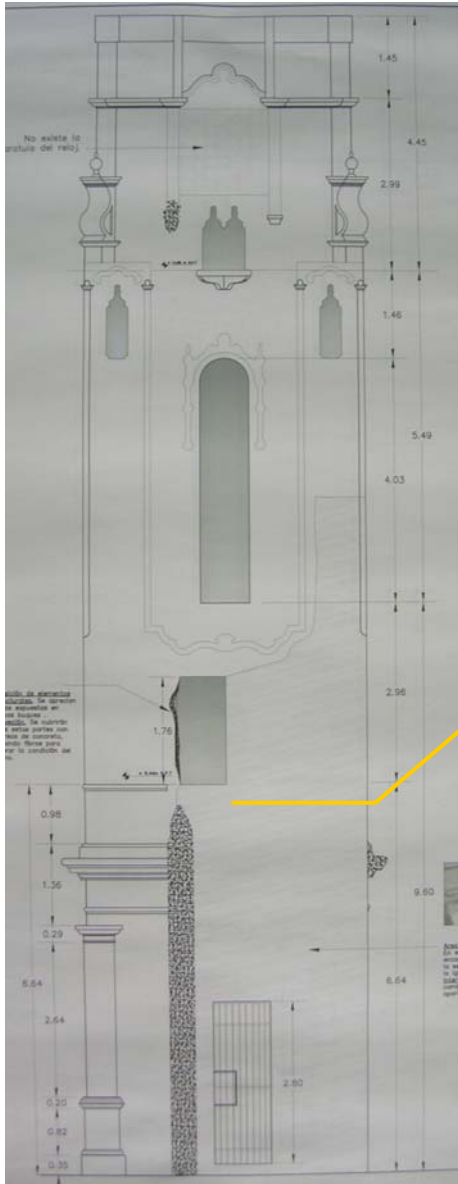
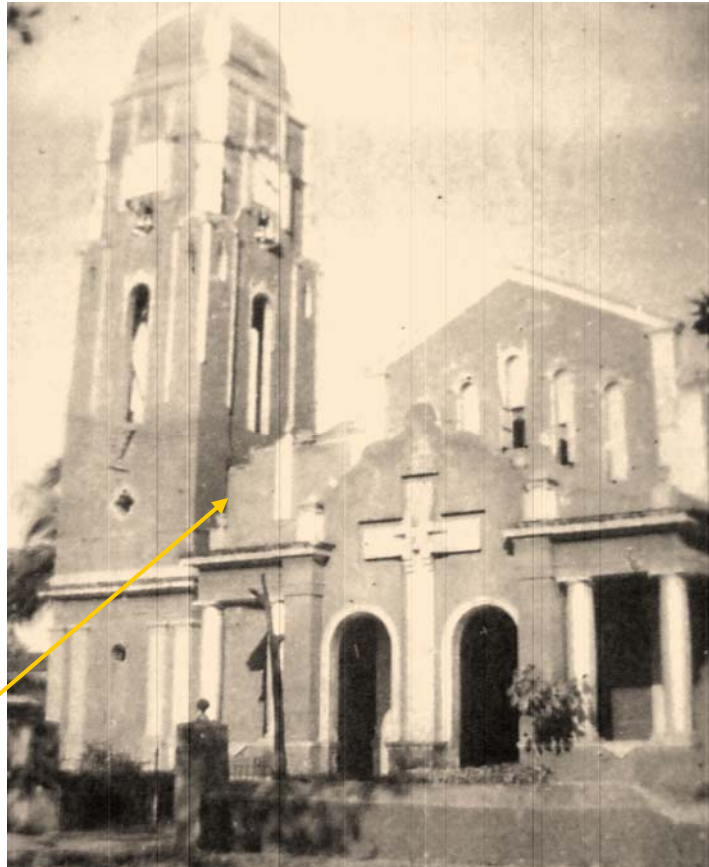
Fig.22. "old church building"

There can be seen the way how was connected the church and the bell tower.

Drawing 4. "lateral view"

How it is today, without the rest of the façade, the marks were the building used to by are easy to see until now.

The bell tower has four façades, very similar between each other, with the exception of one, where there is a door, in this facade used to be the rest of the building that was demolished in 1970 according to build the new modern church. (see drawing.4 and fig 22.)

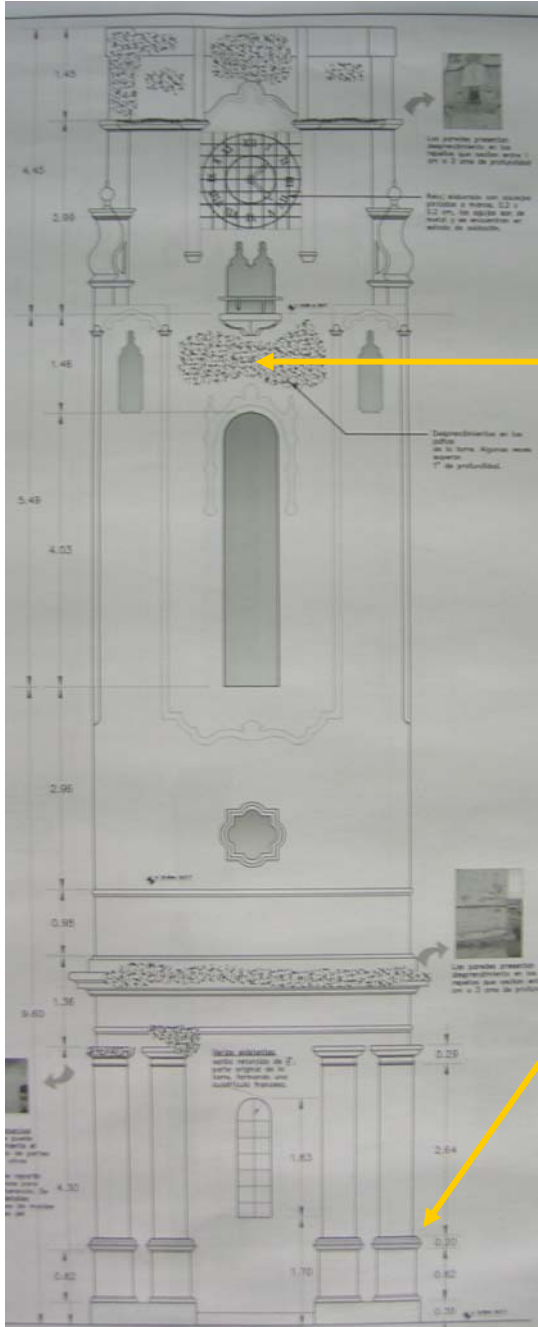
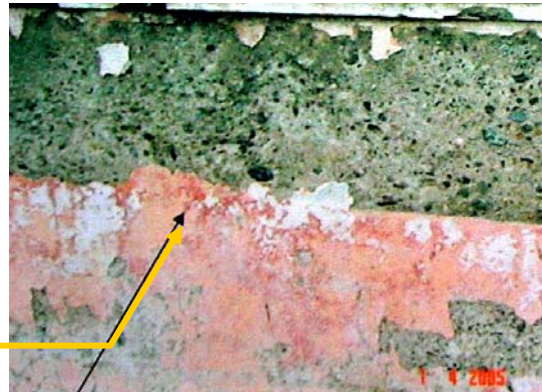
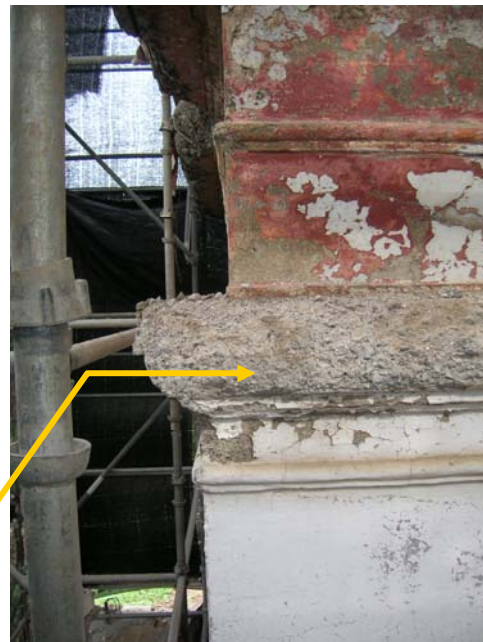
Dra.5. "front view"

Today's tower situation can be describe with five evaluation parameters such as: crakes in the blaster, holes in the blaster, shape loses, structural problems and missing elements. The crakes go from 1mm to 25mm if the crake is bigger and dipper than 25mm is going to be listed as a hole in the blaster, many crakes are not shown in the plans because they were to little to be listed. (Drawing 5)

The crakes in the façade are the sign of time and weather over the structure, it appear when the plaster has to move according with the hot and cold, dowse changes start cracking the plaster, then the algis, and fungus get in this little crakes making the problem even grows.

Mayor crakes as the one show in the photographs, have not become structural problems in most f the cases are plastered crakes.

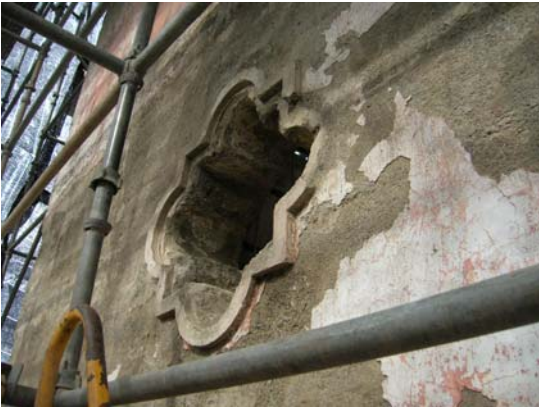
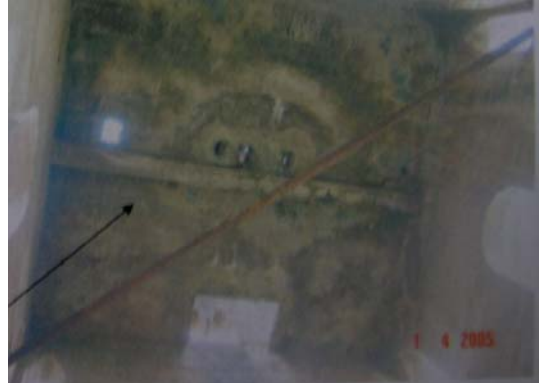
Fig. 23,24. “Non estructural problems”

The holes in the tower appear when part of the plastered is missing or about to fall (see fig 23, 24) other kind of holes appear and they are not structural problem, but the hole cross the concrete wall as it is shown in (fig 23, 24) in most of the cases these holes were done for a reason, specially in the rainy season when the roof was leaking and the water gets in to the tower the only way to take it out was drilling a hole in to the wall.

Non structural problems are the ones that don't interfere with the building structure such as the crakes in the plastered, there are not only crakes, the tower shown missing plaster parts, and missing parts in the permanent adornments. There are also holes in the third floor, this create leaking problems.

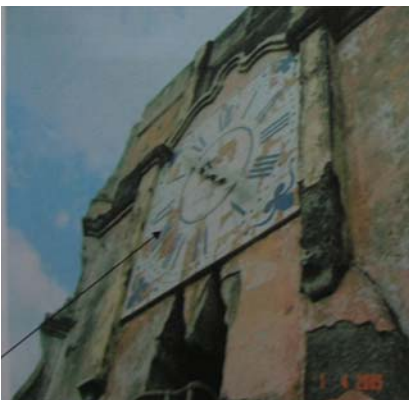
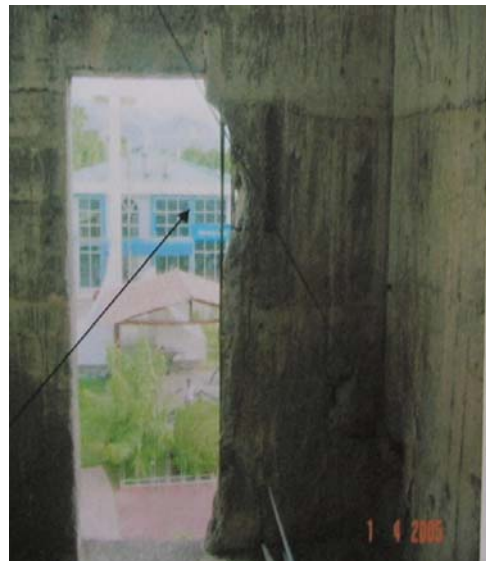
Fig. 24,26 “missing parts in element's shape”

Shape loses are the problems that has some elements in the tower, they has loos part of their shape this problem can be seen in most of window, corners and permanent adornment, they have failed in the past time without appropriate attention. (see fig 25,26)

The first part was to identify how many parts are missing and to analyze, how is going to react the new concrete with the old one, and in that way define what kind of concrete is going to be used to rebuilt those elements.

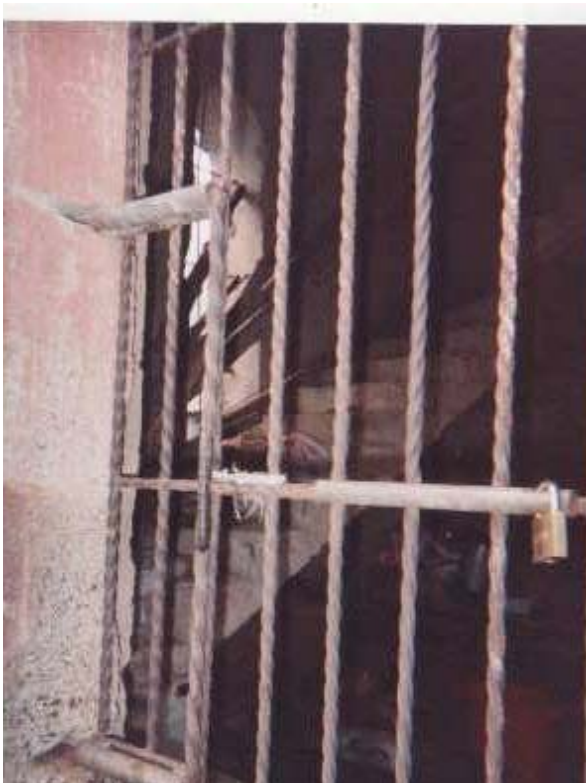
Fig.25,26,27. “un security and accessibility”

Accessibility problems were identify specially inside the tower, were the stair has bad shape and are unsafe, the accesses to the third floor is impossible, because the wood ladder disappear in time, and the windows don't have any protection of the weather. Approach the tower from outside it can be done in an unconftable way, there is no fire protection or light power, according to the public services such as toilets are inexistent. (see fig 25,26,27)

According to the plans the stair only have 0.90m and don't have any security element, and the accessibility from outside can be done walking over the grass in the church garden.

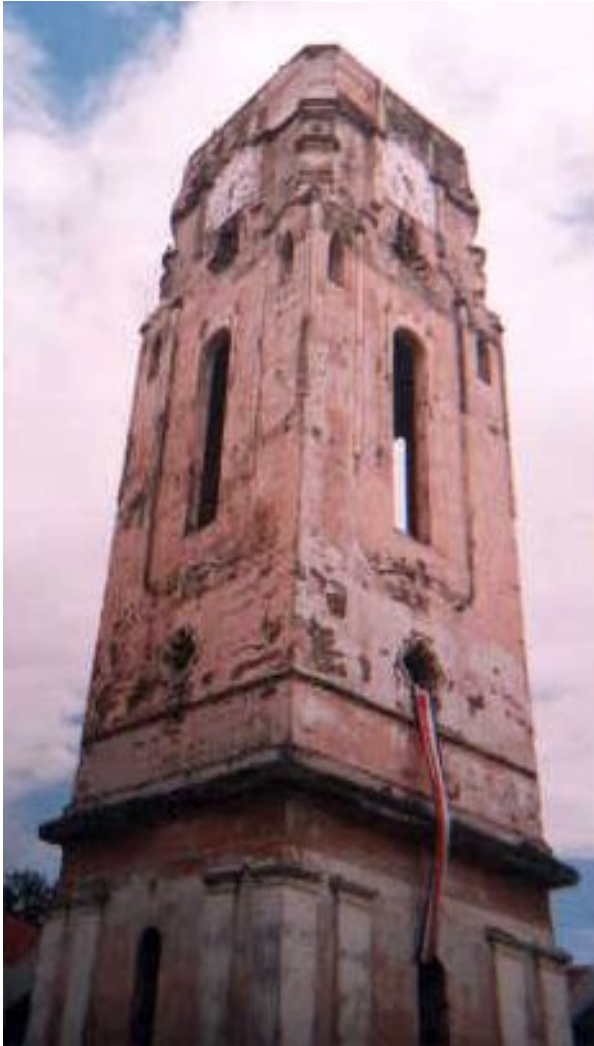
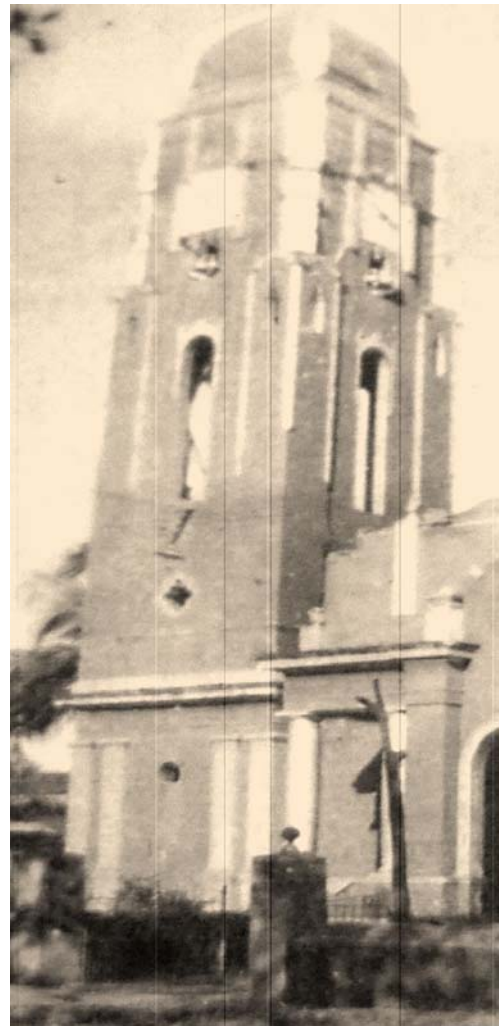
Fig 28,29. “Missing elements in the bell tower”

There are only three elements missing in the tower, the copula, the bell and the clock in the rear façade all of them were remove in 1971, according to built a new church, when the government want to demolish the entire building, in old photographs it can be seen the bell tower with the copula as it is shown in the following pictures see (fig. 28,29)

Comparing the two pictures is easy to see that the copula is missing, the clock don't work any more and bell, was remove in 1971.

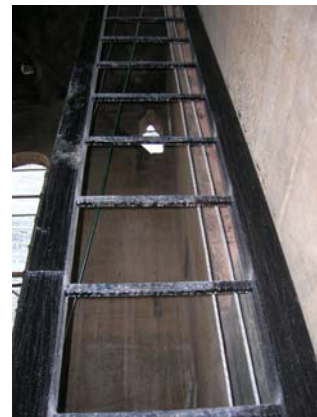
The stair were built and the steel element added, to prevent accidents, and the steal ladder is in the position it used to be long time ago. T

The material change respond a economical reasons, the steel last longer than the wood specially in high humidity countries as Costa Rica.
