Revaluation of Callejón del Fino

Design of the Urban Evolution Museum of the Historical Centre of Guatemala

**Advanced Training Programme of Conservation &
Management of Historic Buildings
Lund University**

March 2006

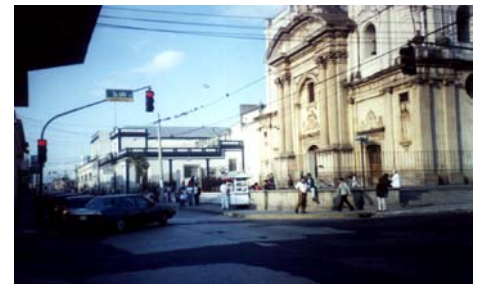
Picture 10
Aerial view
Barrio La Merced

In order to generate a better infrastructure the actual urban furniture is analyzed. The barrio La Merced, has paved roads, electricity, water, phone service and transportation. La Merced church is located on 11th avenue, which is visited by many neighbors on a regular basis, next to it is the Police Hospital, where previously was located the La Merced clerical home, and on the opposite corner are located the police offices. (See Picture 10).

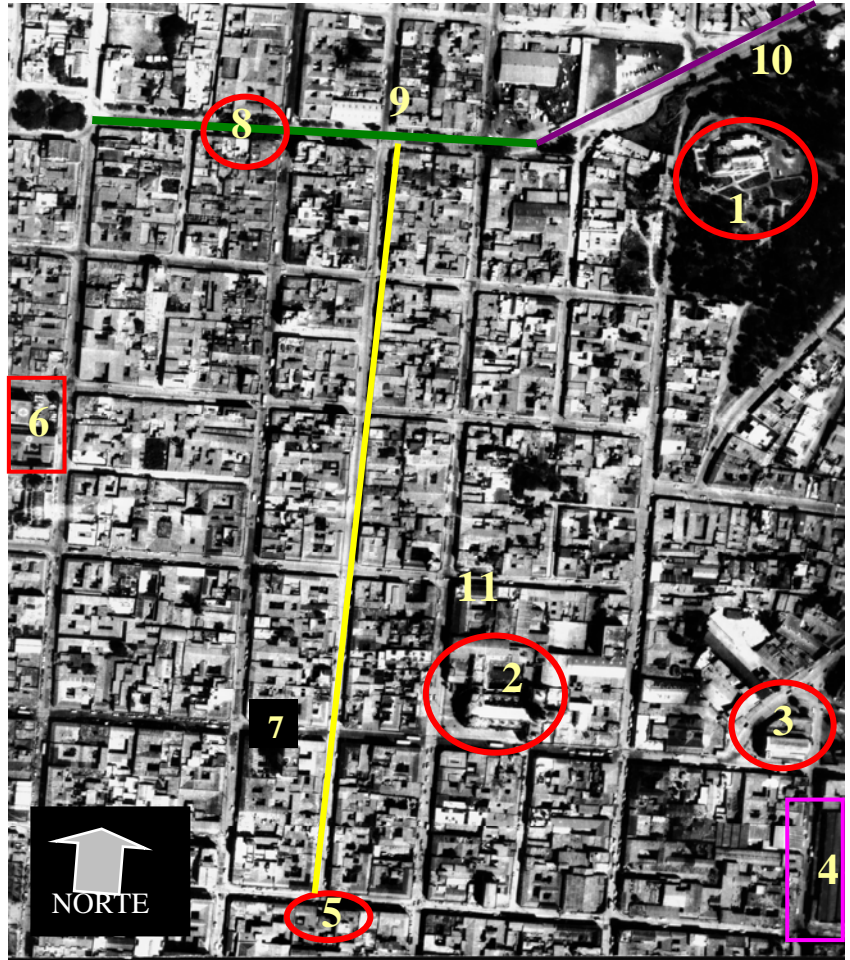
1. Iglesia del Cerrito del Carmen
2. Iglesia La Merced
3. Iglesia San José
4. Mercado Colón
5. Antiguas Oficinas del Periódico “El Imparcial”
6. Cruz Roja
7. Callejón del Fino (10 avenida “A”)
8. Parque Isabel La Católica
9. 1 calle zona 1
10. Diagonal 9
11. Cuerpo de Policía

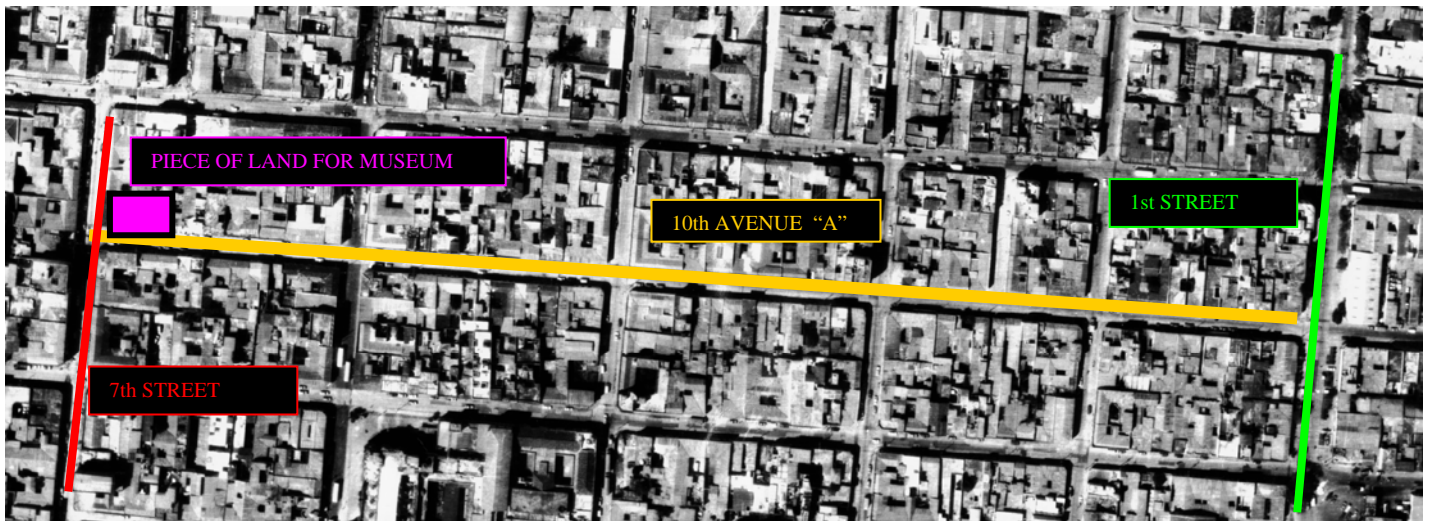
Picture 11
Landscape
Callejón del Fino, and a piece of land for the museum of the Urban Evolution of the Historical Centre of Guatemala

Callejón del Fino is located in the 10th avenue “A” from the 1st to 7th streets of zone 1 (See picture 12). Secondly there is an abandoned land, which still conserves its original front wall, inside the alley, where the Architectonic and Urban Evolution Museum will be developed.

In the picture it can be observed the abandonment of certain monuments. The proportions and colonial style are part of the heritage of the avenue. The multilevel building built on sixth street, breaks with the original scale of the area.

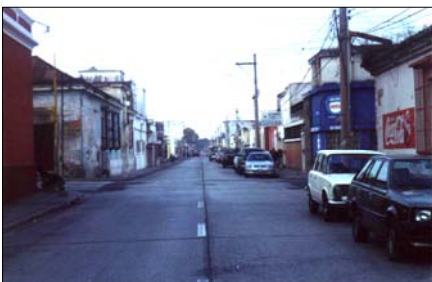
The signs painted in the facades of the houses contaminate the visual environment of the avenue.

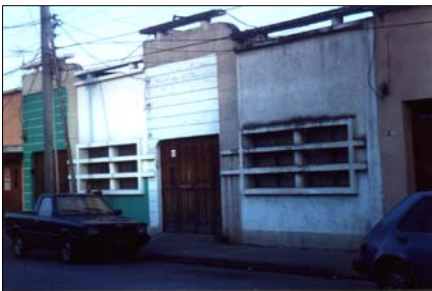
In the picture we can observe an art deco building, it was constructed in the period from 1920 to 1950.

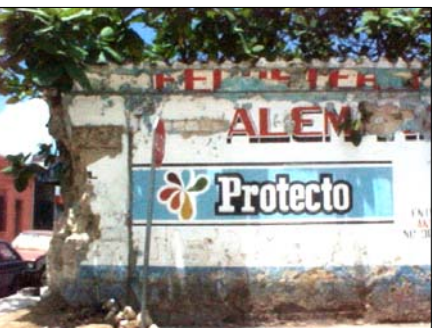
The building conserves only its wall of facade, the interior is covered with vegetation. The facade shows publicity signs. We can see adobe in some sections of the cave in on the corner wall.
