Conservation and management of historical buildings 2008

*Programme of work for the preservation/maintenance
plan for the old District Officer's administrative
colonial building in Malindi, Kenya*

**Abdulswamadu A. Ali
Engineering Technologist
National Museums of Kenya**

November 2008

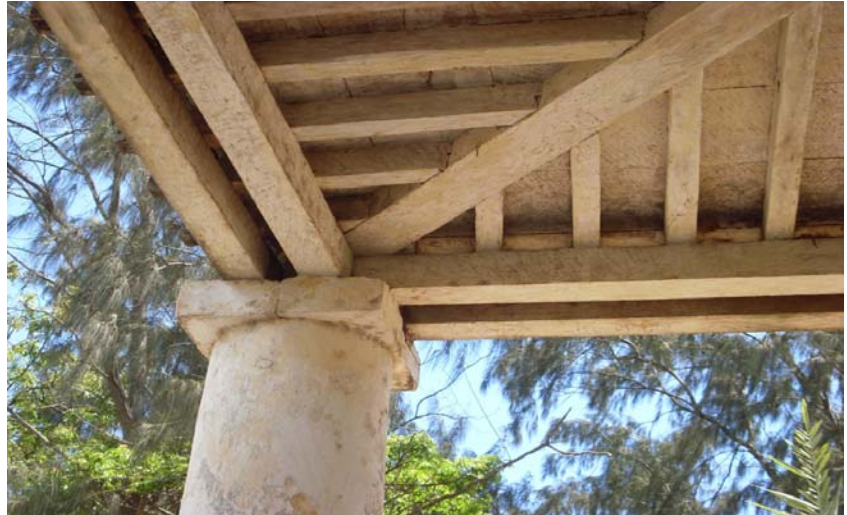
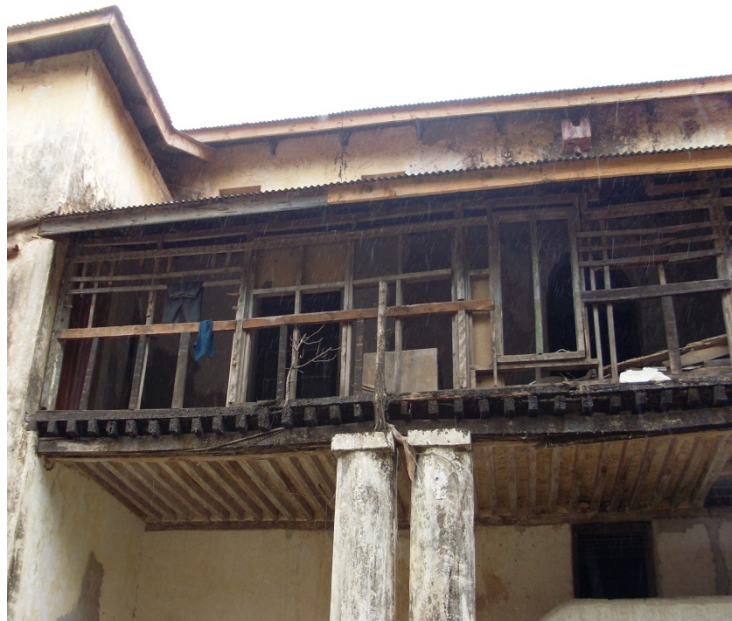
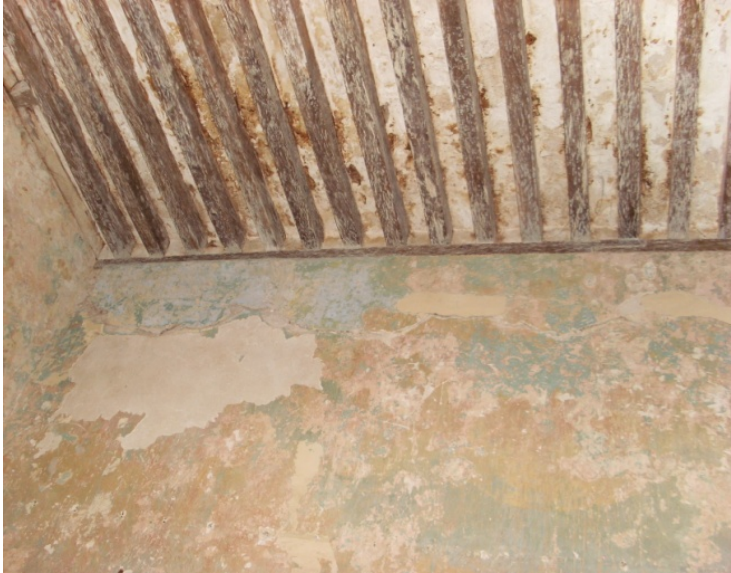
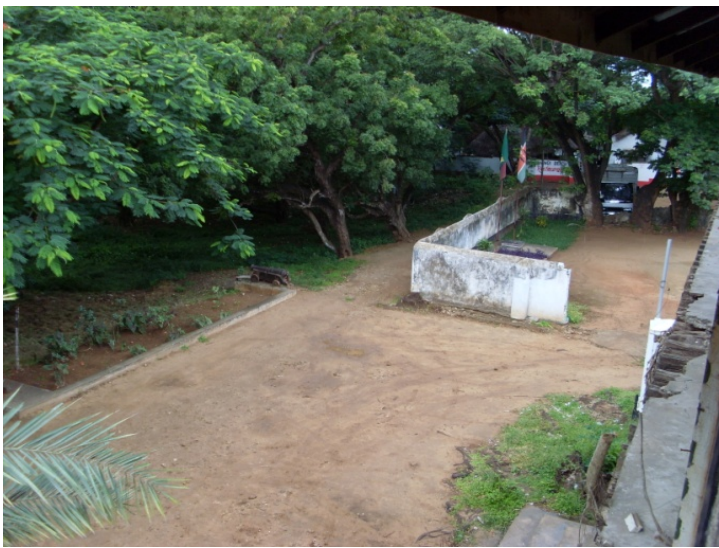
BEFORE INTERVATION

The state of the building is precarious and requires urgent intervention. Water leakages, rotting timber beams, and unstable structural walls are but a portion of the main problems afflicting the building. The corrugated iron sheets leak profusely into the floors, thus causing considerable rot to the wooden roof members (trusses and purlins). Due to leakages, most of the upper walls are partially exposed to rain and sunshine, which destabilize the plastered facades. Ceiling beams, carrying the load of the first floor, have been affected and have rotten to a dangerous degree. In a nutshell, the state of the building is that of total negligence and total decay. Presently, the NMK is undertaking restoration works to the building.
