LANE House

Maintenance Program & Plan

Lia Mayumi

DPH - Department of Historic Heritage/ Municipality of São Paulo/ BRAZIL

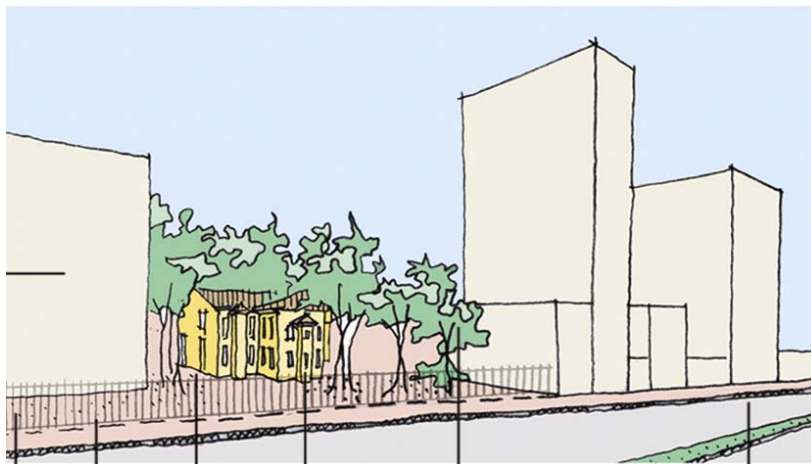
Figure 14: Demolition of the supplementary building, prohibition to build inside the buffer zone: measures to enhance the architectural values of the building.

The demolition of the supplementary building is included in the conservation project.
