The Subercaseaux Building

Evaluation of the structural capacity in traditional construction in Valparaiso

Marcela Hurtado Saldías

Universidad Técnica Federico Santa María – CHILE

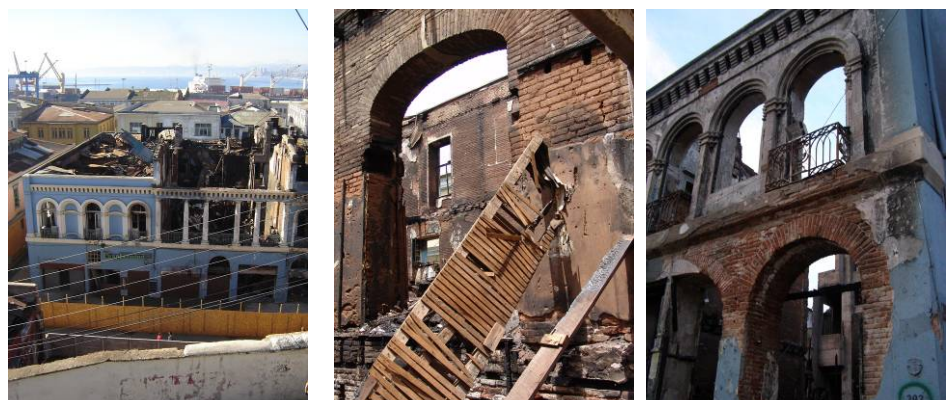
In February 2007, due to the explosion of a colindant building, several damages occurs to the Subercaseaux building. The inner wooden structure and the ceiling are the most damaged ones. The external walls stand, as well as some interior walls, all made out from clay brick masonry.

The impact this event produces encourages local specialists intervention and even the arrival of the UNESCO⁸ General Director with a commission, to offer aid and technical assistance. The photographs show the magnitude of the disaster but also the resistance of the main walls of the building. Generally, those thick clay brick masonry walls are the ones who stand. During the following days to the tragedy, all the remaining of the structure is demolished situated at the west facade, in front of the Subercaseaux building.

The reason for such an action is the lack of security the rest of the walls offer. As it is possible to see, what remains standing are discontinuous fragments that, in a first glance, should be demolished. This crew in charge of the evaluations was composed by civil engineers.
