Conservation of Teferi House As A Museum

A Project Proposal for Rehabilitation of the Teferi House
that will have new function after maintenance and
modifications

Imran AbdAllah

March, 2009

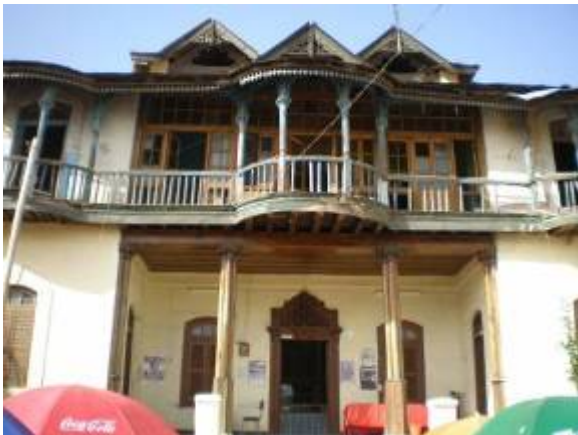
Fig.3.1. The Exterior Wooden Features of the Teferi ouse House

Exterior wood features of the house such as siding, corner boards, brackets, columns, window and door surrounds or architraves, cornices, pediments and balustrades; and their paints, finishes and colors — that are important in defining the overall heritage value of the building are still many. The missing elements of these features are little.

These external wood features will be retained and persevered using standard preservation techniques and guidelines.
