Conservation and Management Plan of the Ganoza Orbegoso House

And guidelines for a *mise en valeur* project

Conservation and Management of the Ganoza Orbegoso House

Melissa Thereliz Cabrera Rodríguez

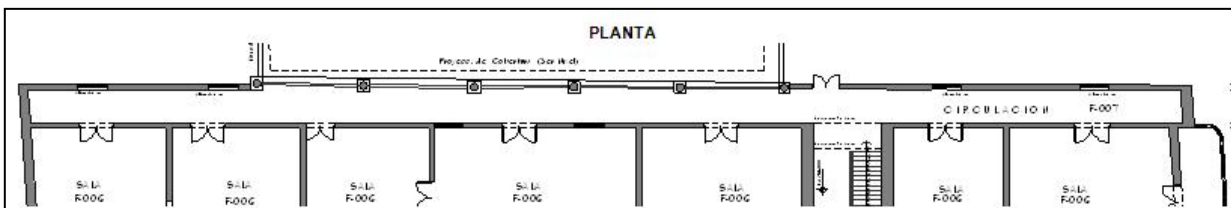
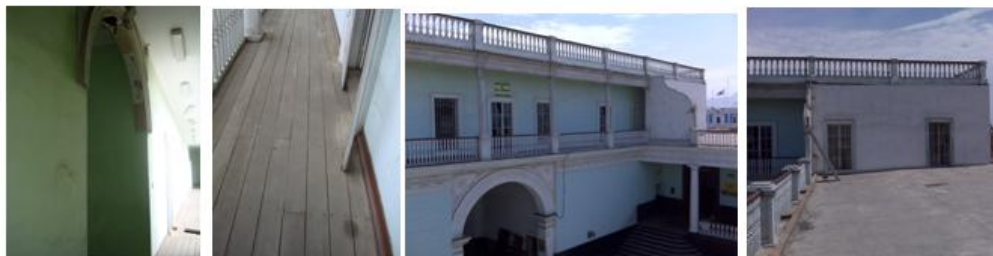
En el segundo nivel de la parte delantera (hacia la Plaza de Armas) posterior se encuentra una circulación horizontal. Esta construido de quincha y su altura es 3,90 m. Tiene buena iluminación y ventilación natural. Es necesario sustituir los vidrios de las puertas y completar las barandas de madera y la cornisa deterioradas por las lluvias y la erosión del tiempo. En la parte superior de la fachada que da hacia el patio tiene una baranda con adornos (pináculos) de madera, los cuales deben ser recuperados. El piso es de madera (entablillado) y presenta un buen estado. En el acceso al pasadizo hay un arco de medio punto hecho con madera, el cual debe ser reparado.

CROQUIS	DESCRIPCION DEL AMBIENTE	ESTADO DE CONSERVACION	RECOMENDACIONES
	Área: 342,75 M ² Altura Interior: 3,90 M	Uso Anterior: Pasadizo	Mantener el uso de circulación.
	Pisos: De Madera	En buen estado	
	Muros: De Quincha.	En regular estado	Necesidad de evaluación estructural
	Puertas y ventanas: De Madera con vidrio.	En mal estado	Colocar cerraduras Completar vidrios de las puertas.
	Techo: Viguetas de Madera con torta de barro con cielorraso de yeso	En mal estado	Completar las barandas, pináculos y cornisas de madera.
	Revoques: Rotachado de yeso.	En buen estado	
	Luminarias: Tiene 0 luminarias	Inoperativo. En mal estado	Sustituir las luminarias existentes
	Pinturas: Zócalos marrones con esmalte, rejas blancas con esmalte, muros color verde agua con latex, cielorraso blanco con imprimante		Pintar los muros, cielorrasos y puertas.

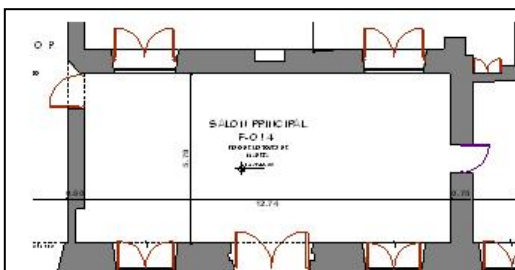
Desde el centro de la Galeria Principal se accede al Salón Principal. Antes funcionaba como Biblioteca. Tiene buena ventilación e iluminación natural. El piso es de tabloncitos de madera apoyados sobre viguetas de madera y se conserva en buen estado. El techo es de madera con cielorraso de yeso y presenta dos tallados (fotos 7 y 8), los cuales deben ser completados respetando su diseño.

CROQUIS	DESCRIPCION DEL AMBIENTE	ESTADO DE CONSERVACION	RECOMENDACIONES
	Área: 73,50 M ² Altura Interior: 5,15 M	Uso Anterior: Biblioteca	Cambiar el uso a Sala de Exposición.
	Pisos: De Madera	En regular estado	Cambiar maderas deterioradas del piso
	Muros: Adobe	En regular estado	Demoler pizarra existente, resana tarrajeo, Colocar cerraduras.
	Puertas y ventanas: De Madera y Rejas de Hierro	En regular estado	
	Techo: Viguetas de Madera con torta de barro con cielorraso de yeso y adornos.	En buen estado.	Completar adornos del cielorraso (rosetones).
	Revoques: Rotachado de yeso	En buen estado	
	Luminarias: Existen 8 fluorescentes.	Inoperativo, en mal estado	Sustituir las 8 luminarias existentes
	Pinturas: Zócalos, puertas y ventanas de maderas marrones con esmalte, rejas blancas con esmalte, muros color rosado con latex, cielorraso blanco con imprimante	En regular estado	Pintar los muros, cielorrasos, puertas y rejas.
