**Conservation and Maintenance of
Dutch Naval Commissioners House,
Trincomalee - Sri Lanka**

Conservation and Management of Historic Buildings
Advanced International Training Program 2009/10
Lund University- Sida

MAINTENANCE PROGRAM AND MAINTENANACE PLAN AND DOCUMENTAION

THE DUTCH NAVAL COMMISSIONER'S HOUSE AT TRINCOMALEE - SRI LANKA

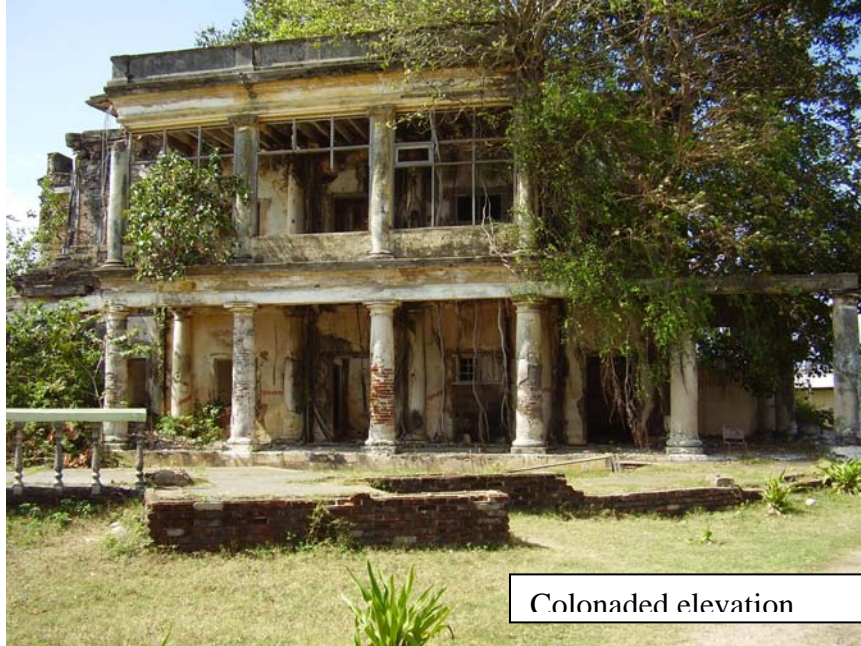
Colonnaded elevation

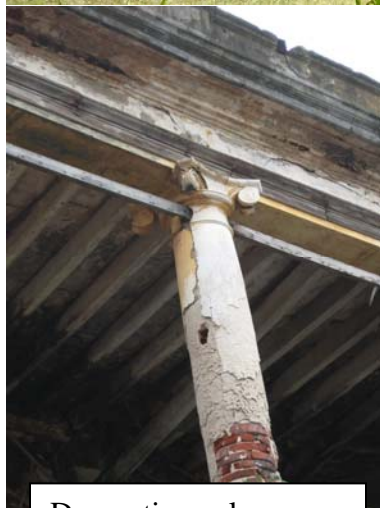
Decorative columns

The brick masonry columns- Plaster of the columns could be decayed due to exposure to weather and due to salty wind from the sea. Periodical inspection and treatment is needed.

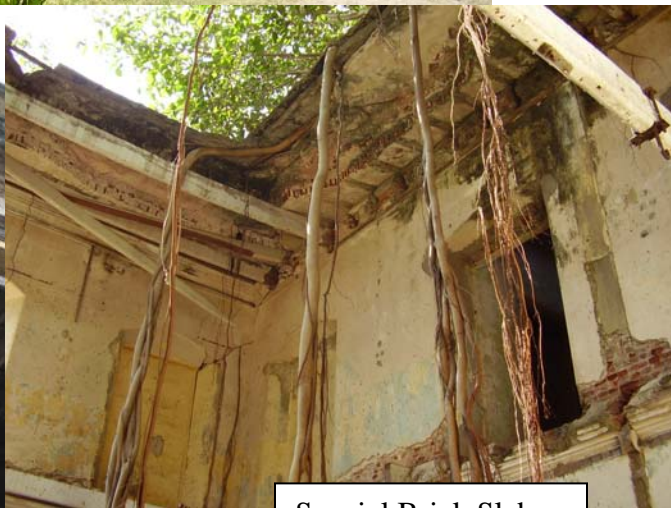
Special Brick Slab

First floor and roof slab- Part of the original brick slab is remaining and was conserved. Periodical inspection of changes and cracks should be done to prevent damages.

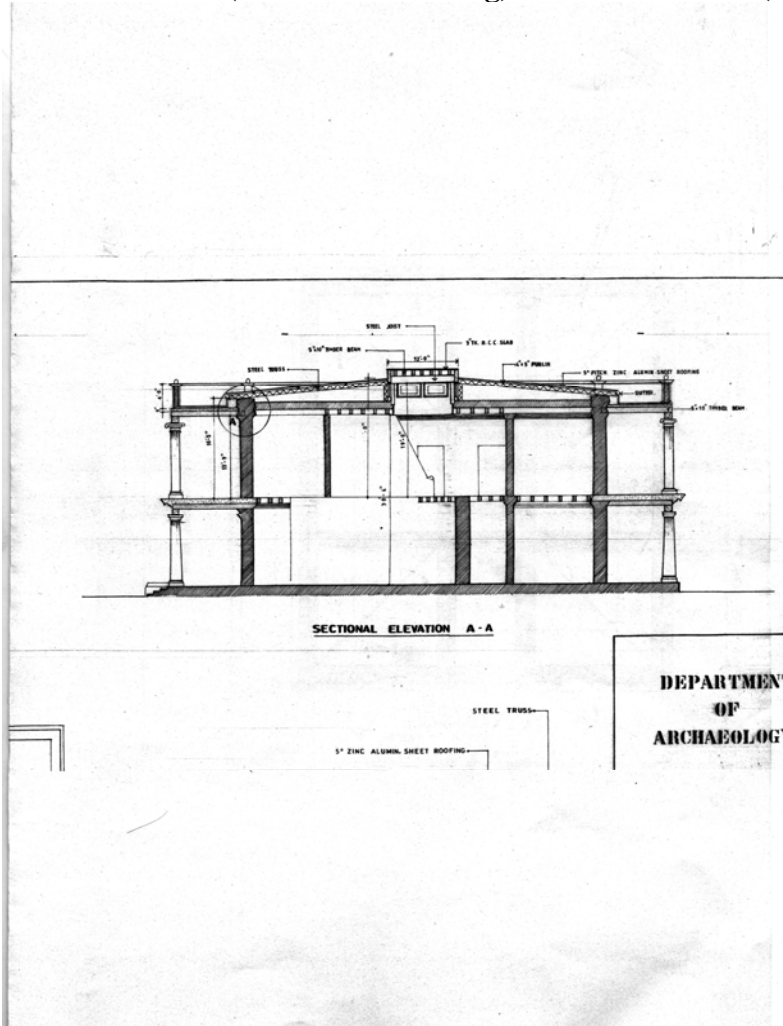
Section with the modern roof

Modern roof – galvanized iron is used for the modern roof. Corrosion should be avoided with necessary actions time to time.

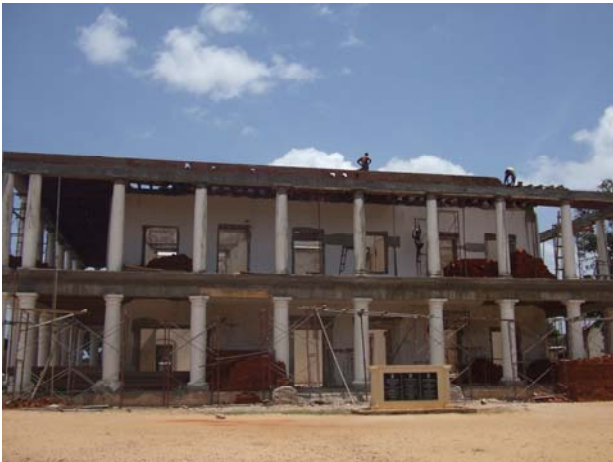
Building being conserved – Modern roof
